***CONDITION ASSESSMENT  
AND REPAIR EVALUATIONS***

***CEDAR LAKE DAM / DEP #16603***

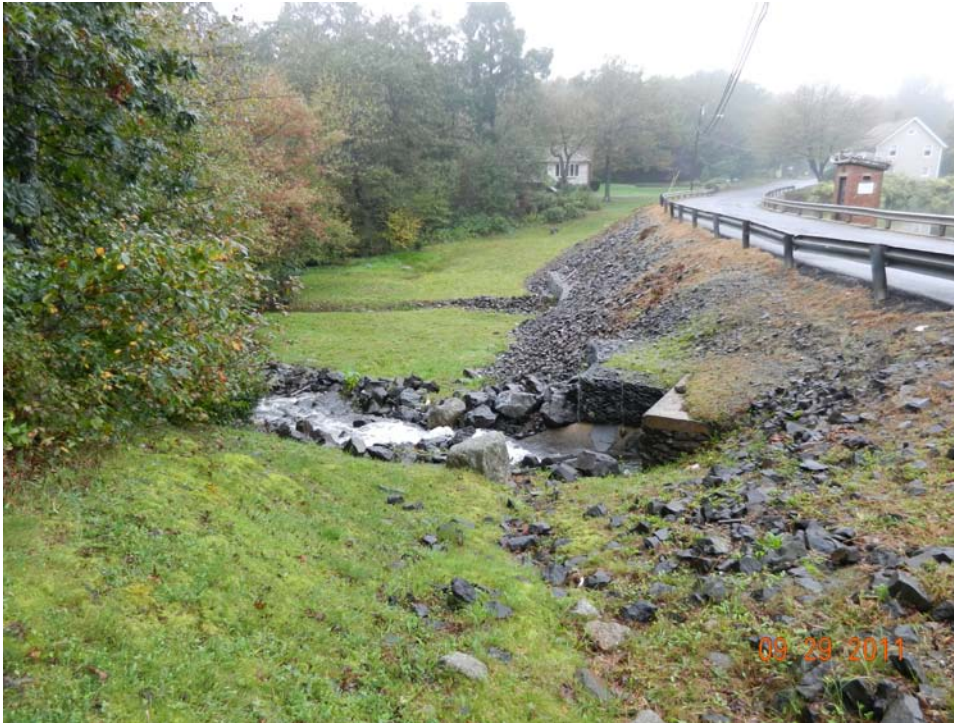
Photo 1 - An overview of the downstream side of the dam embankment taken from the left side. Small trees and other vegetative growth were removed from the slopes since the last inspection. Grass growth along the base is in good condition. The wet area noted in the inspection report is situated at the upper center of the photo, past the low level outlet channel.

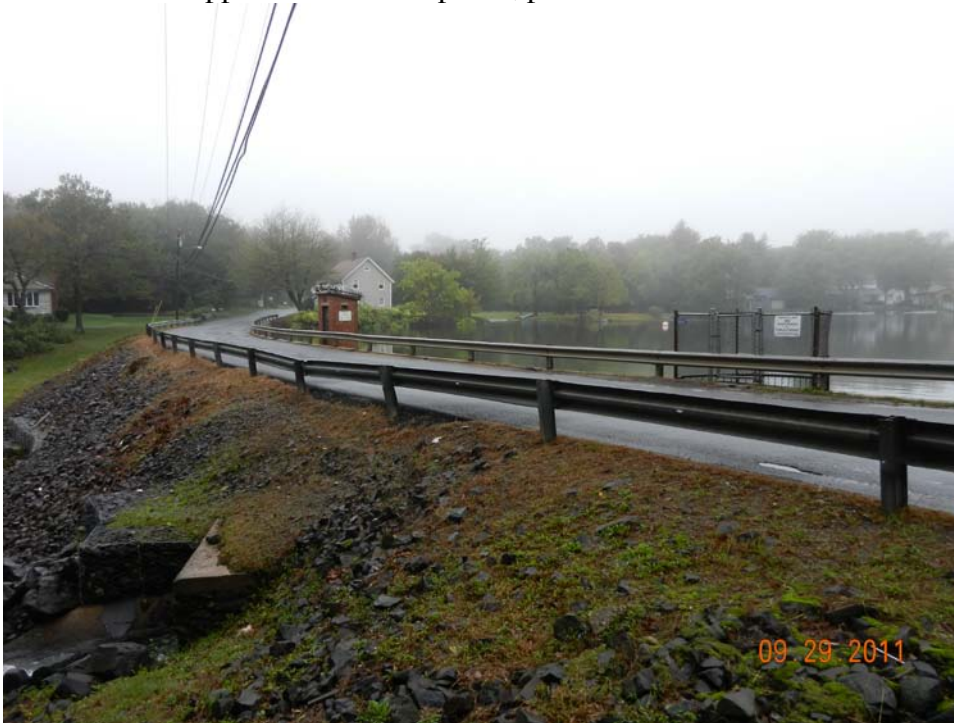
Photo 2 – The top downstream crest showing the area used frequently by pedestrians crossing the dam area.

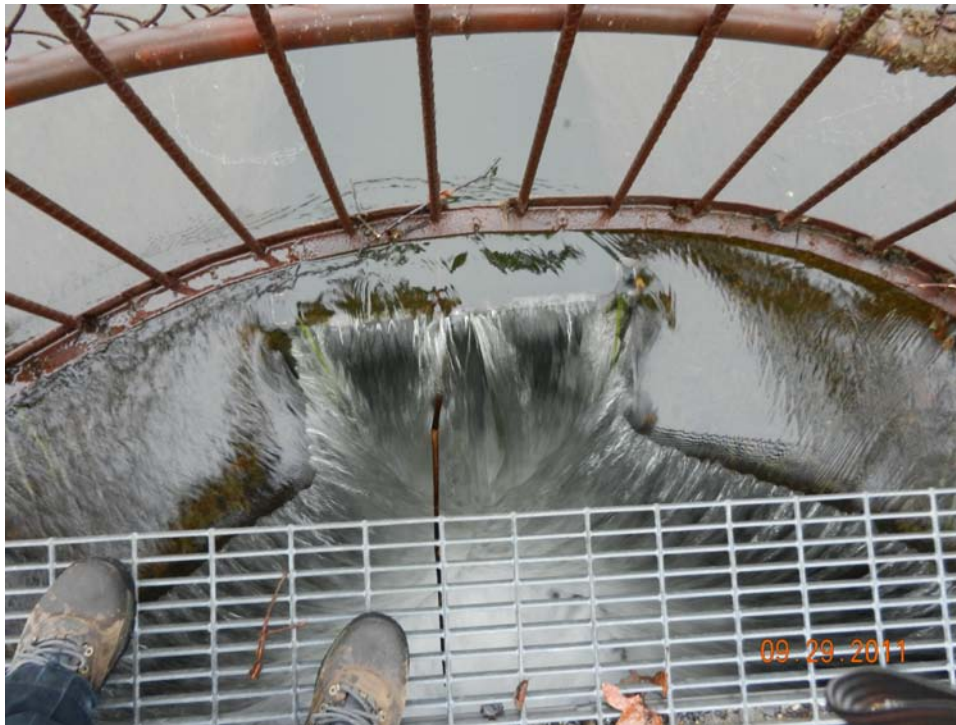
Photo 5 – The spillway weir area during normal lake water level condition in September of 2011.

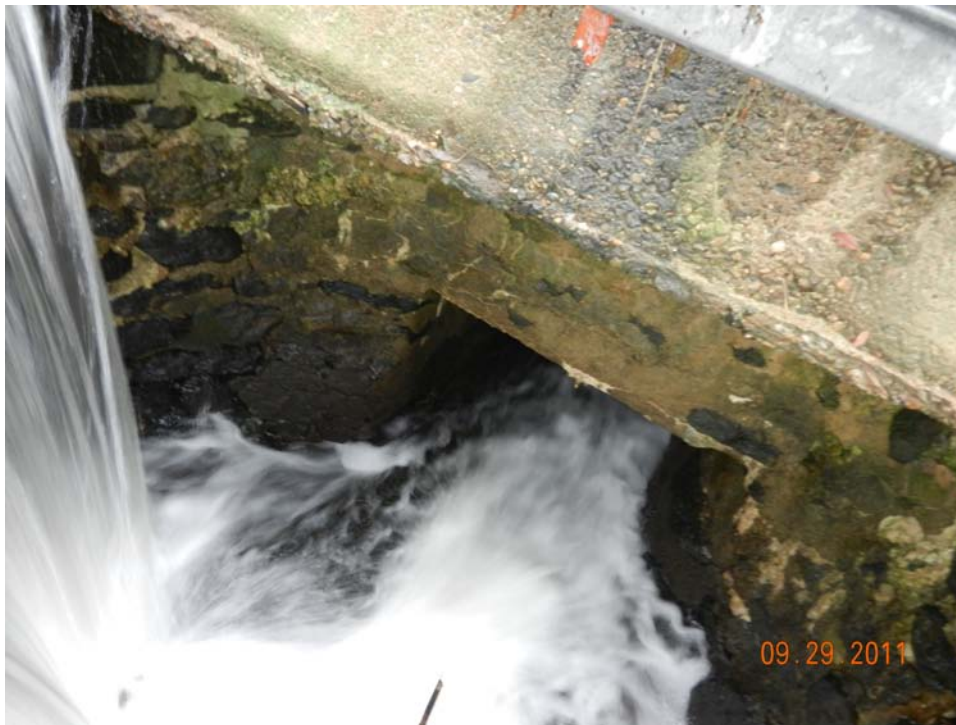
Photo 6 – Flow over spillway dropping into the entrance area of the tunnel / culvert beneath the road.

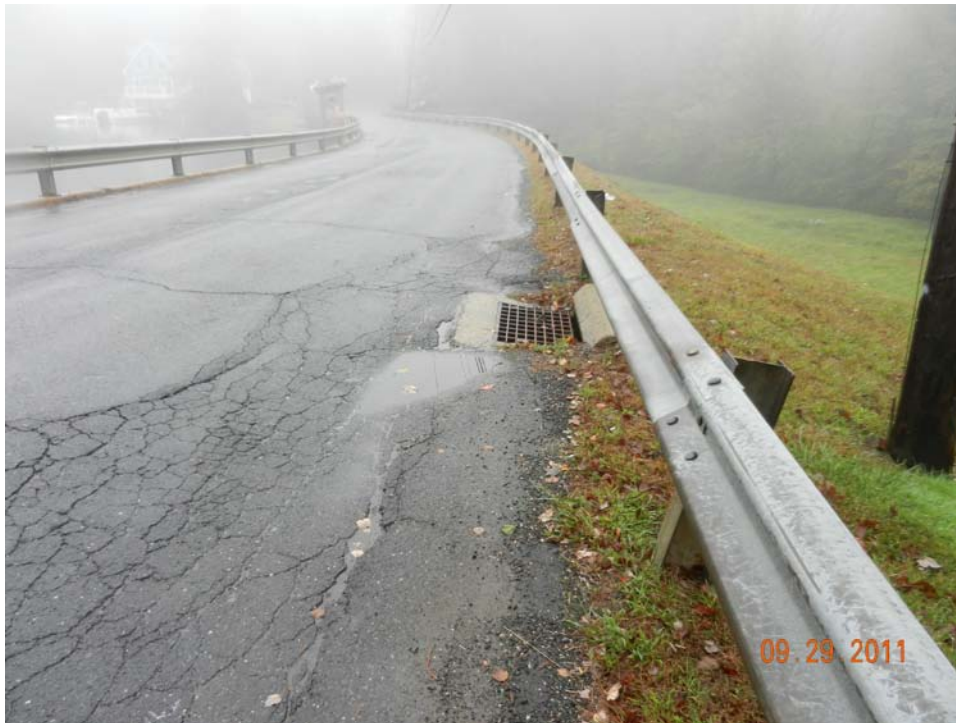
Photo 9 – A rutted and cracked asphalt area near the right end of the dam, indicative of many of the other asphalt issues along the top of the embankment.

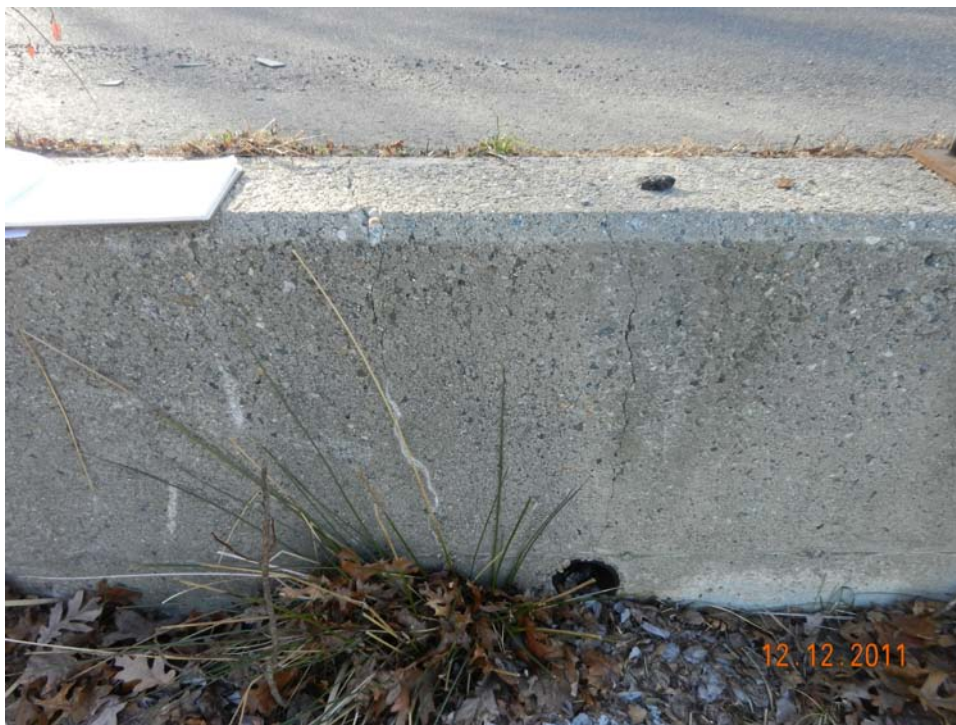
Photo 10 – One of the many minor vertical cracks along the upstream concrete embankment wall that needs to continue to be monitored.

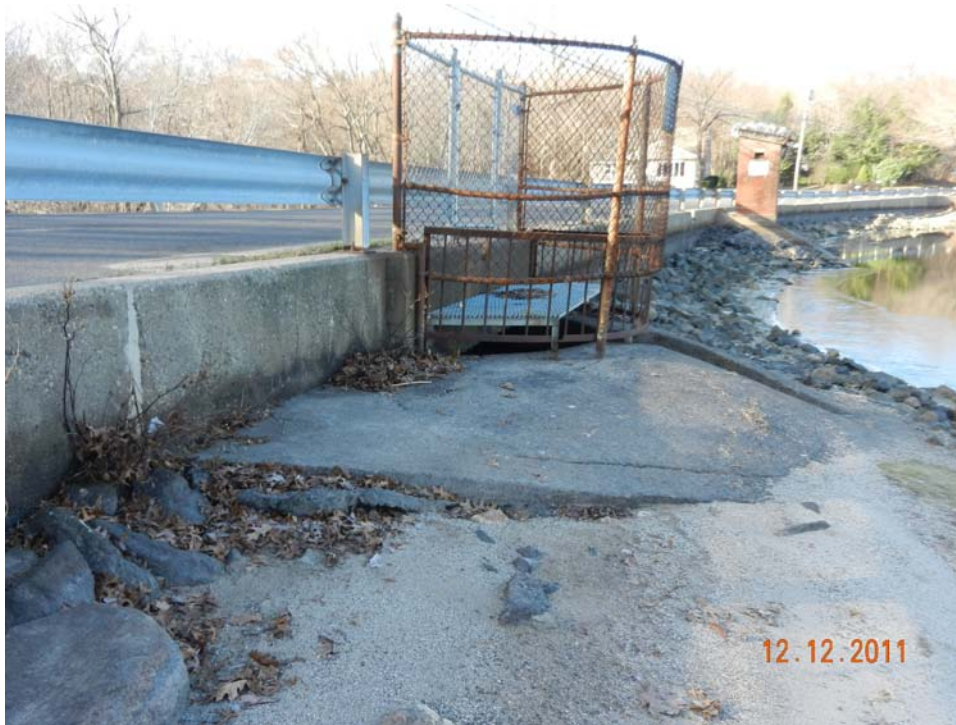
Photo 11 – A view towards the spillway. Note the woody vegetation growing at the base of the vertical joint at the left of the photo and the crack along the concrete surface in the center.

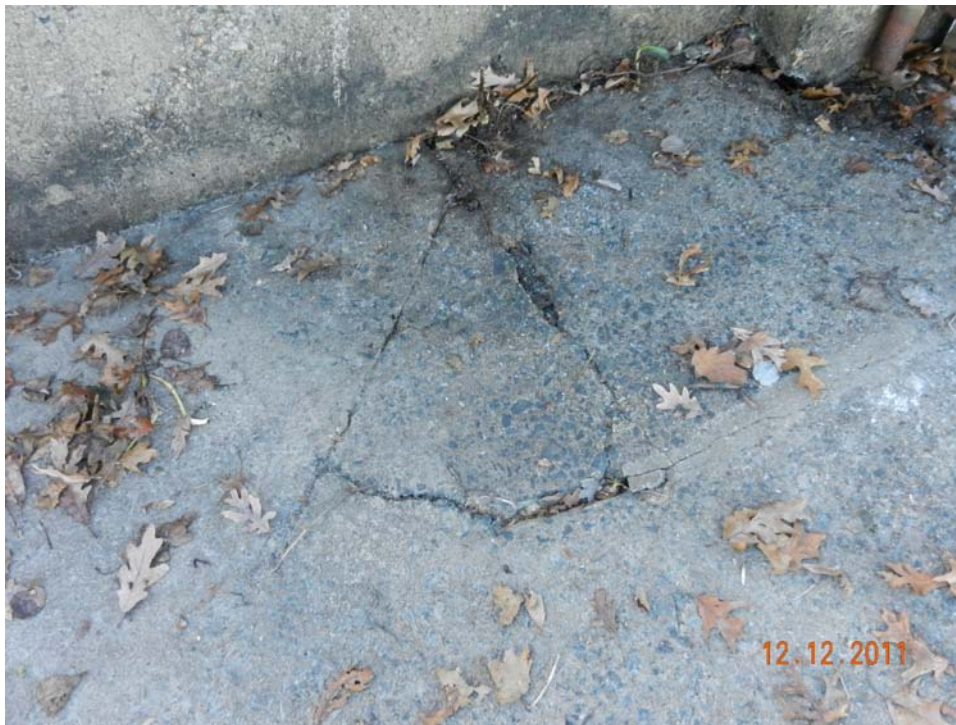
Photo 12 – Cracked section of concrete surface on the left side of the spillway.

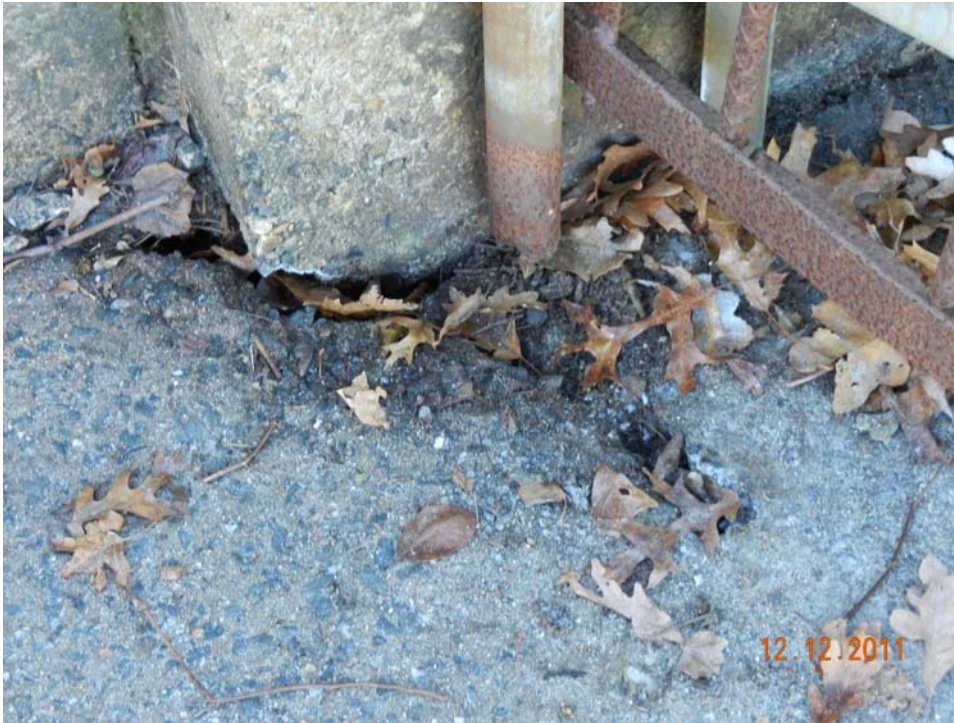
Photo 13 – A closeup of the void area beneath the embankment wall just left of the spillway opening.

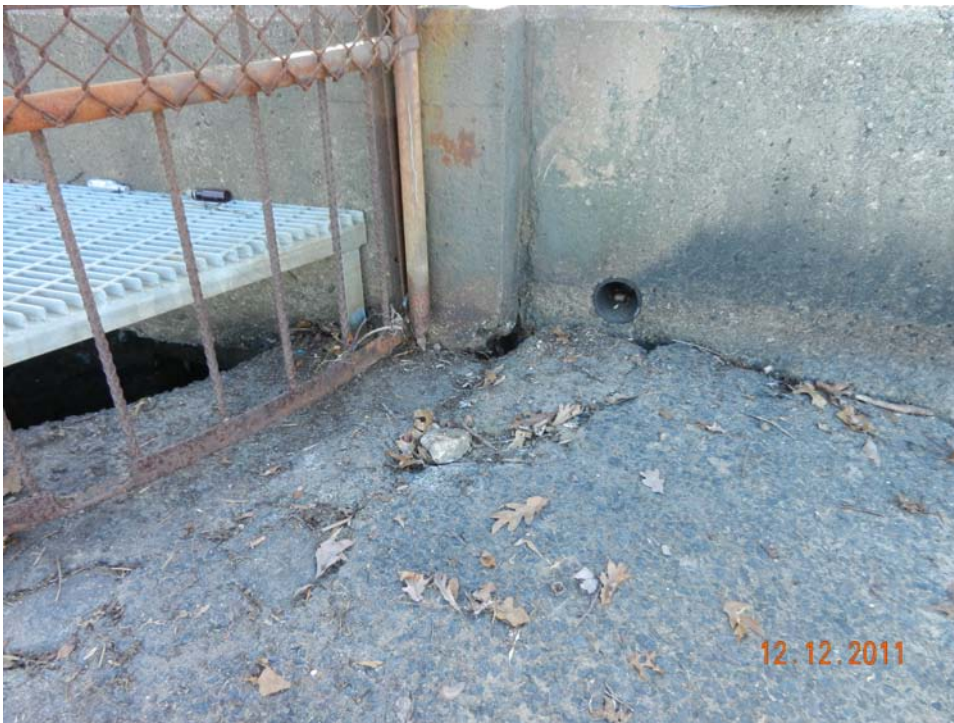
Photo 14 – The right side of the spillway slab, again showing cracked sections of concrete and a void area at the base of the wall. Note also the corrosion of the metal protective barrier, indicative of other sections (see previous photos).

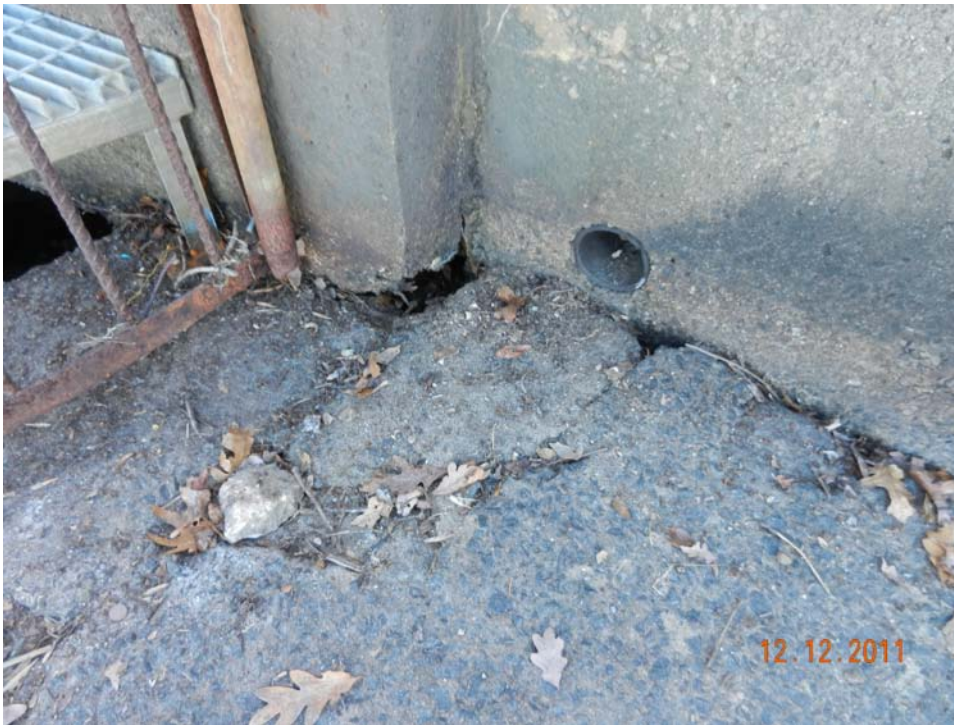
Photo 15 – A closeup of the view of the void area beneath the wall in Photo 14; this void went at least 9” deep beneath the wall and is very likely the source of some of the seepage emanating from the base of the masonry wall beyond.

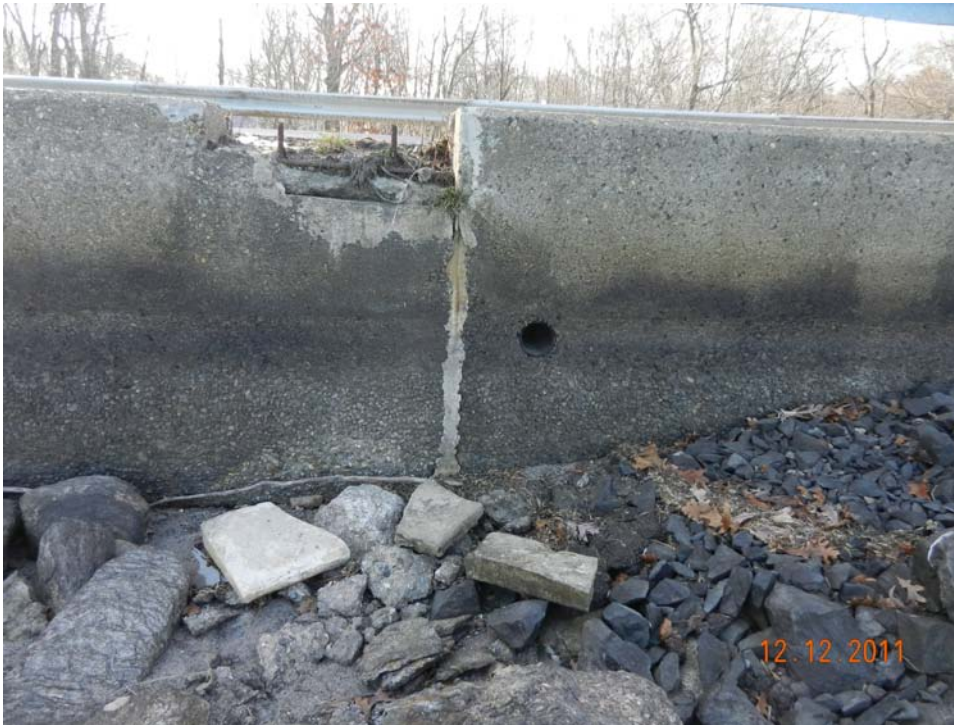
Photo 16 – One of the many vertical joints with deteriorating sealant. This one has vegetation growing out the top, with sealant being pushed out by the roots.

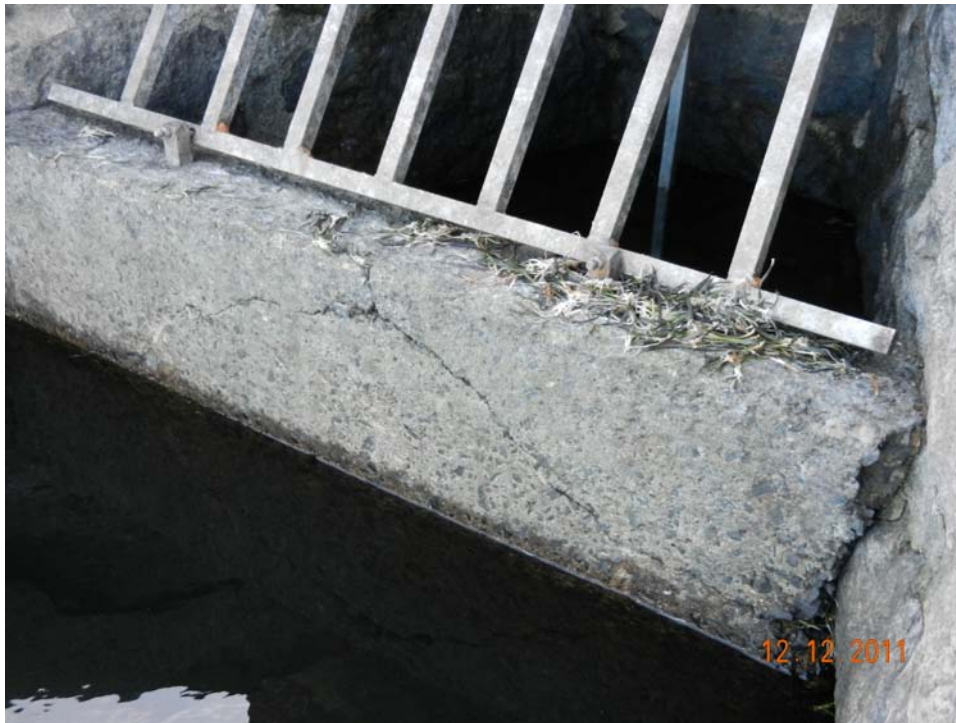
Photo 17 – A closeup of the trash rack support at the gatehouse intake, with a 30” long crack and a broken section adjacent to the wall.

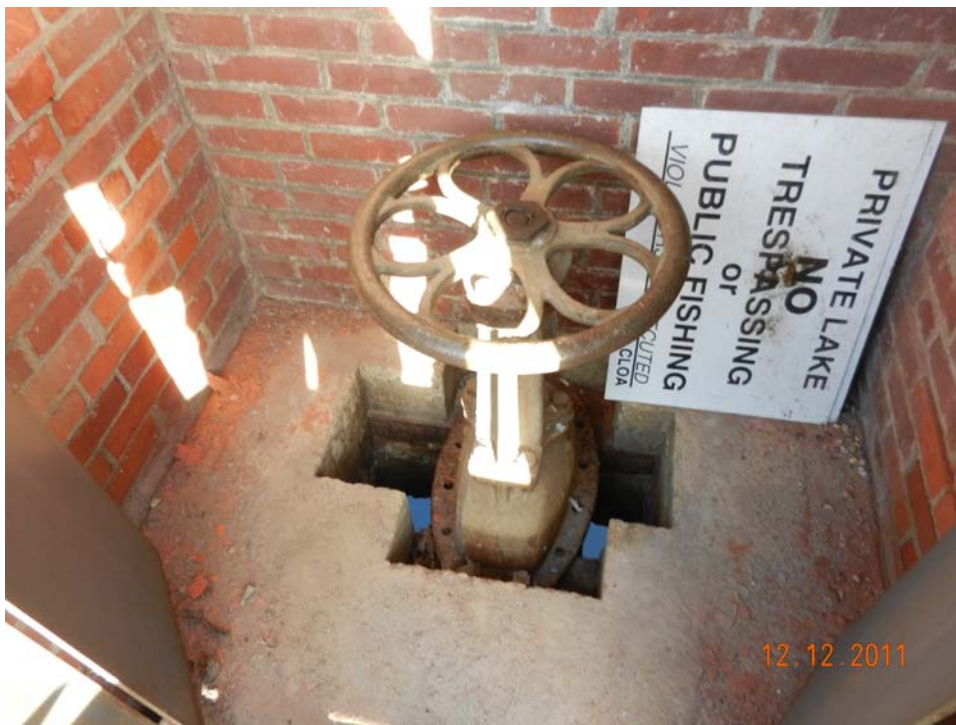
Photo 18 – Interior of the gatehouse. Note the mild corrosion on the gate wheel control mechanism and some spalling of interior brick (see chips at left base).

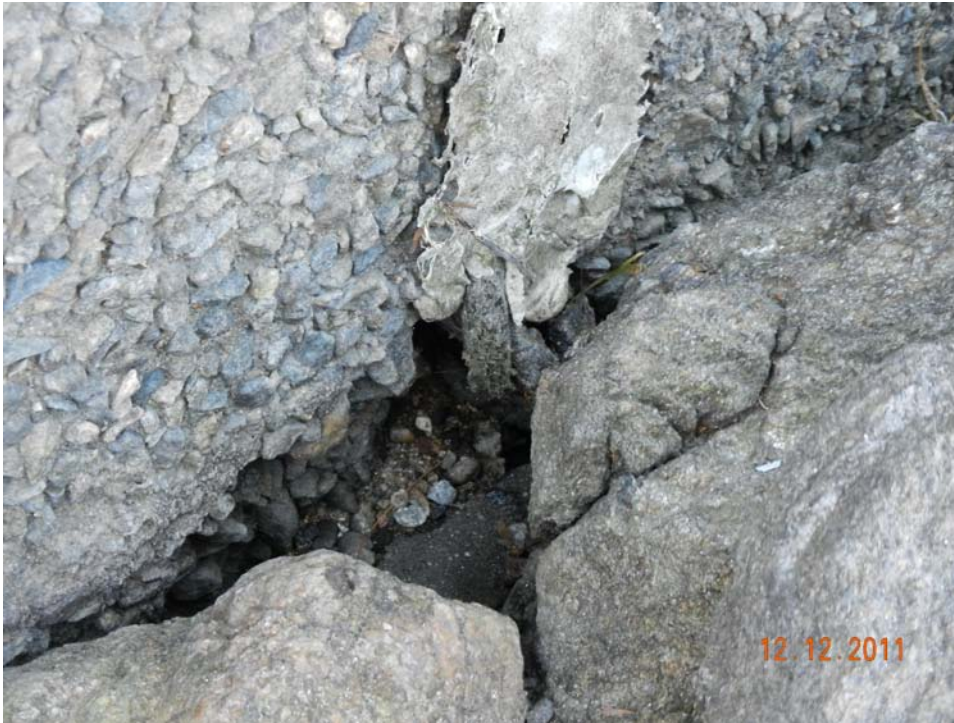
Photo 19 – Typical of the vertical expansion joints is the missing sealant at the base and open voids leading beneath the wall. Footing conditions are unknown at these locations.

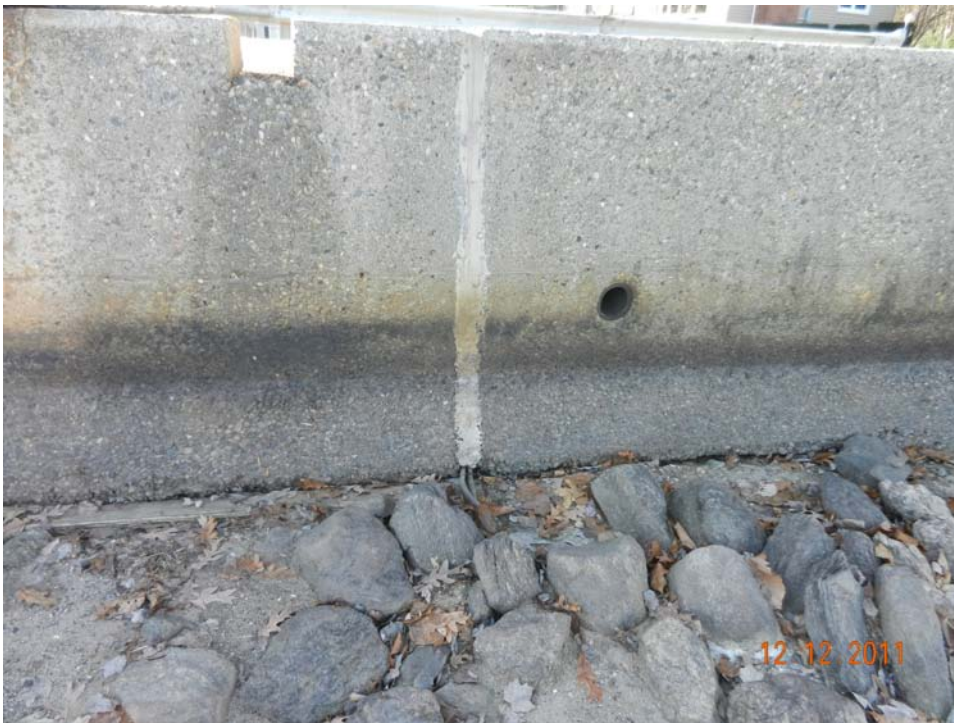
Photo 20 – Another of the vertical joints. Note that at this location, the void at the base of the wall extends on both sides for a total length of about 5' to 6'.

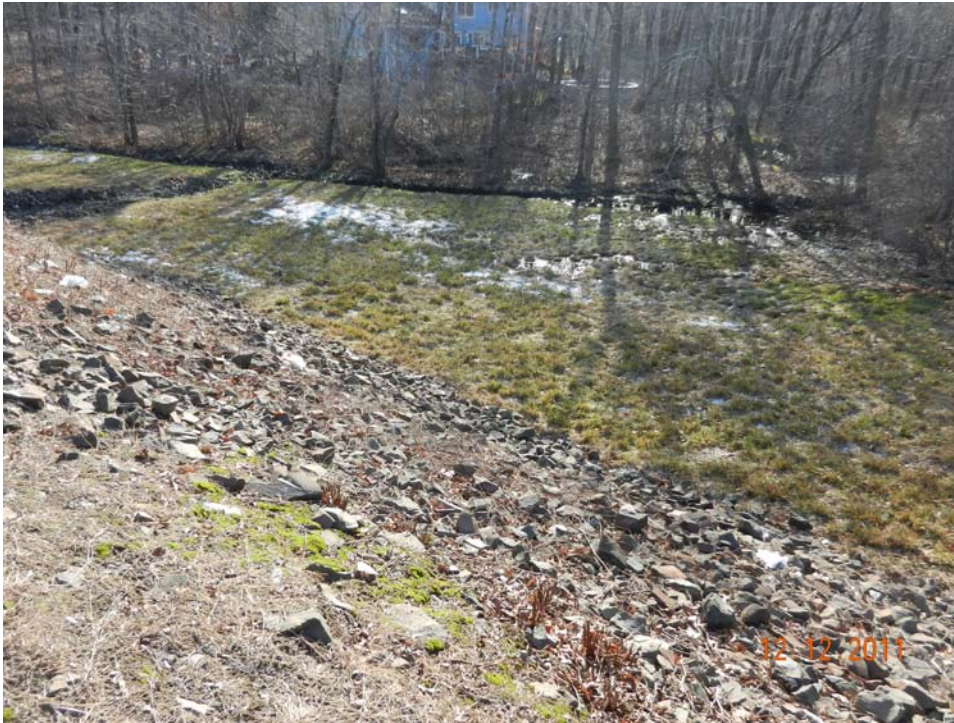
Photo 21 – View of the right downstream wet area, noted by the reflective water surfaces. Note that this area is typically and normally wet and saturated with lake water levels at their high or low elevations.

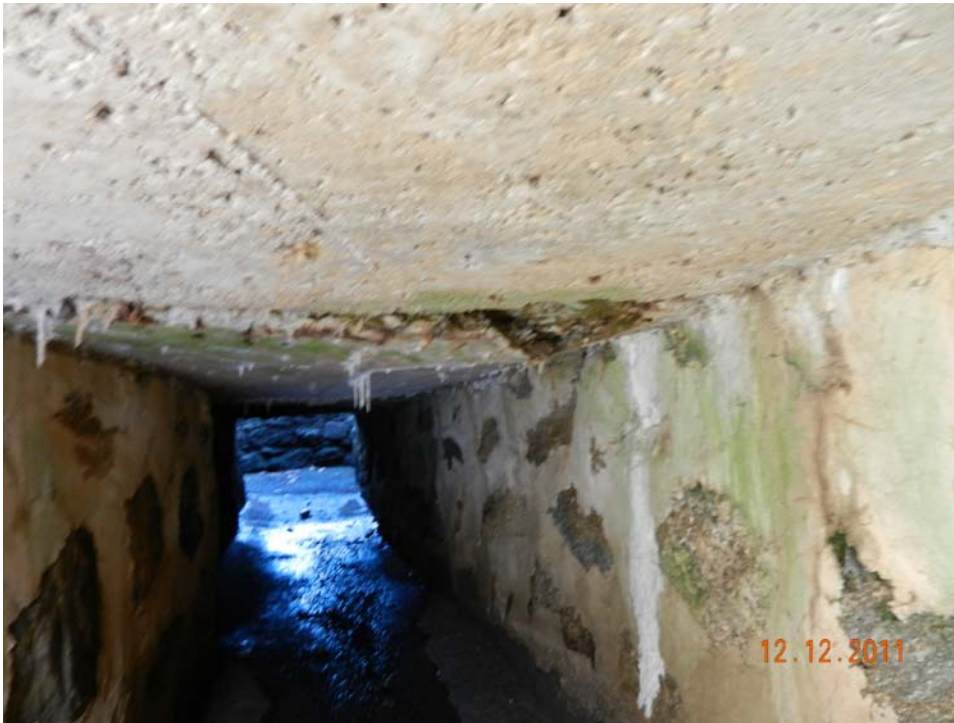
Photo 22 – The spillway discharge tunnel beneath the road, with severe concrete roof deterioration, evidenced by a downward bulge and exposed interior disintegrating concrete.

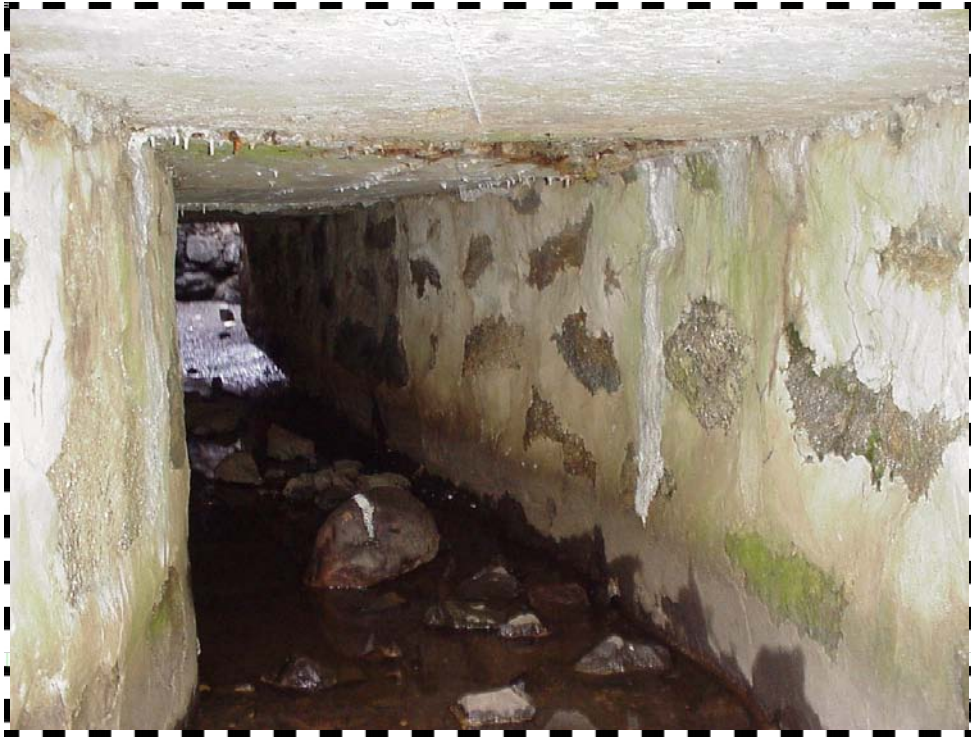
Photo 23 – Comparison photo from the 2006 inspection showing the interior condition of the discharge tunnel area. Note the difference in roof condition.

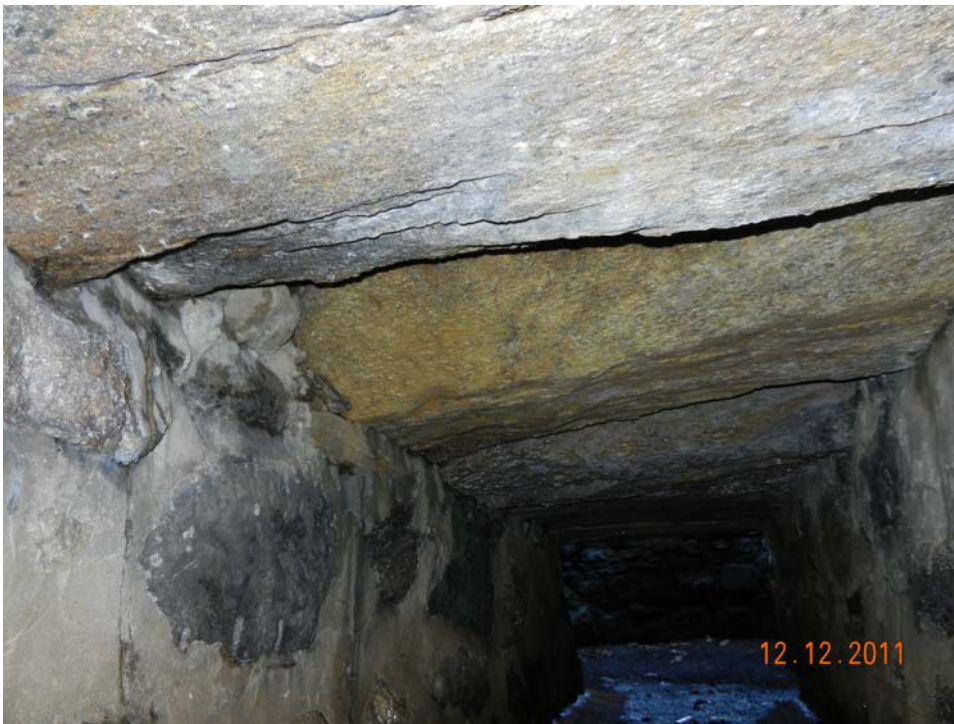
Photo 24 – The roof of the spillway discharge tunnel just beyond the concrete section, at the approximate center of the road above. Note open areas between large stones spanning the structure.

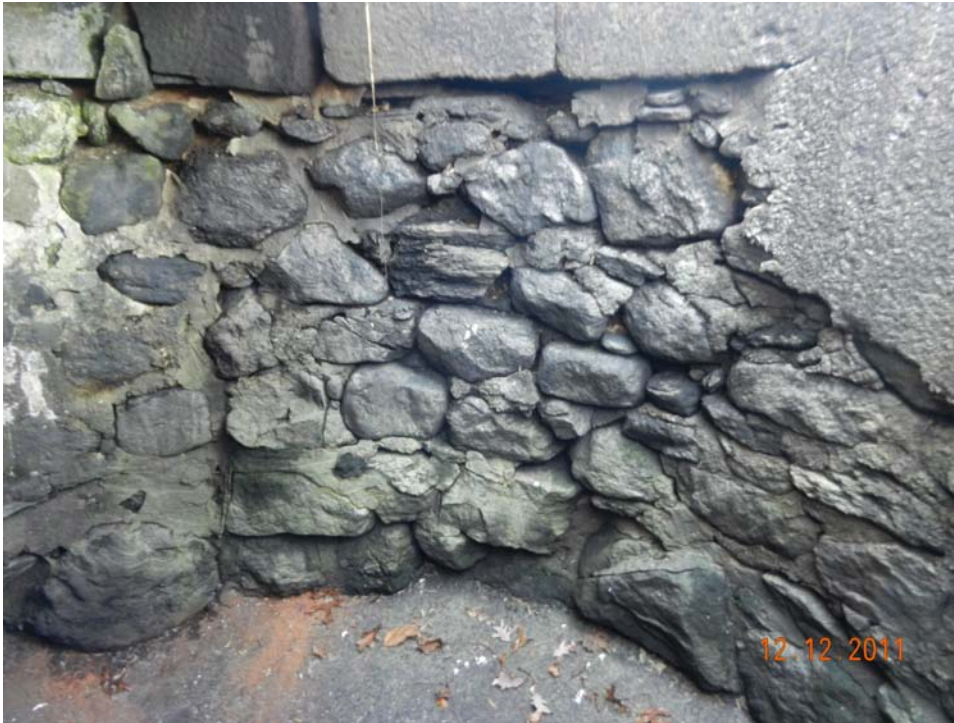
Photo 25 – Interior of the spillway drop structure, showing some of the smaller typical voids in the stone wall and the staining from seepage and leakage at the base. A note for Photo 15 shows that some of this seepage may be from a void at the spillway slab and wall juncture area at the top of this wall.

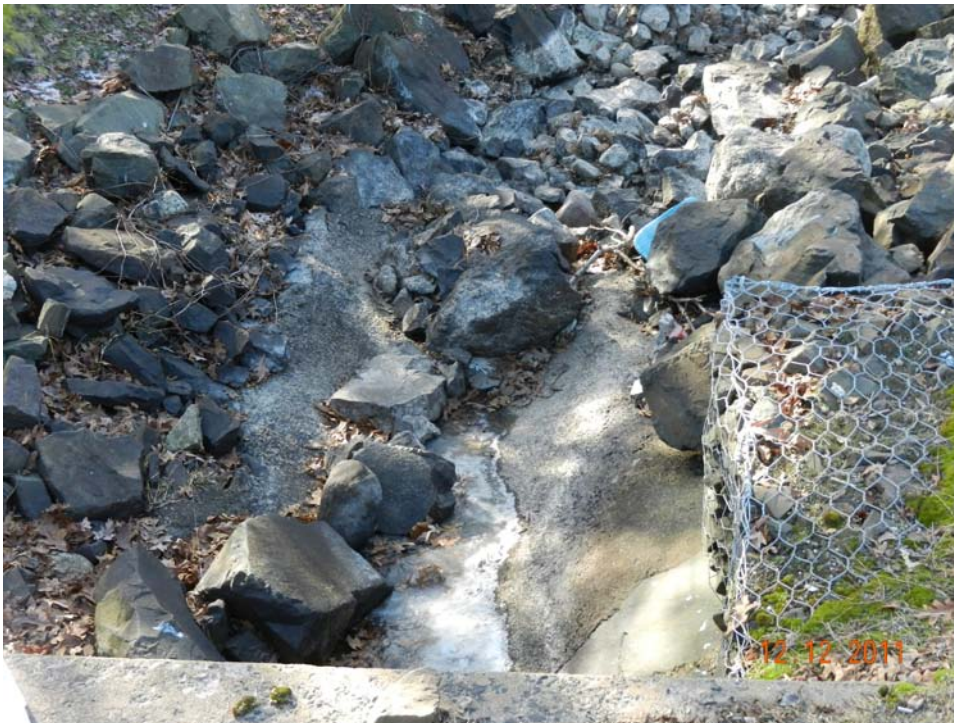
Photo 26 – The existing discharge area for the spillway tunnel beneath the road. Large stones are a partial block to flow efficiency at this channel location.

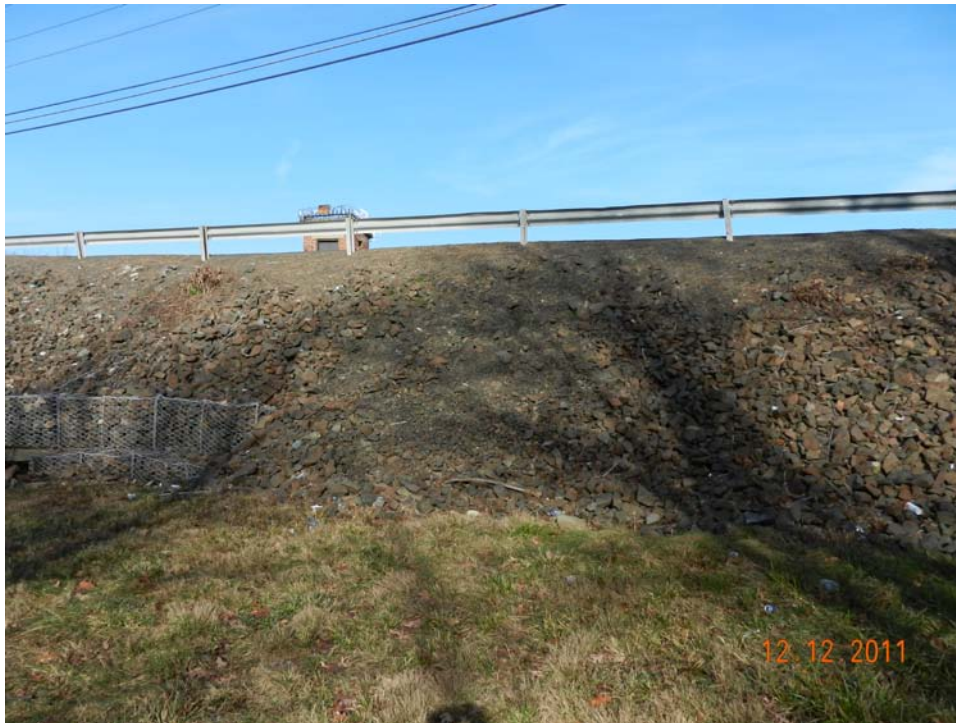
Photo 27 – A portion of the downstream slope showing an area of surficial sloughing caused by the steep slope and the movement of pedestrians along the top crest behind the guard rail.

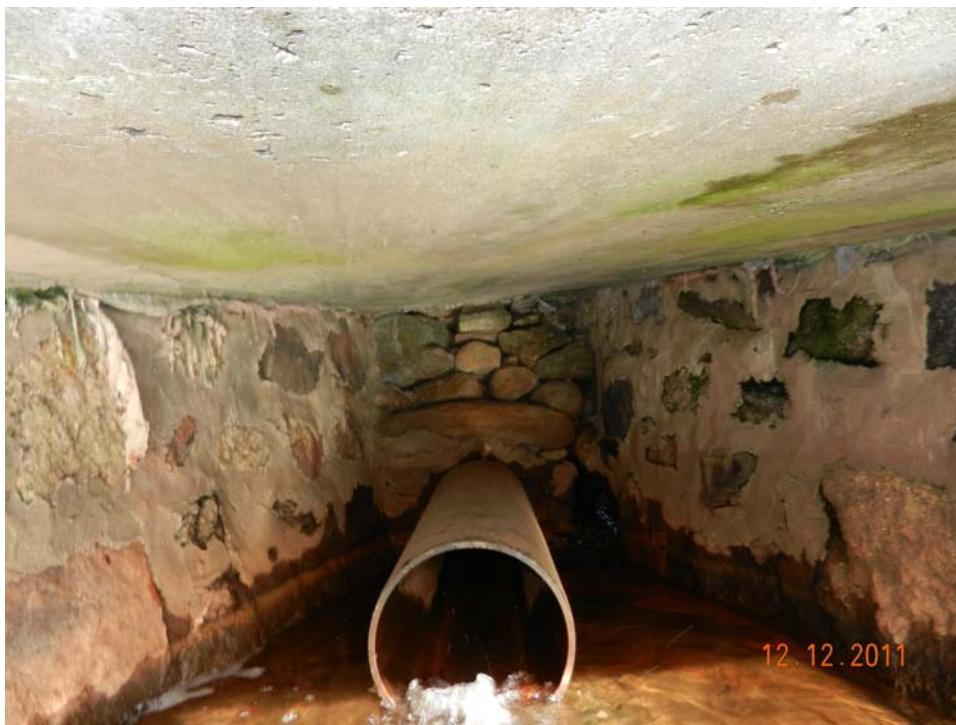
Photo 28 – The low level discharge pipe emanating from the center base of the downstream embankment. This area has changed little since the last inspection and seepage at the wall adjacent to the pipe remains constant.
