**CONDITION ASSESSMENT
AND REPAIR EVALUATIONS**

CEDAR LAKE DAM / DEP #16603

NORTH STREET
WOLCOTT, CONNECTICUT

INSPECTION REPORT

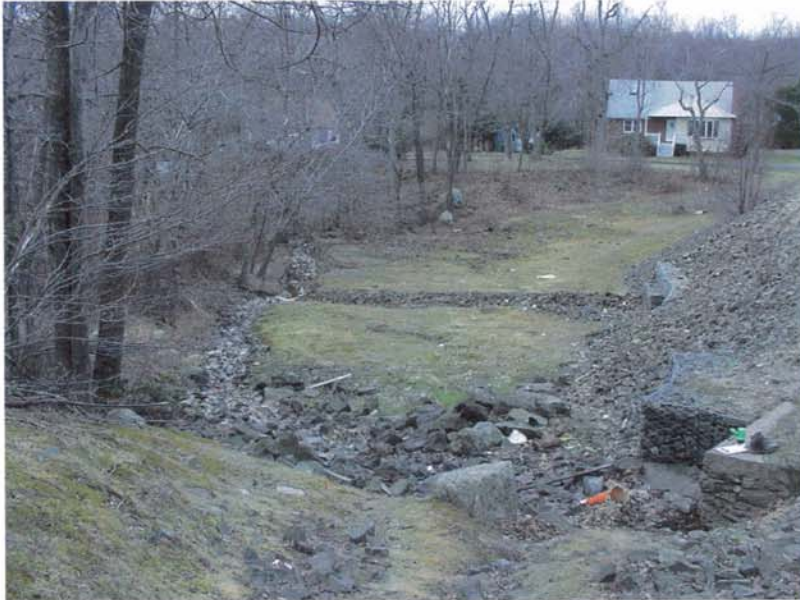
Photo 1 - An overview of the downstream side of the dam embankment. Note the growth of small trees at the right center of the photo, debris and displaced riprap at the discharge opening of the spillway channel and the wet area at the right downstream side of the dam.

1. **Downstream Embankment** - Remove vegetative growth, specifically small trees and woody vegetation, to prevent the expansion of tree growth and the spread of roots throughout the embankment and toe areas. Repair erosion areas from pedestrian traffic and stormwater drainage flows. [See long term recommendation below for roadway area.]
2. **Downstream Toe Area** - The downstream toe area is currently kept in relatively good condition, but is fairly saturated along the right side. This is probably due to low level seepage beneath the embankment of the dam, from high groundwater levels along surrounding embankments and from occasional drainage coming off the roadway. A plan was drawn up in 1995 to install toe drains along this saturated area, but no action has been taken to date. While the need is not critical, consideration should be given to place-

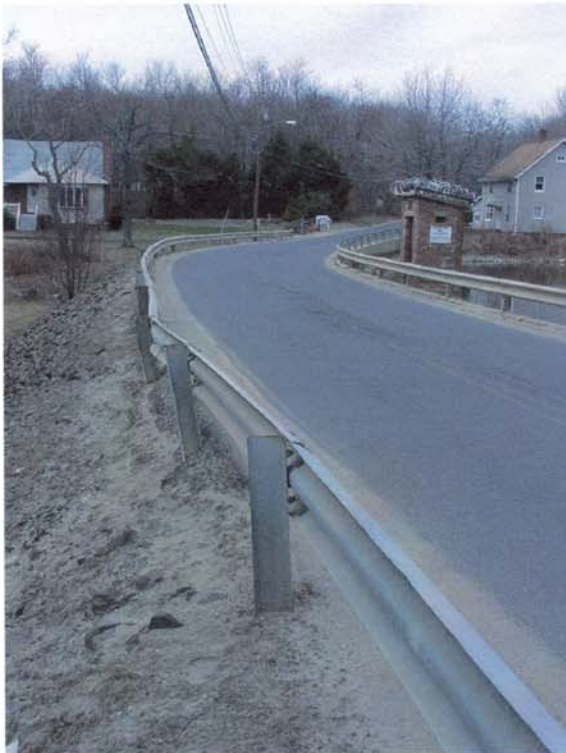
Downstream Side - Most riprap here is also in generally good condition, except along the downstream embankment crest where pedestrian traffic along the south side of the road has led to a displacement of the upper portion of the riprap. There is no room for pedestrians along the road surface itself (on either the south or north side), thus for optimal protection, persons walking on foot proceed along the back of the guardrail on the south side of the dam.

Photo 2 - The top of the dam as seen from the left (east) side. Note the erosion of the downstream embankment crest from pedestrian traffic - due to the lack of a road shoulder with proper sidewalk.

In addition, it has been noted that pedestrian traffic along the downstream slope crest has caused erosion of the ground surface behind the guardrails. As a long term recommendation to prevent continued damage to the dam crest and for the safety of pedestrians passing across the dam's narrow roadway, it is recommended that the Town and the CLOA look into widening the road by extending out the southerly side of the dam to provide for a walkway and to reconstruct the downstream earth embankment at the same time to a 3H:1V gradient landscaped with grass. This would improve many of the current maintenance issues in addition to providing a safe traffic and pedestrian situation. There are several potential funding sources through the State which might provide financial assistance to accomplish this goal.

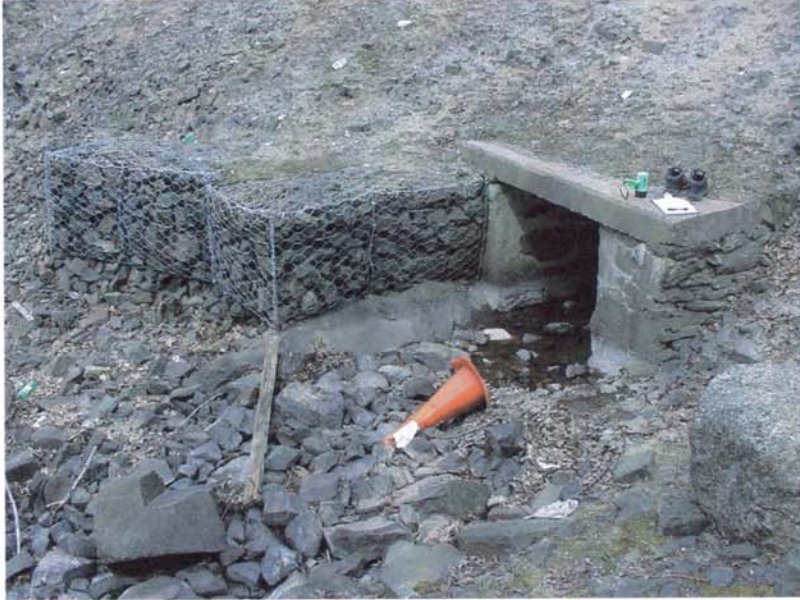
Photo 3 - The downstream discharge from the primary spillway, showing the buildup of debris and riprap in the discharge channel. Due to the rocks blocking the channel, flow is currently directed along the base of the gabions and the left downstream toe of the dam embankment.

3. **Downstream Primary Spillway Discharge Channel** - While none of the seepage noted at the upstream end of the tunnel is currently a problem, it should be monitored on a continuous basis for any change in quantity or quality (see Item 4 below). The steel beam supporting the upstream concrete wall along the roadway edge, although not in current danger, should be cleaned and coated to avoid continued corrosion and loss of structural support for the wall and tunnel. The interior roof of the tunnel at the location of the stone masonry supports spanning its width should also be repaired due to the loss of supporting roadway fill noted between the stones. At the outlet of the tunnel, the discharge channel riprap should be regraded to form a defined swale to carry flow directly away from the dam embankment and avoid the potential for problems with the current overflow that runs along the toe area. In addition, trees and brush in close proximity to the left edge of the downstream channel should be removed to avoid blocking or diverting flow during severe storm situations.

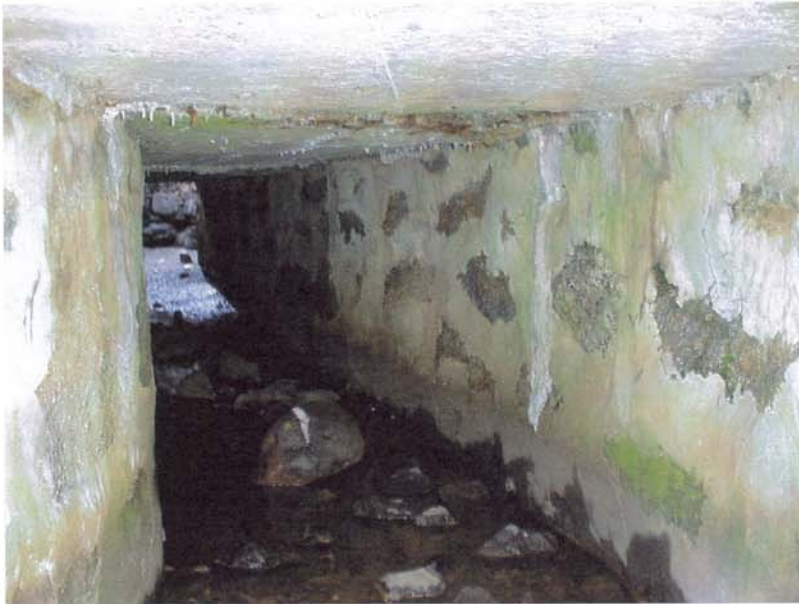
Photo 4 - The inside of the primary spillway discharge channel, looking in an upstream direction. Several large rocks within the "tunnel" are visible along the base of the channel. Note that the overall condition of the channel near the downstream end is good, with sidewalls and roof in relatively good condition (stone and concrete).

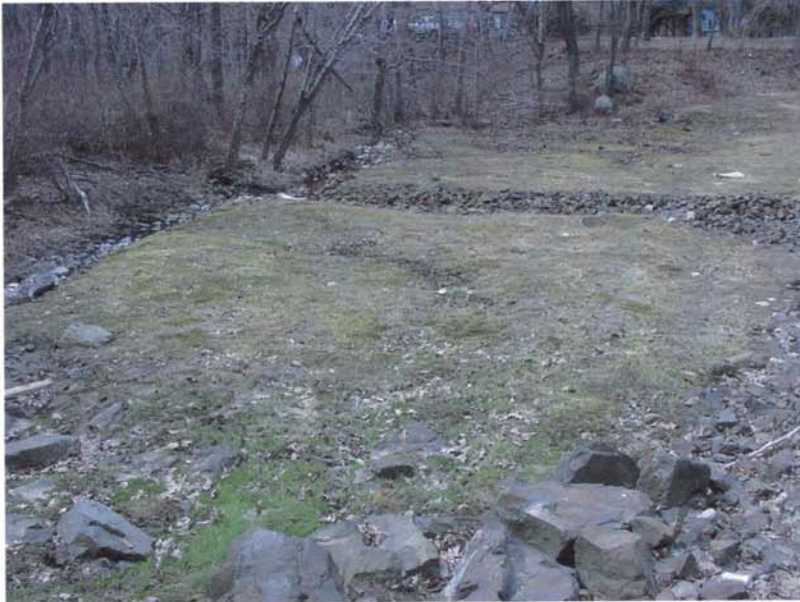
Photo 5 - The left downstream toe area. Note the swale (in the center of the photo) developing from redirected flow emanating from the spillway discharge channel.

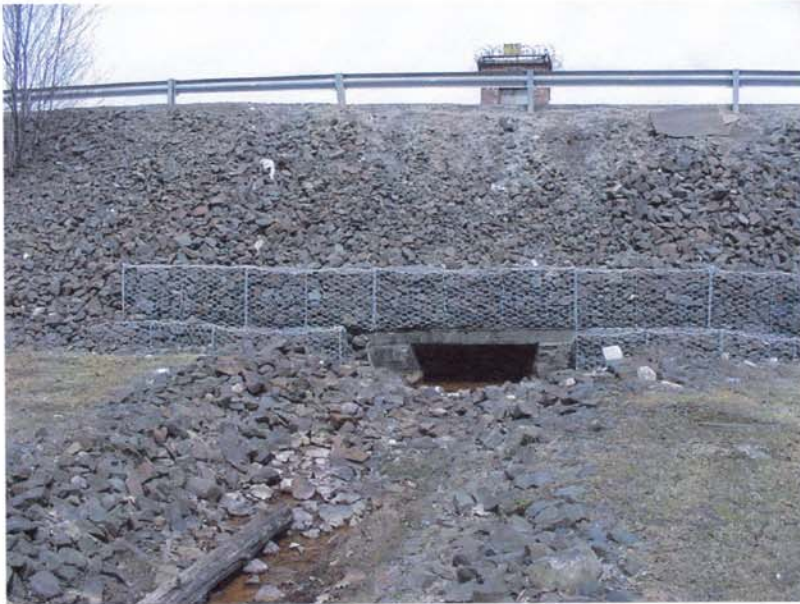
Photo 6 - Looking upstream toward the low level outlet from the upstream gatehouse. Note the good condition of the gabions above the outlet, the erosion and displacement of riprap along the embankment crest and the growth of small trees along the embankment at the left of the photo.

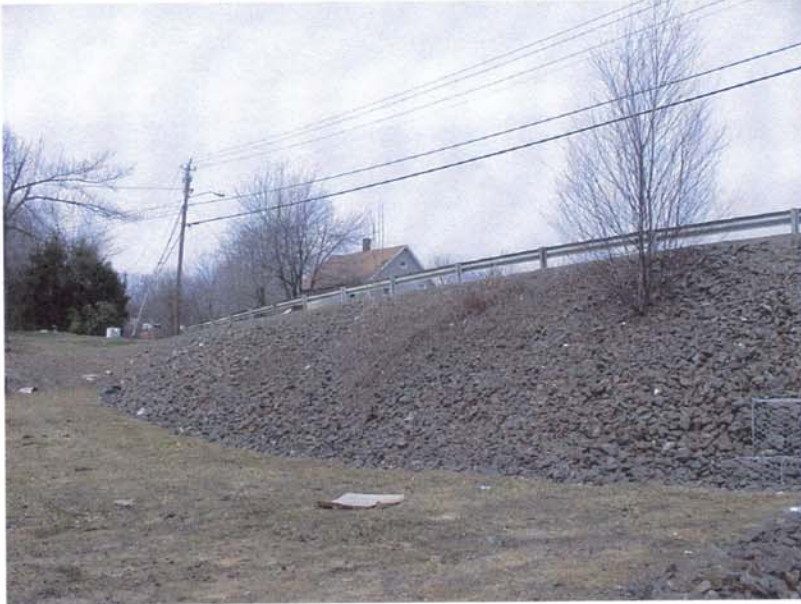
Downstream Embankment - Brush, small, trees and ivy need to be removed from the embankment section to the right of the low level outlet; minor brush growth on the left side should be monitored and removed when feasible.

Photo 7 - The right downstream embankment as seen from the low level outlet discharge channel, showing the tree and brush growth on the embankment.

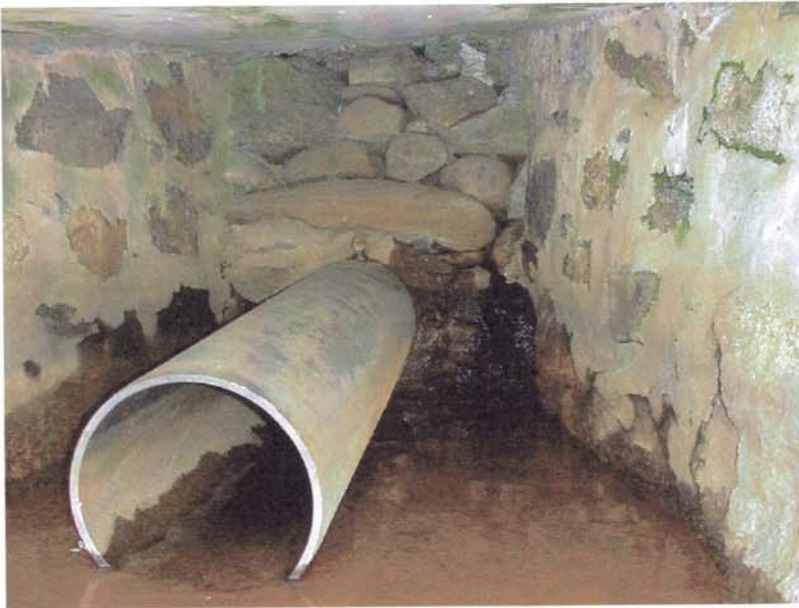
STONE MASONRY: As may be seen in the photos, the stone masonry is in good condition, as is the grout between stones. There are no significant issues at this time and, the seepage through the masonry wall (currently estimated at 0.5 to 1.0 gpm) along the sides of the pipe is minor and should only be monitored at this time (see recommendations and also the 1994 report previously referenced).

Photo 8 - Seepage emanating from the left side of the low level outlet pipe. The seepage flow rate is currently low, but should be monitored on a frequent basis for any change.

4. **Downstream Low Level Outlet and Channel** - The channel appears to be in relatively good condition and should be maintained clear of debris. The seepage emanating from around the low level outlet pipe perimeter, while currently low in flow, should be monitored on a continuous basis for any change in quantity or quality (e.g., turbidity). If a change in flow is observed, its relation to any varying water level in the reservoir should be documented. In any case, a significant change should be brought to the attention of an engineer and / or the DEP Dam Safety Section.

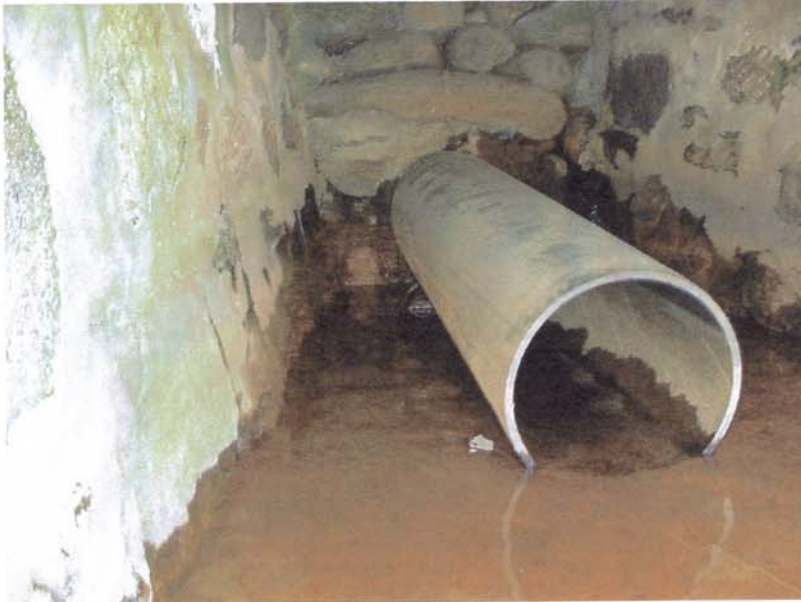
Photo 9 - Seepage is also present along the wall on the right side of the low level outlet pipe. Again, this flow should be monitored for any changes, but no further action is required at this time.

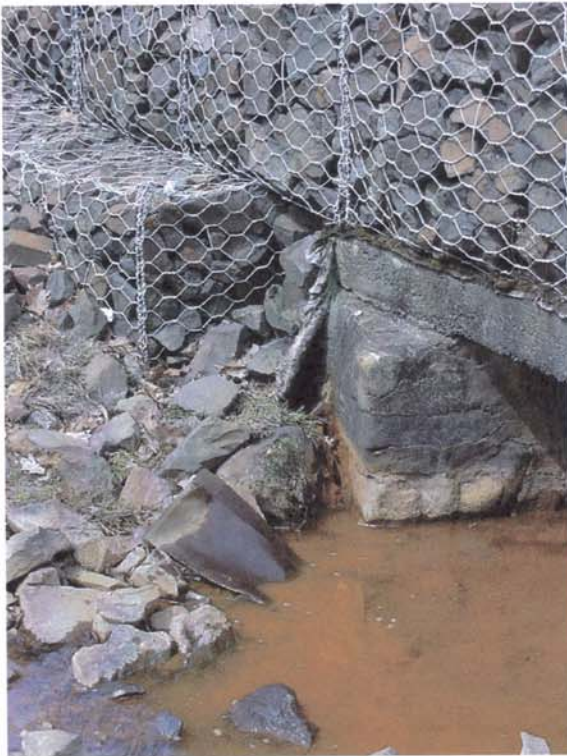
OTHER: Seepage is also apparent on the outside of the right downstream end of the outlet wall, adjacent to the gabions and riprap. The seep-

age amount is approximately the same as inside the structure (about 0.5 to 1.0 gpm), does not appear to carry any sediment from within the embankment and should only be monitored at this time.

Photo 10 - Seepage emanating from the back of the right side of the low level outlet channel wall adjacent to the gabions. This flow is most likely passing along the back of the low level outlet pipe and wall and should be monitored, as pointed out for the other seepage areas noted above.

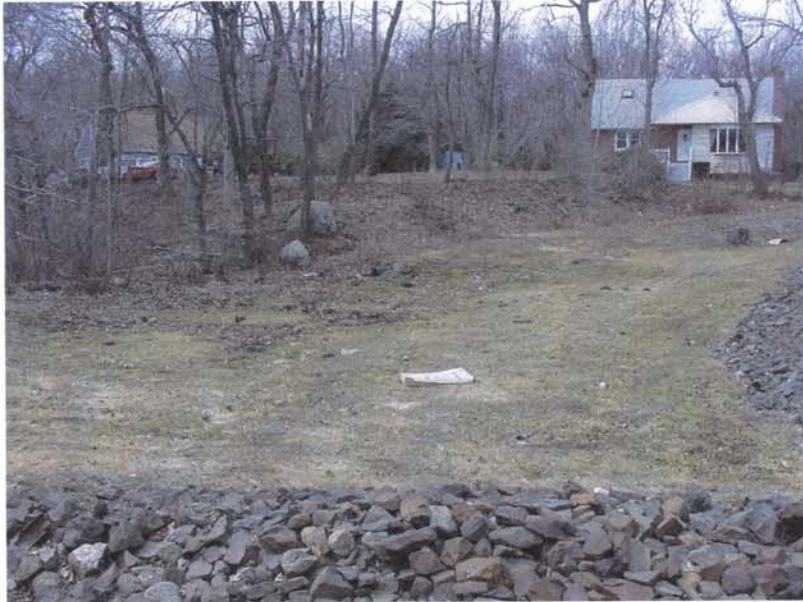
No new or significant seepage areas, except for the same right downstream toe area as noted in previous inspections. In a letter dated 1995, the following observation was made (still pertinent today): *"The water levels at the downstream toe of the dam have always been fairly high, as evidenced by the soft and saturated condition of the soil and the several outflow points of groundwater. Some of this has emanated from beneath the dam and some from the groundwater adjacent to the dam's embankments."* Although not a structural problem to the dam itself, a proposal had been made to install toe drains to ease routine maintenance. Bids were sought in 1996 to perform this work but, due to cost, the work was apparently not completed.

Photo 11 - The right downstream toe area of the dam as seen from the low level outlet channel. The end discharge of the Town's drainage pipe is visible at the center of the photo, as is the saturated groundwater area in the foreground.

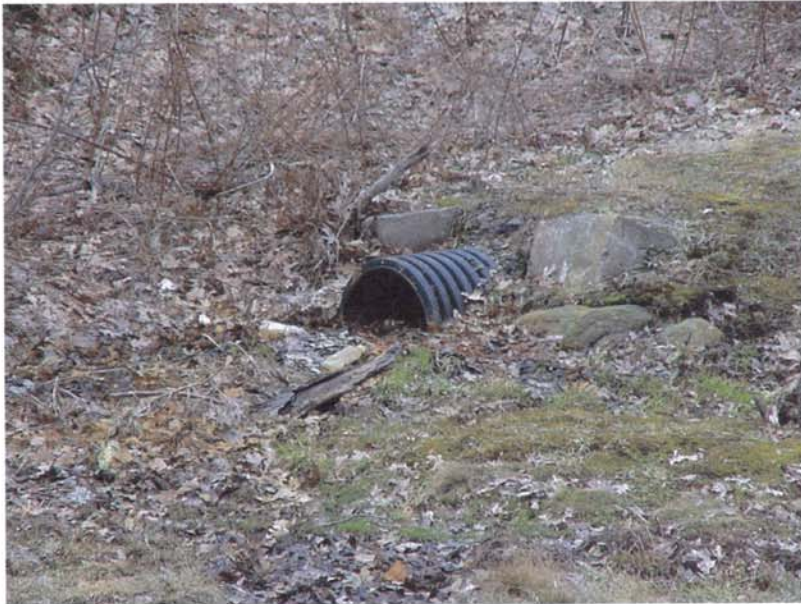
Photo 12 - The discharge of the drainage pipe shown in Photo 11; note that the pipe is partially filled with sediment.

ment of these drains to facilitate better maintenance. In addition, the Town's drainage pipe, partially filled with sediment, should be cleared out to restore its full capacity and to avoid the possibility of excess overflow running along the right downstream embankment. Note that there are signs that such flow may already occur.

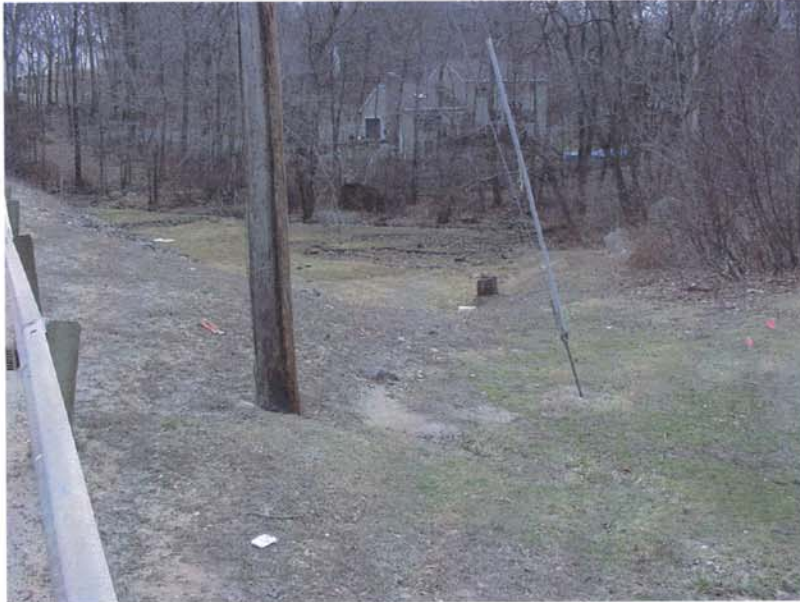
Photo 13 - The right end of the downstream embankment; the drainage pipe mentioned in the previous photos runs adjacent to the pole guy wire with the discharge at the base of the embankment near the center of the photo. Note the lack of vegetation along the embankment crest and sediment near the pole from apparent surface runoff at the road.

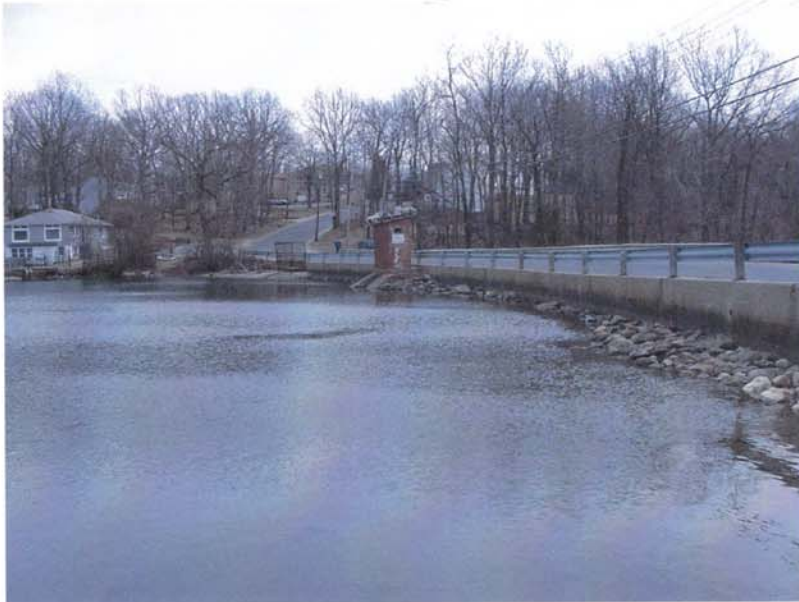
Photo 14 - An overview of the upstream side of the dam from the right abutment. The low level gatehouse is at the center of the photo with the primary spillway just beyond and to the left. Riprap along the base of the upstream concrete wall is in overall good condition.

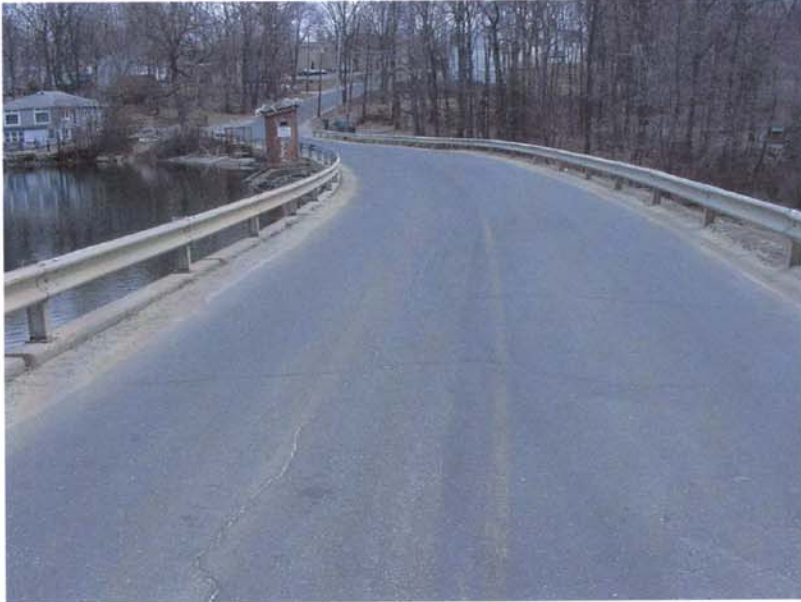
The small drainage leak-offs on the north side of the dam (along the concrete wall) need to be cleaned of built up sand and sediment. Along with some longitudinal and transverse cracking within

the pavement, ponding caused by this build-up could cause infiltration into the dam.

Photo 15 - The top of the dam consists of the Town road, which in general appears slopes toward the upstream side of the dam. Although there are leak-offs through the concrete wall crest, the buildup of sand sediment indicates areas of ponding which may lead to infiltration into the embankment through cracks in the roadway.

5. **Top of Dam / Roadway** - Although drainage improvements were carried out in 1995, some minor problems were noted during this inspection, namely a build-up of sand along the north side leak-off areas and cracking within the road pavement. To avoid ponding and infiltration of flow into the embankment of the dam, the sand build-up should be removed and the cracks in the pavement filled.

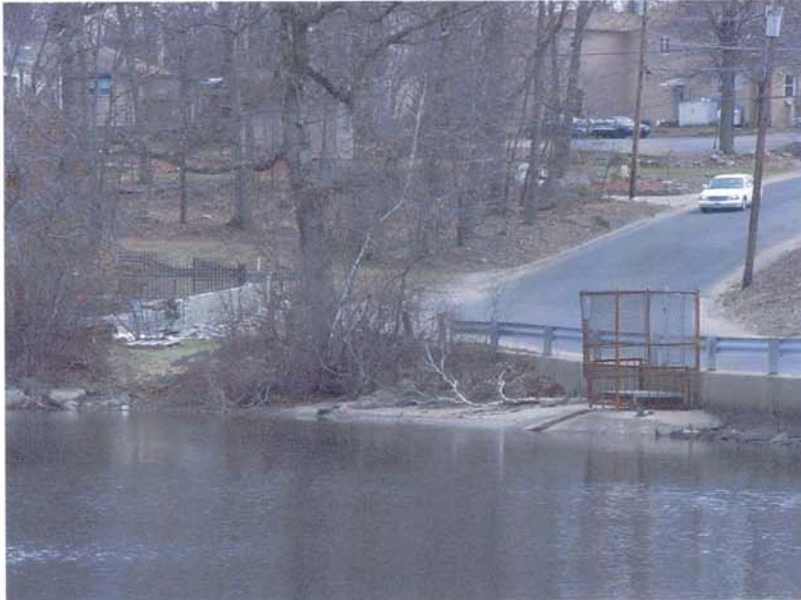
Photo 17 - The primary spillway near the left end of the dam. Note here the growth of woody vegetation and a tree within 25 feet of the end of the dam, both of which should be removed.

6. **Upstream Embankment Vegetation** - As pointed out in the inspection report, brush, debris and trees need to be removed from the left end of the dam; some of this material

appears to have been dumped from nearby construction. Once this debris is removed, removal of brush and small tree growth should be carried out on a continuous basis from all areas within 25 feet of any portion of the embankment or toe areas.

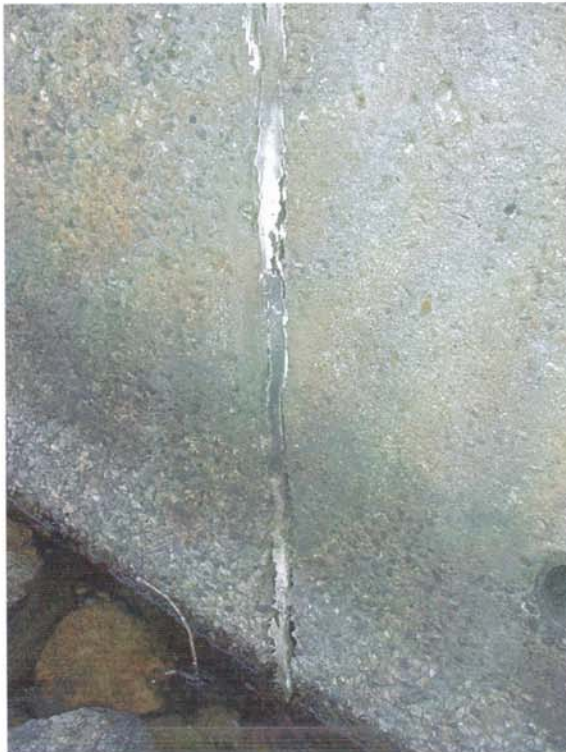
The upstream concrete wall is in good condition. Vertical expansion joints, however, show signs of deterioration. The sealant is currently in a weathered condition, with sealant at the base of many joints missing. These should be cleaned and resealed to avoid infiltration into the embankment of the dam.

Photo 18 - Typical of the joints along the upstream concrete wall. The joint sealant is weathered and in most instances has separated from the concrete; ins some cases, sealant is missing form the bottom of the joint which is close to or just below water level. This leads to infiltration of flow into the embankment.

7. **Upstream Concrete Wall** - Although the wall itself is in good condition, joints should be cleaned of existing sealant, the joint filler should be checked for integrity and replaced if necessary and then, new sealant should be set into the joints to as low as possible in the wall to avoid infiltration into the embankment. The broken concrete section on the support wall to the left of the gatehouse should also be repaired.

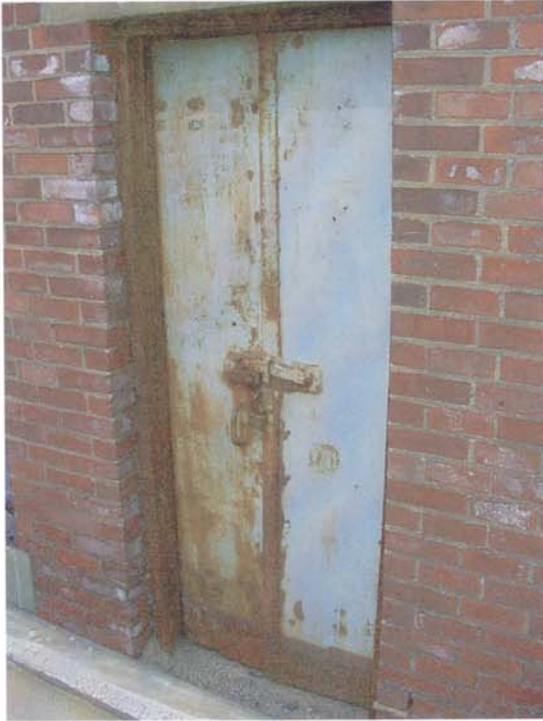
OTHER: The building exterior is in generally good condition, except for the horizontal open joint (approximate 1/2" displacement) which starts above the door lintel and runs around to the side of the building past the window lintel on the east side. In addition, there is corrosion on the door and door frame, especially at the base, and the door frame shows displacement at its base.

Photo 19 - The entrance door to the gatehouse, showing signs of corrosion and some displacement of the door frame at the base, which leads to difficulty in opening the door.

8. **Gatehouse** - The door and door frame should be replaced with a new steel door and the open joints along the outside of the building itself should be repaired. The gate or valve should be exercised on a routine basis to make sure of its operational capability when needed and to avoid a buildup of sediment and debris on the upstream side.

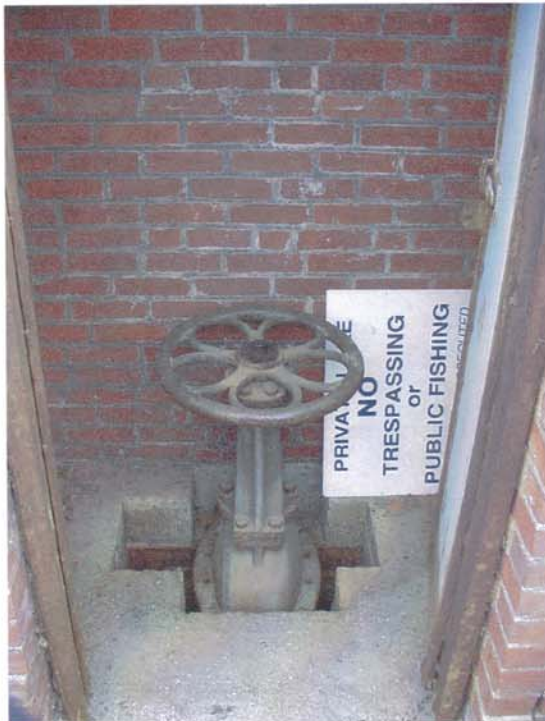
Photo 20 - The inside of the gatehouse, showing the low level outlet control valve. Corrosion is minimal and the valve is reportedly in good operating condition. Note the condition of the door frame base.

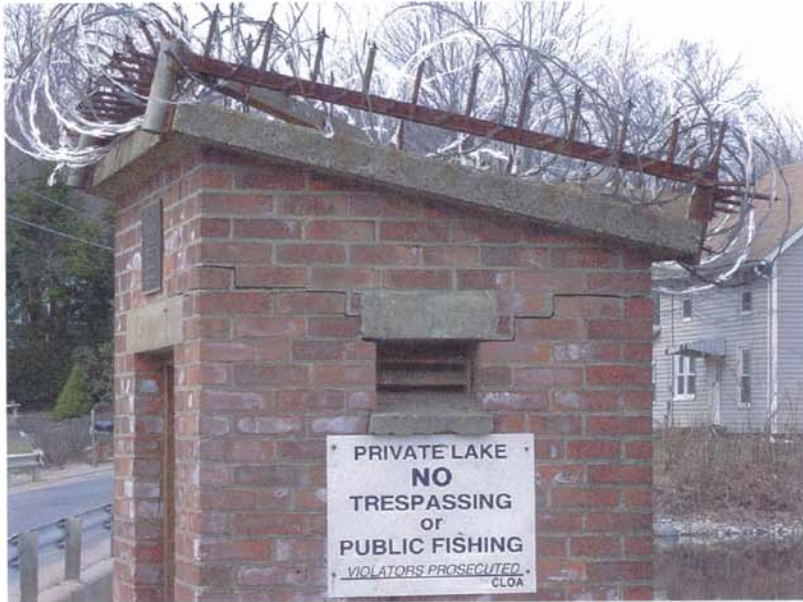
Photo 21 - The left side of the gatehouse, with a crack emanating from the top of the right window corner. While not a serious problem at this time, the crack should be repaired to avoid more serious displacement with continued exposure to the elements.

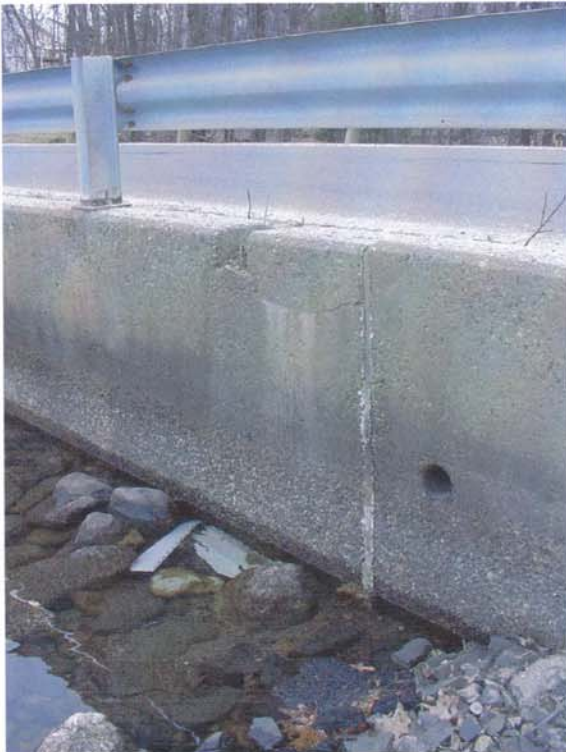
At a point about 15' left of the gatehouse, there is a horizontal crack along a small section of concrete near the top of the wall and adjacent to both a vertical joint and one of the drainage leak-offs. If not repaired, the concrete will most likely fall off.

Photo 22 - Another of the upstream weathered joints with deteriorating sealant. This photo also shows a piece of concrete ready to fall off due to a horizontal crack, located between a vertical joint and a cutout leak-off for road drainage.

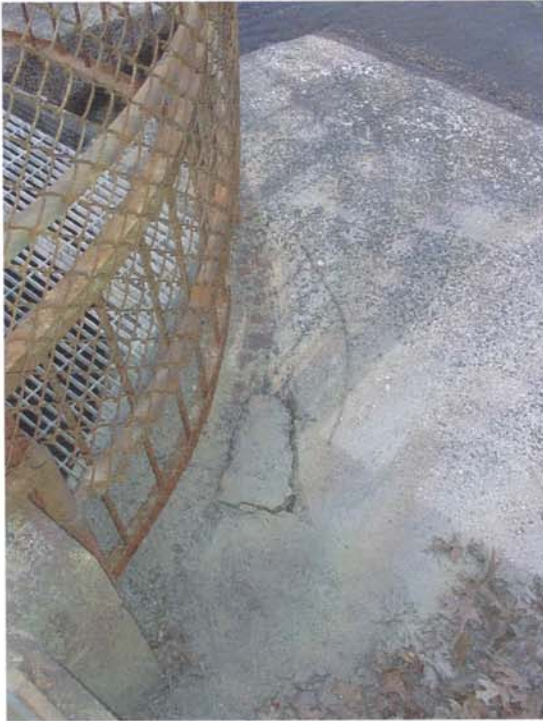
CONCRETE CONDITION: The top surface is in overall good condition, except for one loose chunk of concrete near the left upstream interface between the wall and approach slab (see photos). This, along with the adjacent crack, should be repaired.

Photo 23 - A section of broken concrete and open joint on the left side of the spillway in need of repair. This area, because of the grating and fence screen should always be closely monitored for the buildup of debris, particularly during storm situations when blockage could occur.

9. **Primary Spillway** - The loose chunk of concrete near the left upstream interface between the wall and approach slab along with the adjacent crack should be repaired. In addition, minor seepage noted at the base of the vertical spillway wall should be monitored for any future changes in quantity or quality, but requires no further action at this time.

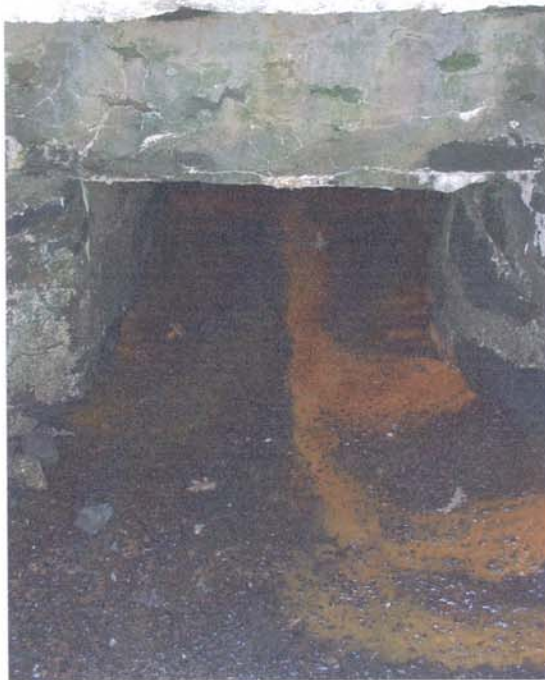
Photo 24 - The upstream end of the primary spillway discharge channel, showing minor cracking along the upper wall area and seepage along the base of the right wall. Of note here are two items not visible; first, there is a steel support beam which spans beneath the concrete support wall at the base of the tunnel roof and, secondly, there are open joints in two of the support stone masonry blocks just inside the upper end of the tunnel where there are voids in the soil area between the blocks.

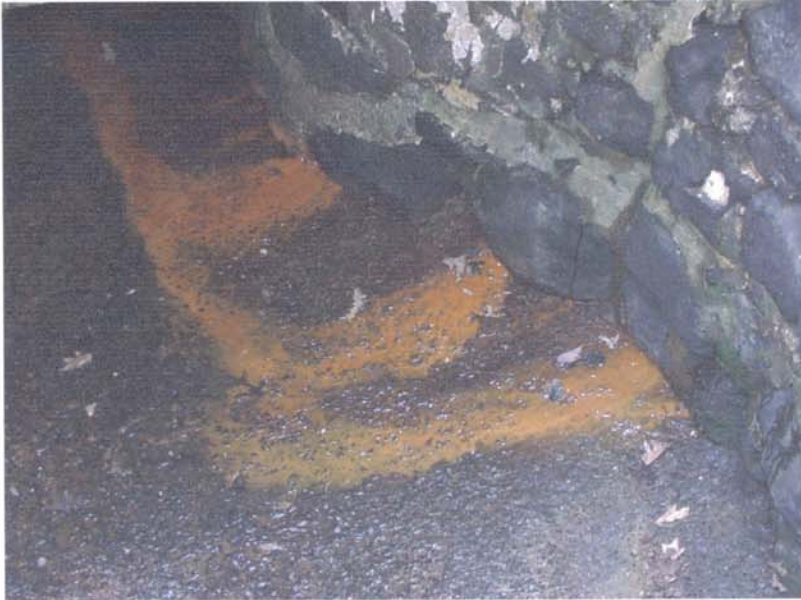
STONE MASONRY: There is mortared stone masonry on the downstream vertical face of the spillway which is in good condition. Minor seepage noted at its base is not a problem, but should be monitored for any future changes in quantity or quality.

Photo 25 - A close-up view of the seepage at the base of the spillway wall . The seepage is currently minor, but should be monitored on a continuous basis for any change in quantity or quality (turbidity) - as with that noted for the low level outlet discharge area.
