INSPECTION REPORT

CEDAR LAKE DAM CT DEEP #16603

NORTH STREET
MAD RIVER
WOLCOTT, CONNECTICUT

DECEMBER 2019

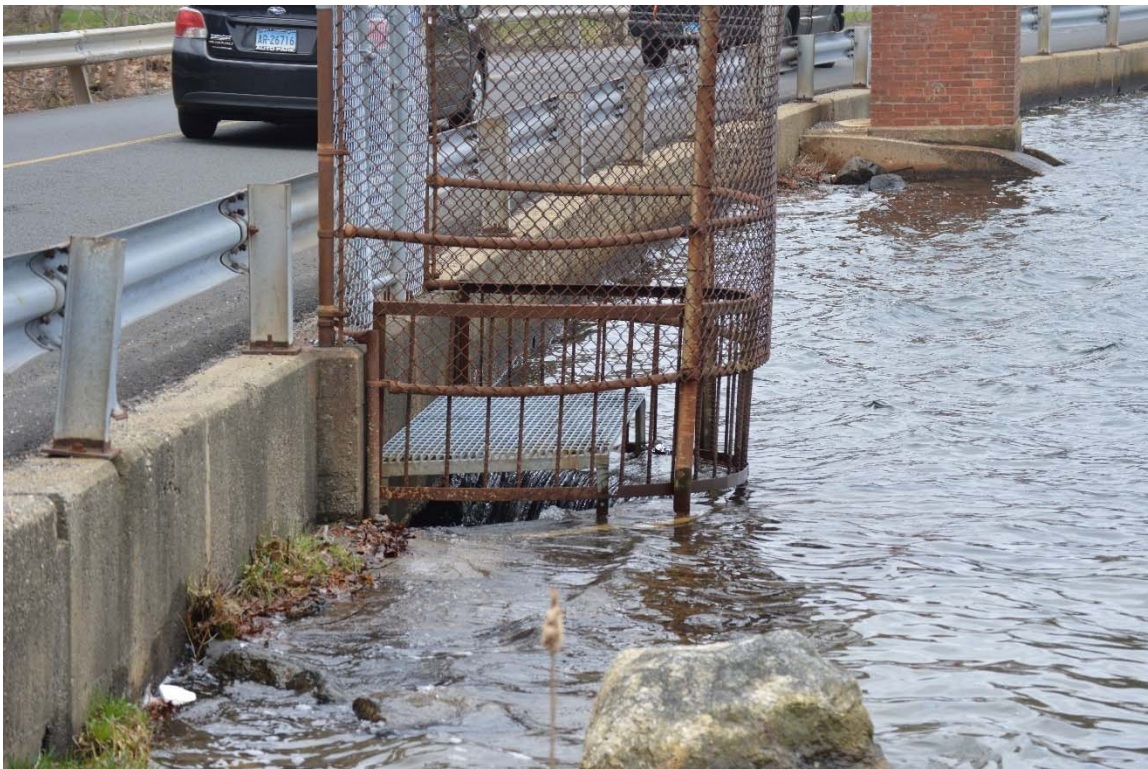
Photo 9c – A closer view of the spillway from the left side, with the trash rack visible. The rack is in good condition, but the fencing around the spillway exhibits progressive corrosion.

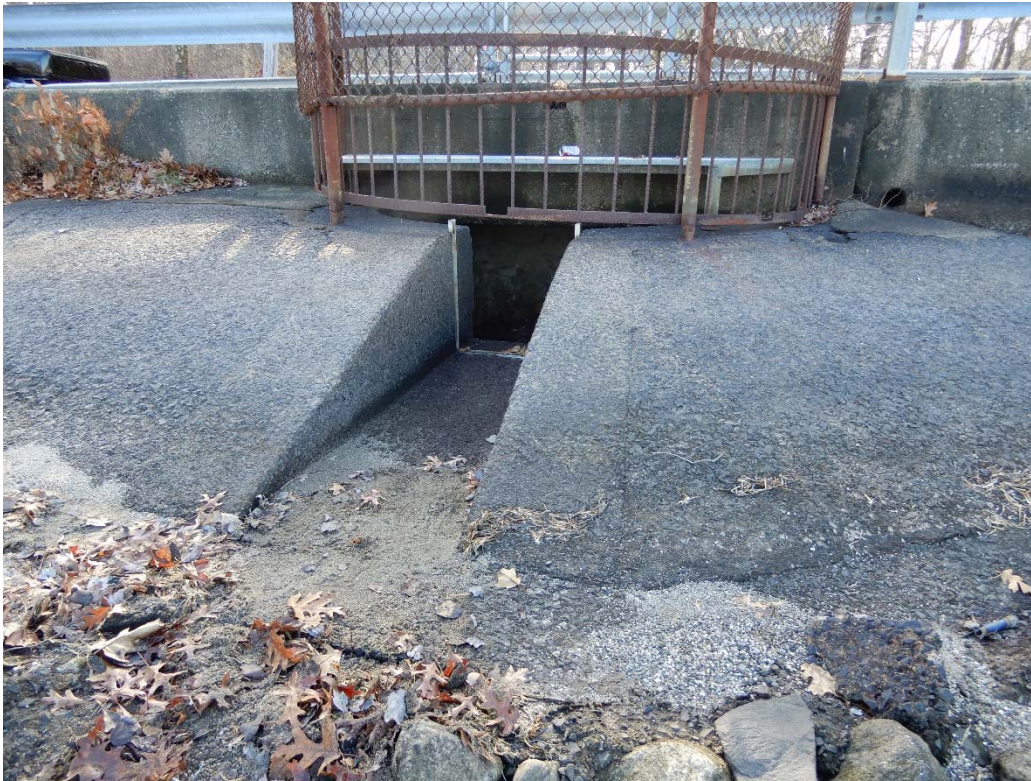
Photo 9f – The spillway approach area as seen from the upstream during the winter drawdown. The concrete is in overall good condition with minor spalls and cracks near the overflow crest area.

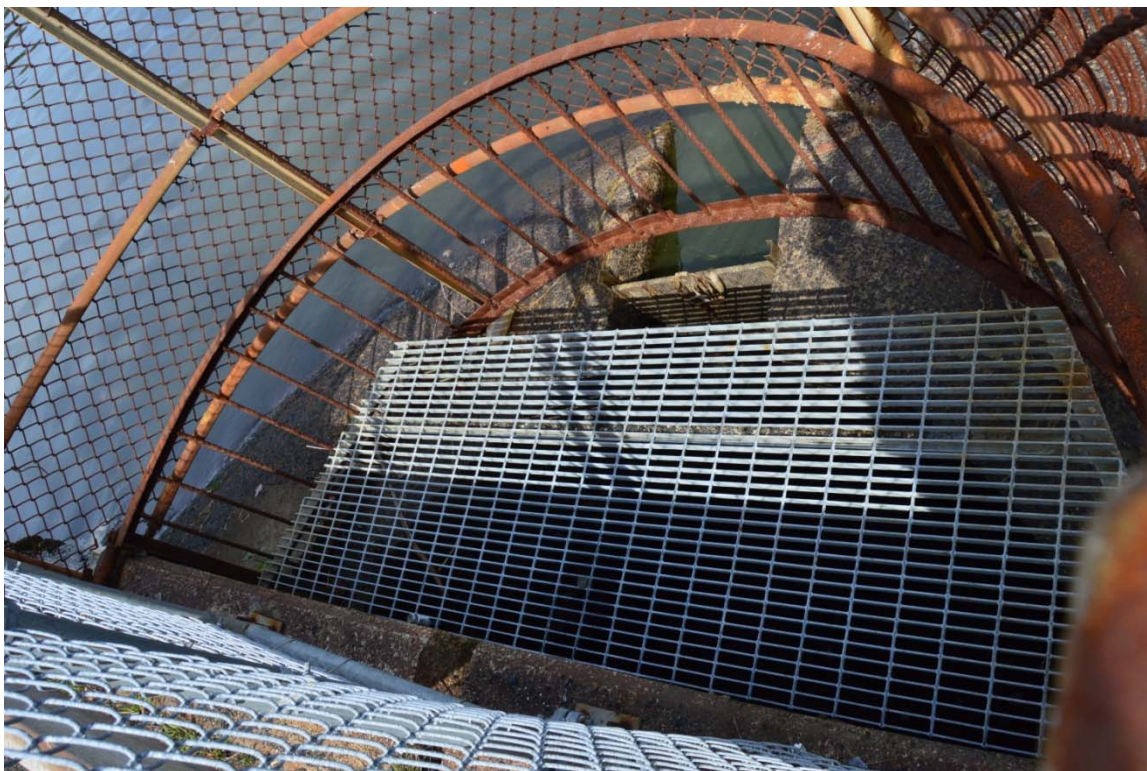
Photos 11 & 12 – A view of the concrete approach apron and adjustable weir channel surrounding the spillway inlet area. The concrete is a bit weathered but still in sound condition.

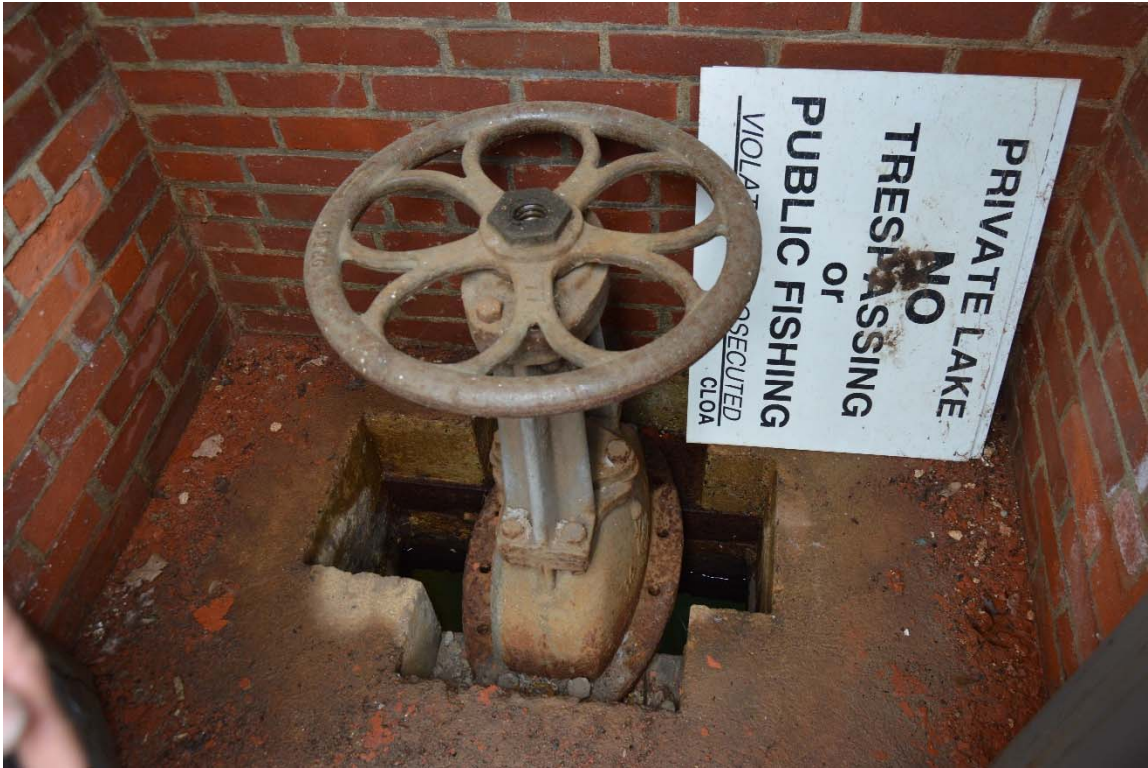
Photo 21a – The interior base of the gatehouse. Note the mild corrosion on the base brackets for the valve operator, which should be cleaned and coated. In addition, the occasional difficulty in turning the valve indicates that the valve needs to be serviced on a regular basis (i.e., bonnet removed, gaskets replaced, stuffing repacked, etc.).

The gate operator was inspected inside the gatehouse. The operator itself (a large wheel) was in good condition, but the brackets at its base exhibited surficial corrosion, and should be cleaned and coated.

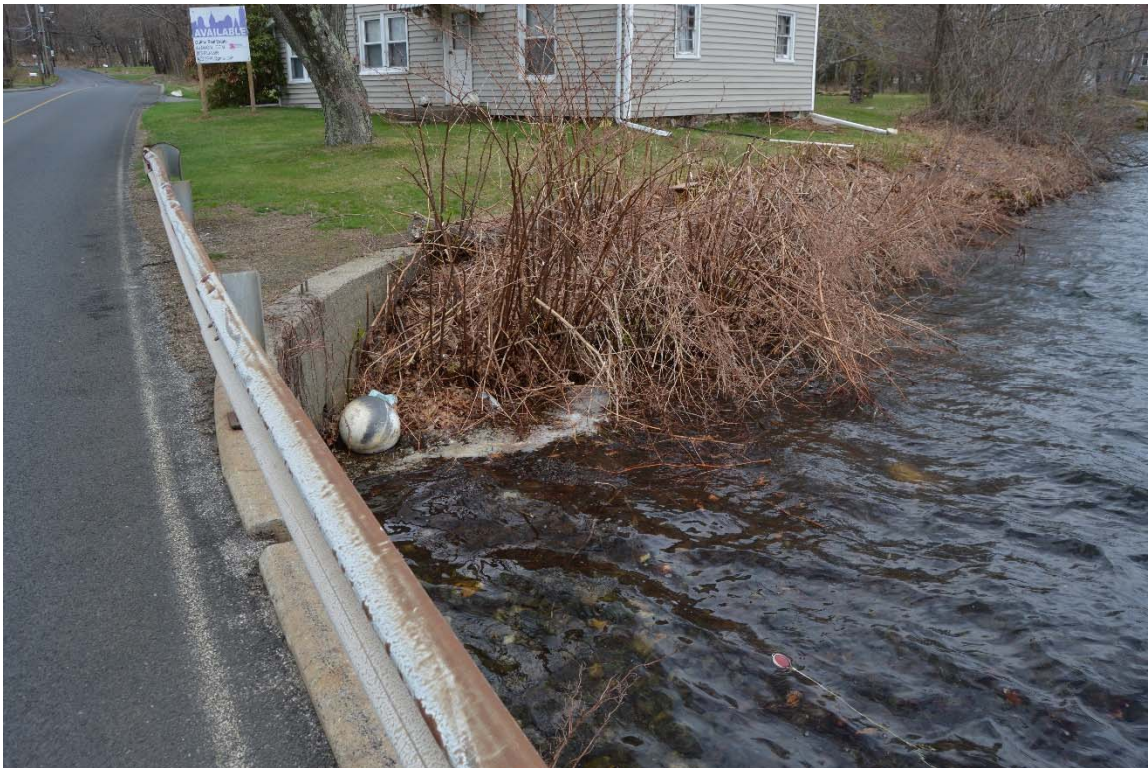
Photo 21b – Brush growth at the right end of the upstream embankment wall. Although not as prolific as during the peak growing season, it is clearly a nuisance, and should be removed to open the area for observation of any problems along the wall and abutment area.

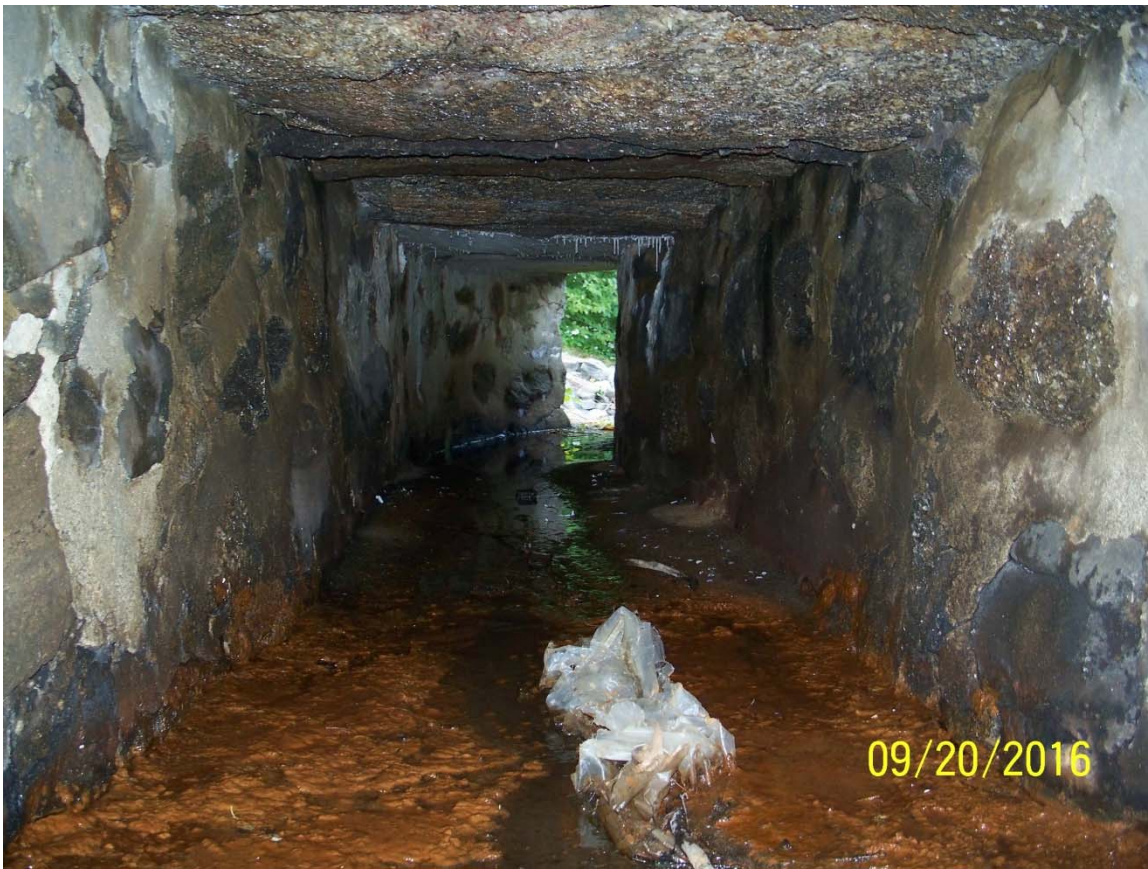
Photo 21d – The interior of the spillway tunnel (looking downstream from the upstream end), showing a section of roof with open voids between stone that spans the width of the tunnel.

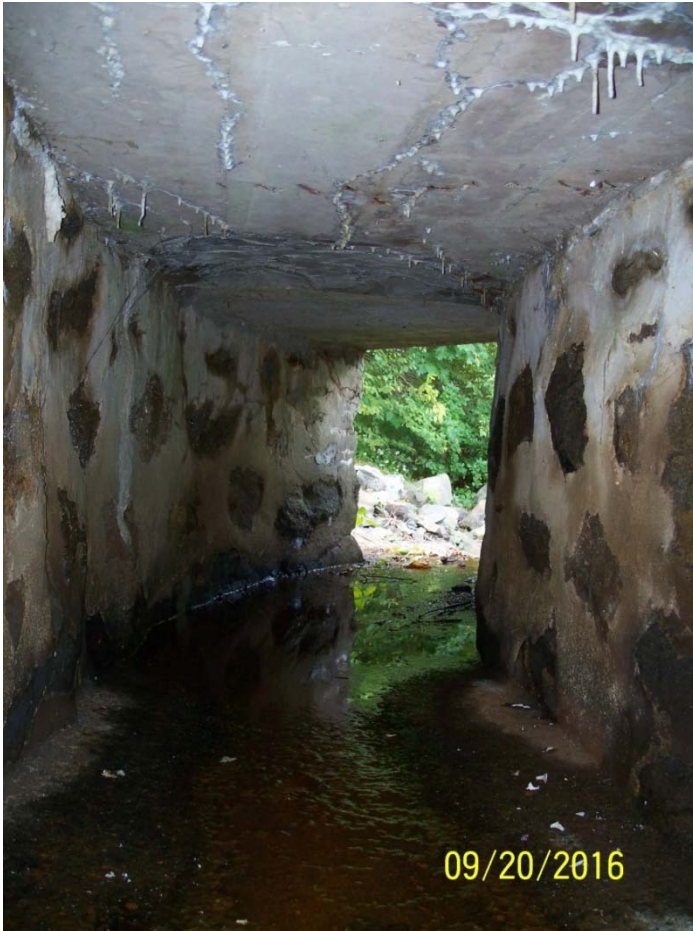
Photo 21e – The interior roof of the spillway discharge tunnel. There are cracks in this section, downward bulging and pitting further along near the downstream end.

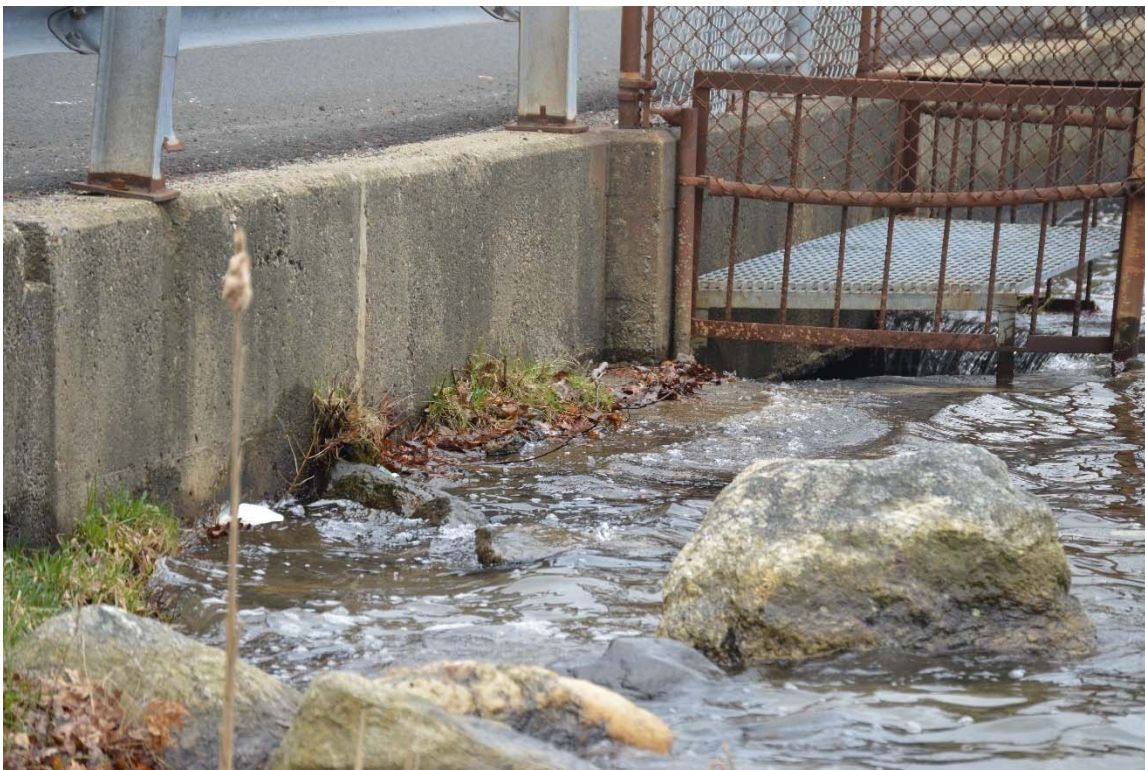
Photo 21f – The left side of the spillway approach area, showing the corrosion present on the fence post and rails surrounding the spillway.

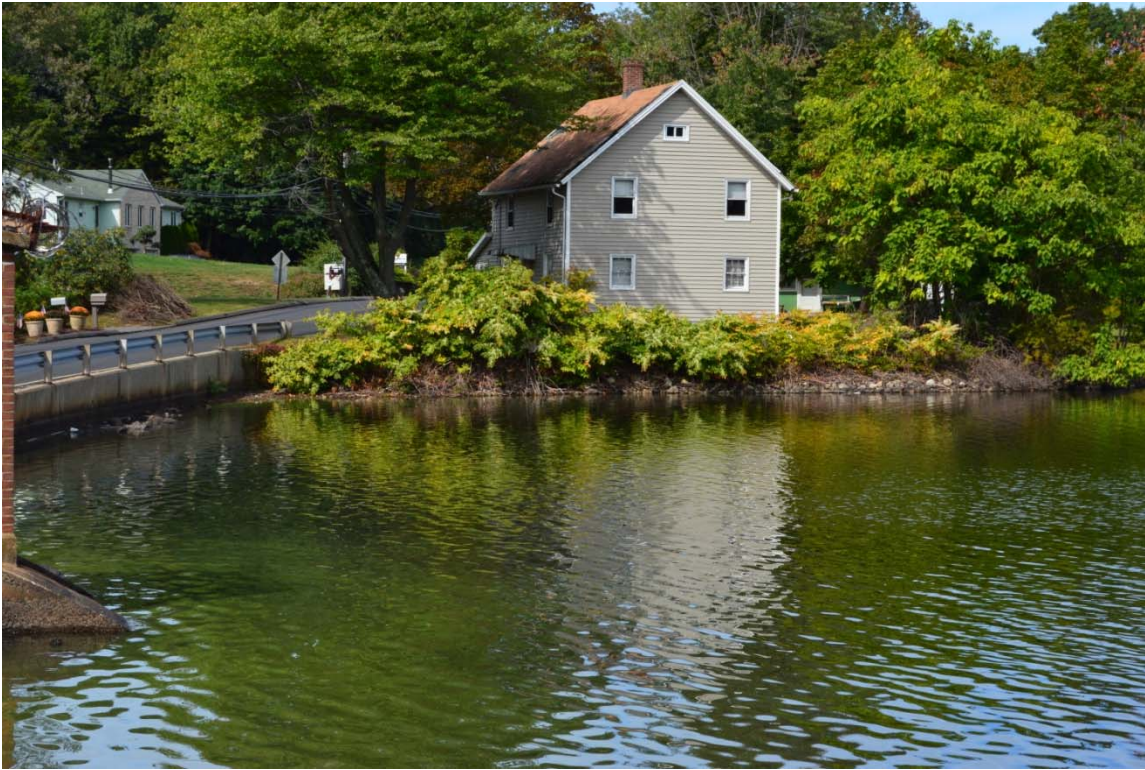
Photo 21g – Another view of the right side upstream embankment area of Cedar Lake Dam, with the full extent of seasonal brush growth visible (2016 photo).

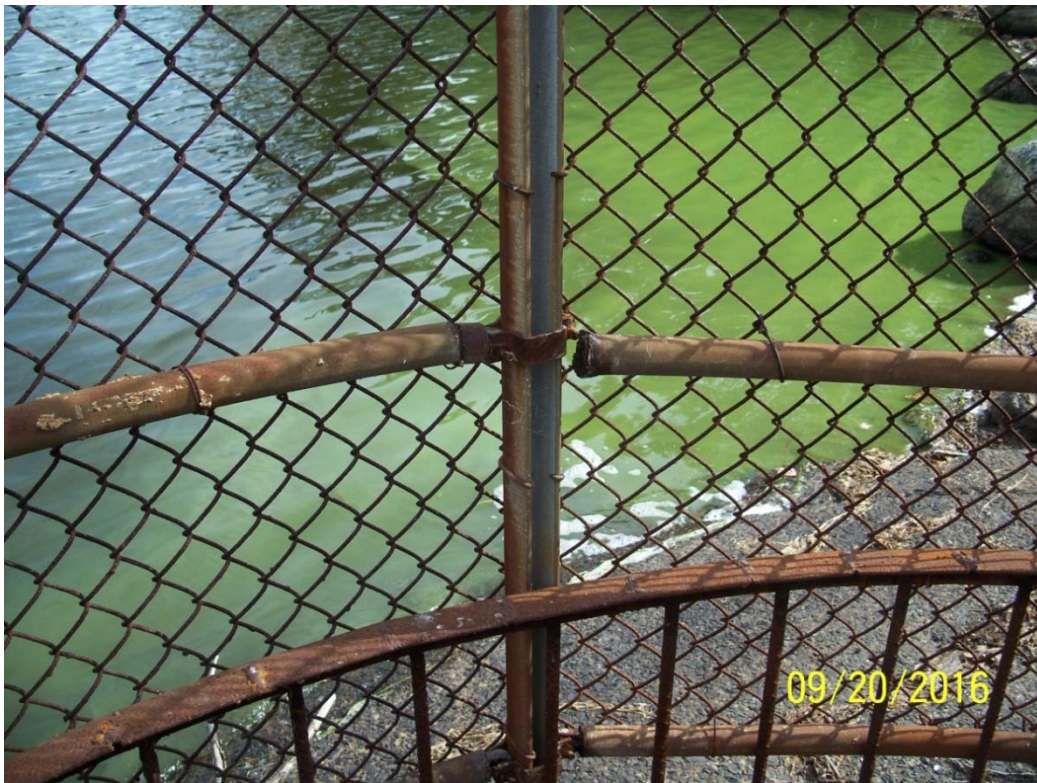
Photo 21h – The fencing surrounding the spillway inlet has begun to show wear, along with separation of some structural members. Steel should be cleaned and coated where practicable, while deteriorated portions of the chain link fence should be replaced.

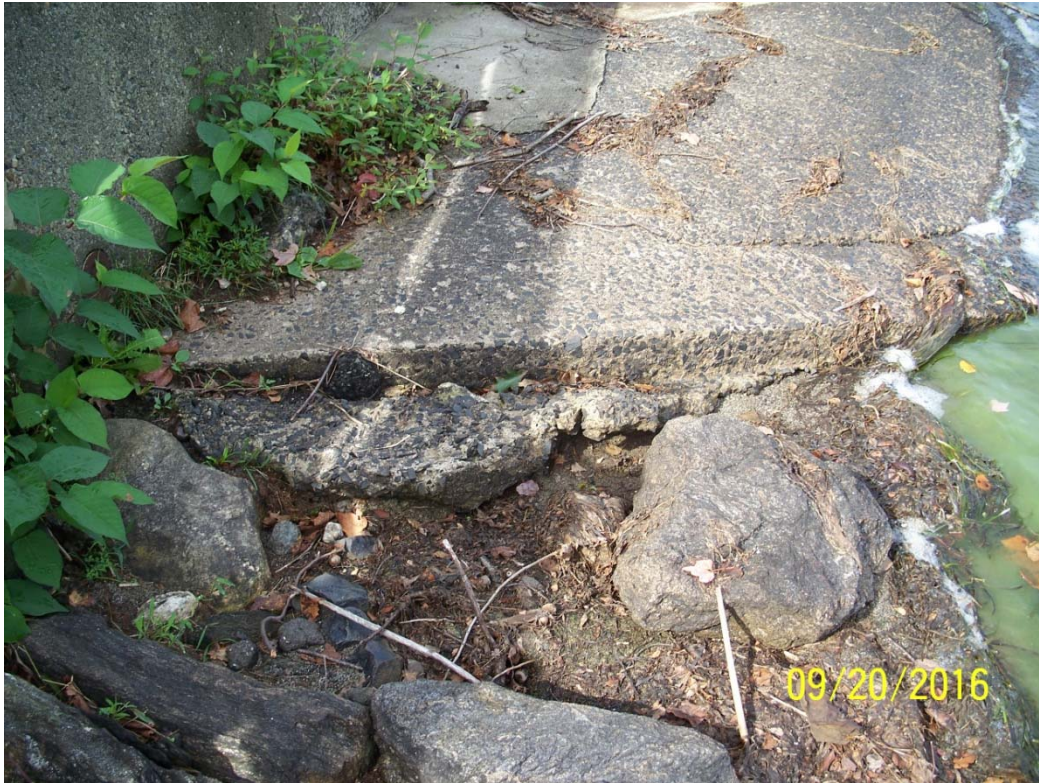
Photo 21i – Concrete deterioration at the left upper end of the spillway approach slab. The concrete must be cleaned, and cracks and openings closed off and re-mortared where necessary.

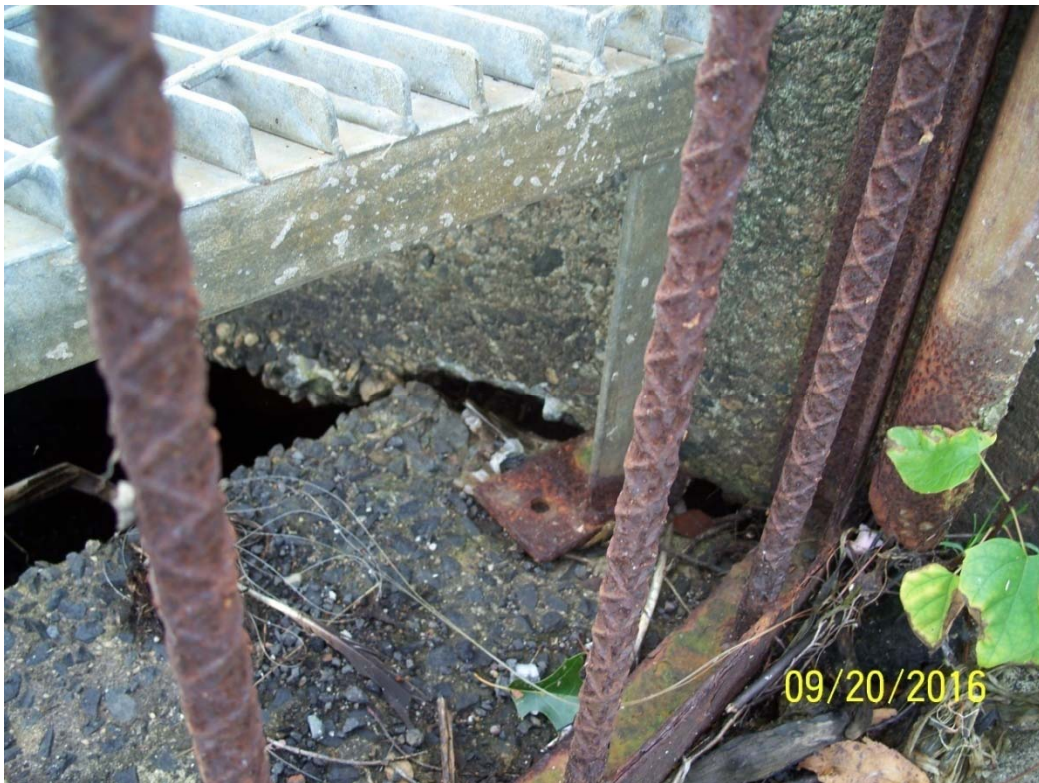
Photo 21j – The right side of the spillway at the junction between the weir and right side abutment wall. Note the gap between concrete wall sections. This should be cleaned and mortared. Wear of the steel bars and the bracket for the protective outer grate is also extant.

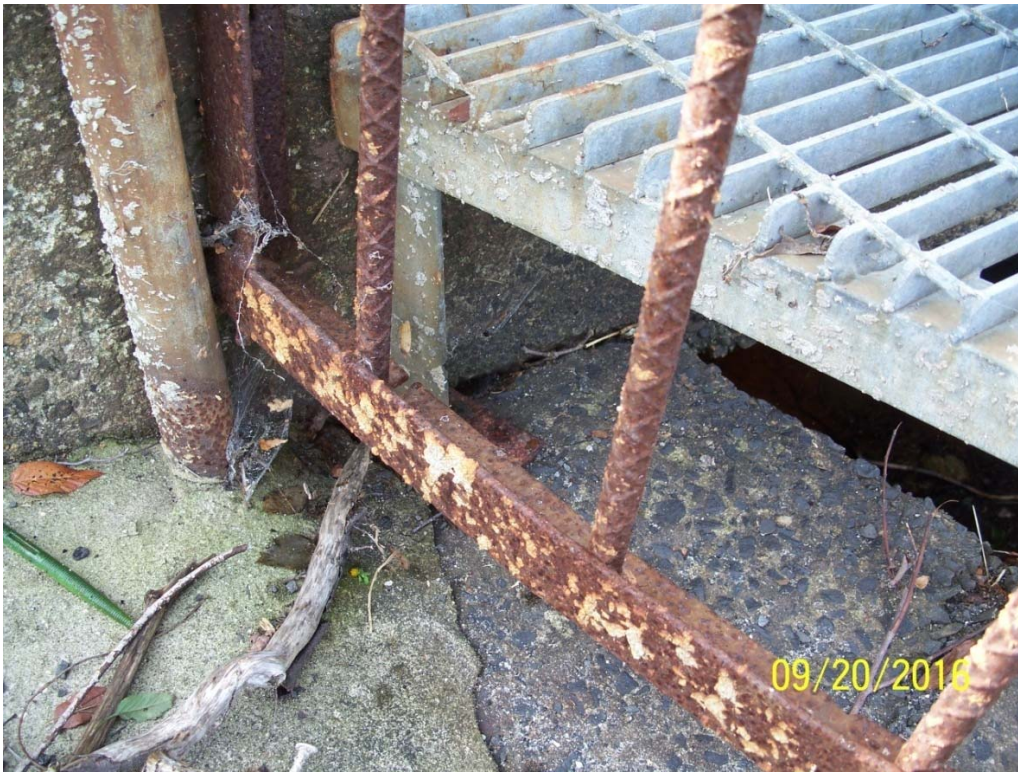
Photo 21k – The left side of the spillway weir, showing conditions similar to those on the right side.

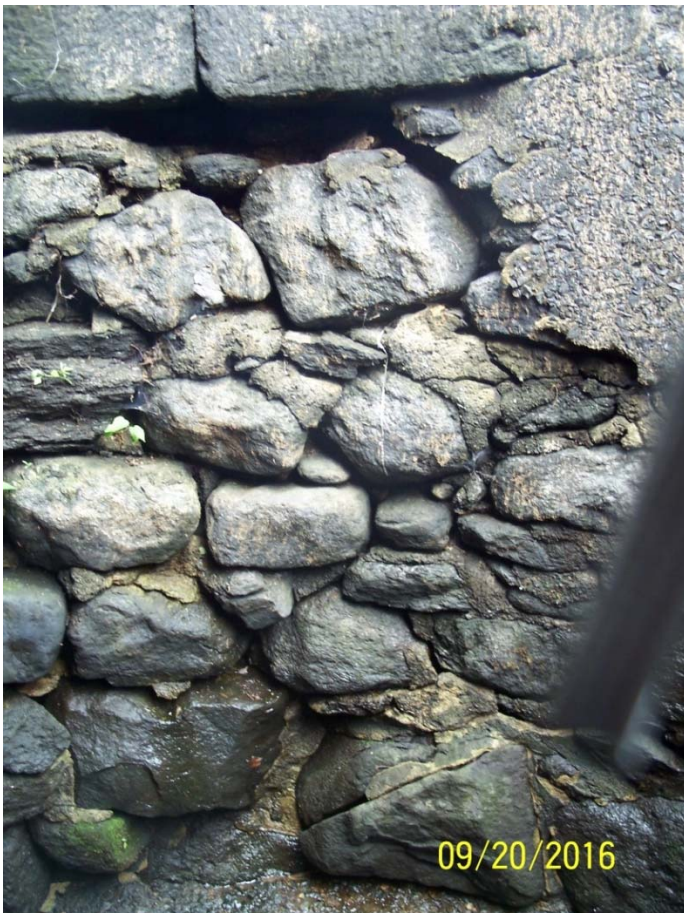
Photo 21l – The base of the spillway wall. The stone wall face and base area should be cleaned, chinked and re-mortared where gaps between stones are present. Seepage at the base is not severe or problematic, but should be monitored on a regular basis.

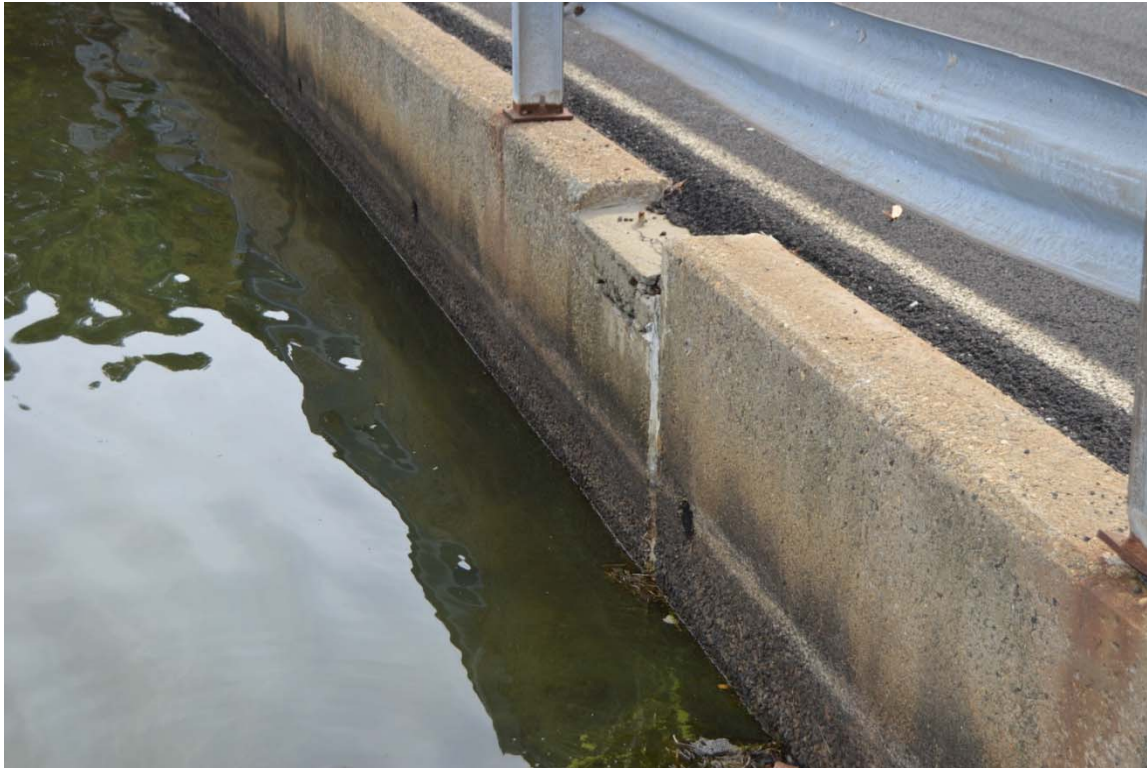
Photo 21m – A leak off for road drainage to flow into the lake. Note minor concrete deterioration just below the leak off point. This area should be patched and coated before the deterioration worsens.

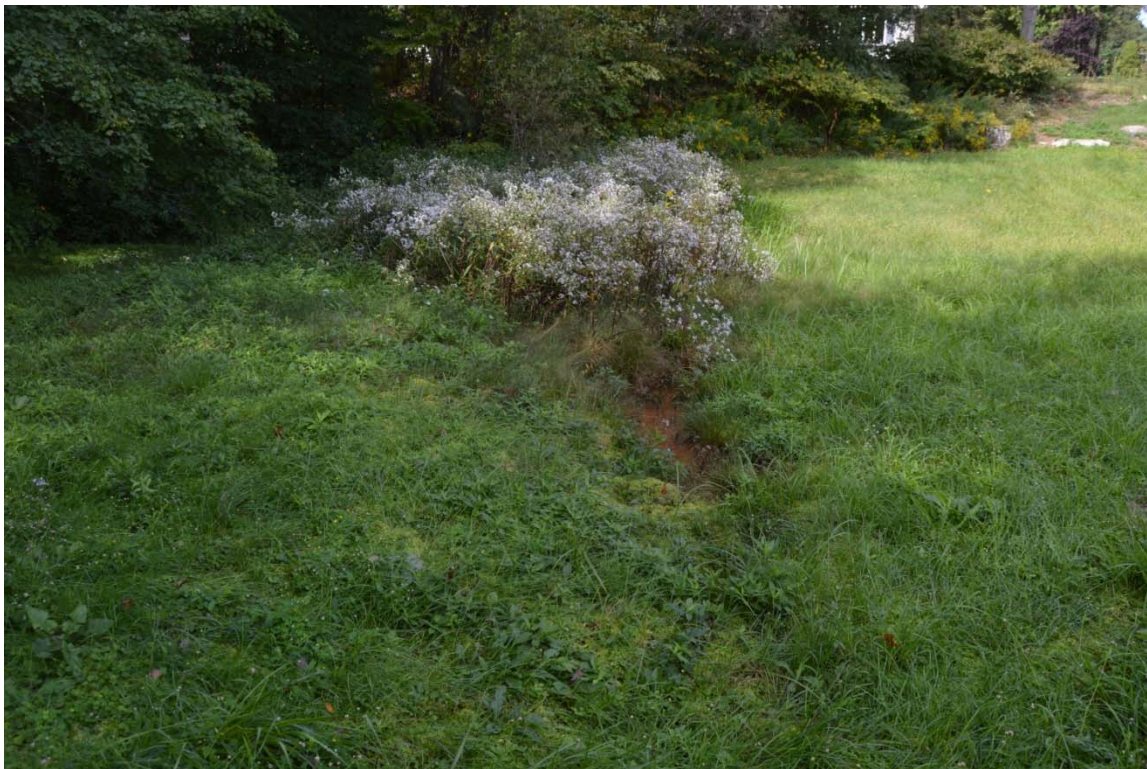
Photo 21n – An area of standing water near the base of the downstream slope, indicating seepage through the embankment, although to a moderate extent. Continued monitoring is recommended.

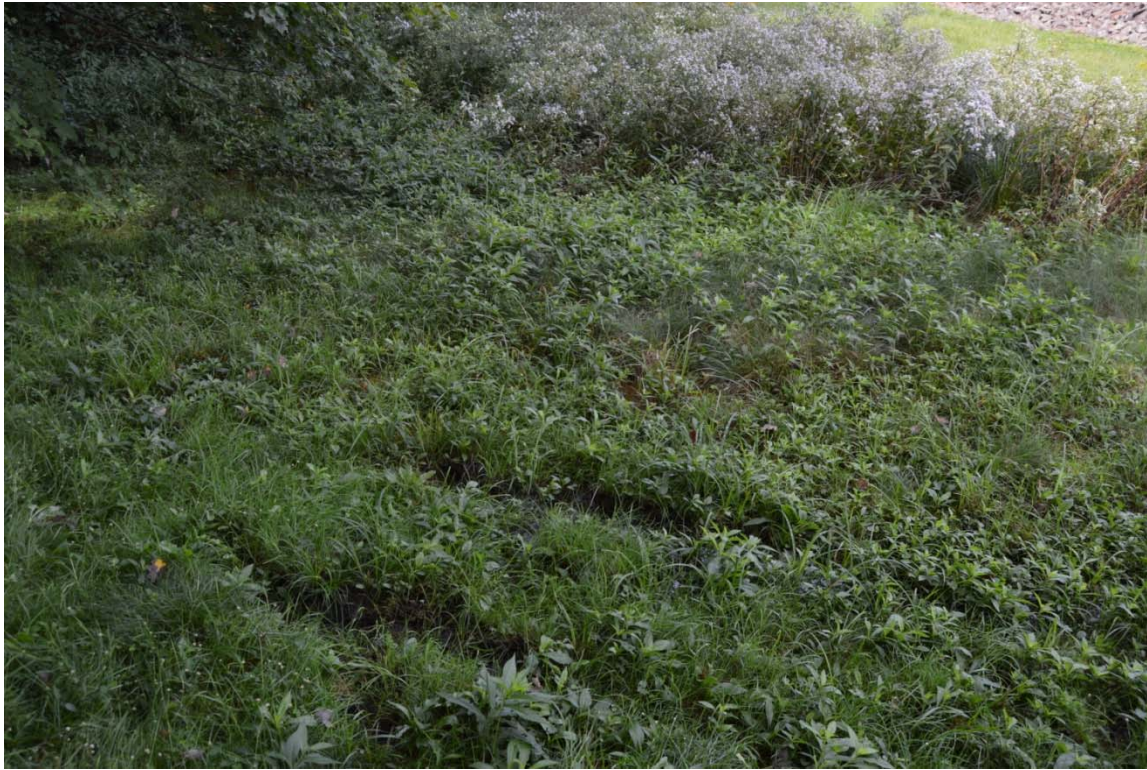
Photo 21o – Rutting from vehicular tracks in the downstream base area, probably caused by mowing equipment being driven through a wet area. Such sections may have to be mowed with a hand-push mower or weed whacked.

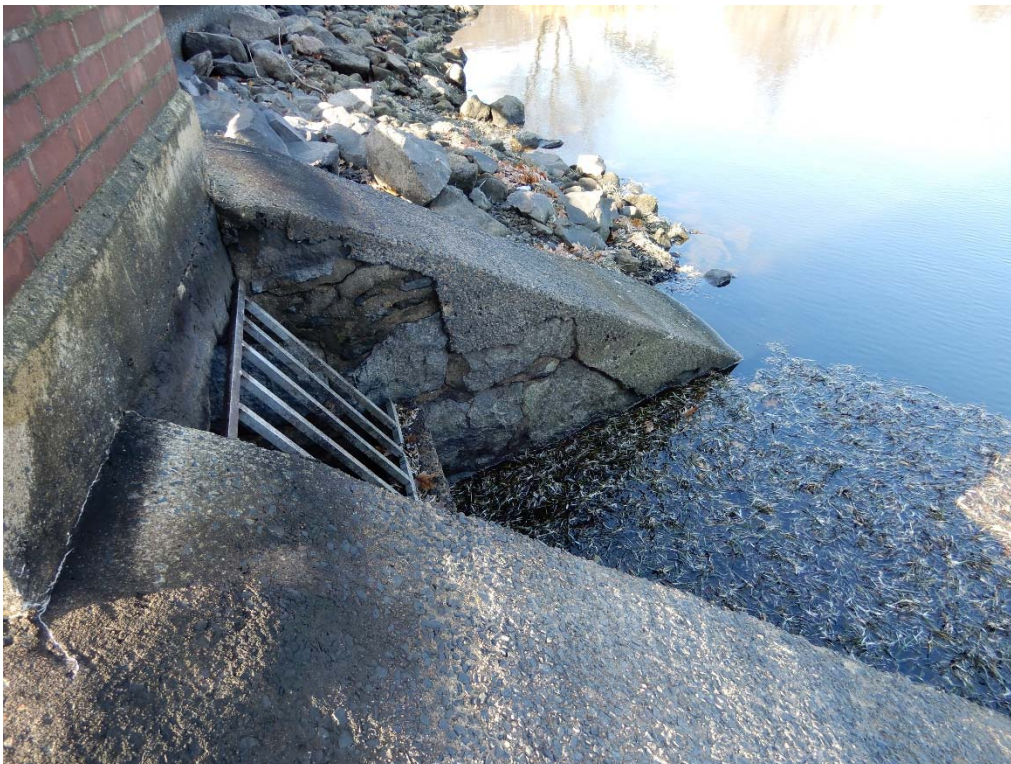
Photo 21p – The stubby right side training wall at the base of the gatehouse and low level intake area. The concrete cap over the stone masonry and concrete surfaces should be inspected during annual drawdowns for any potential defects.

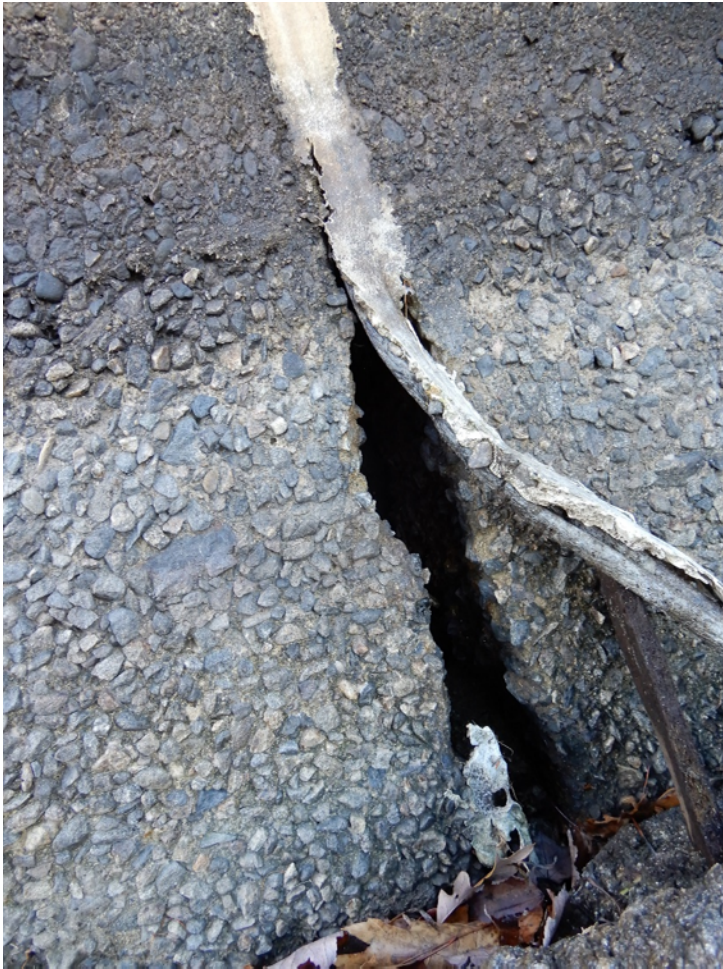
Photo 21q – The base of the upstream embankment wall, to the right of the spillway. The joint filler has been displaced, and the gap at the joint is expanding, creating a void in the wall (typical of several vertical joints).

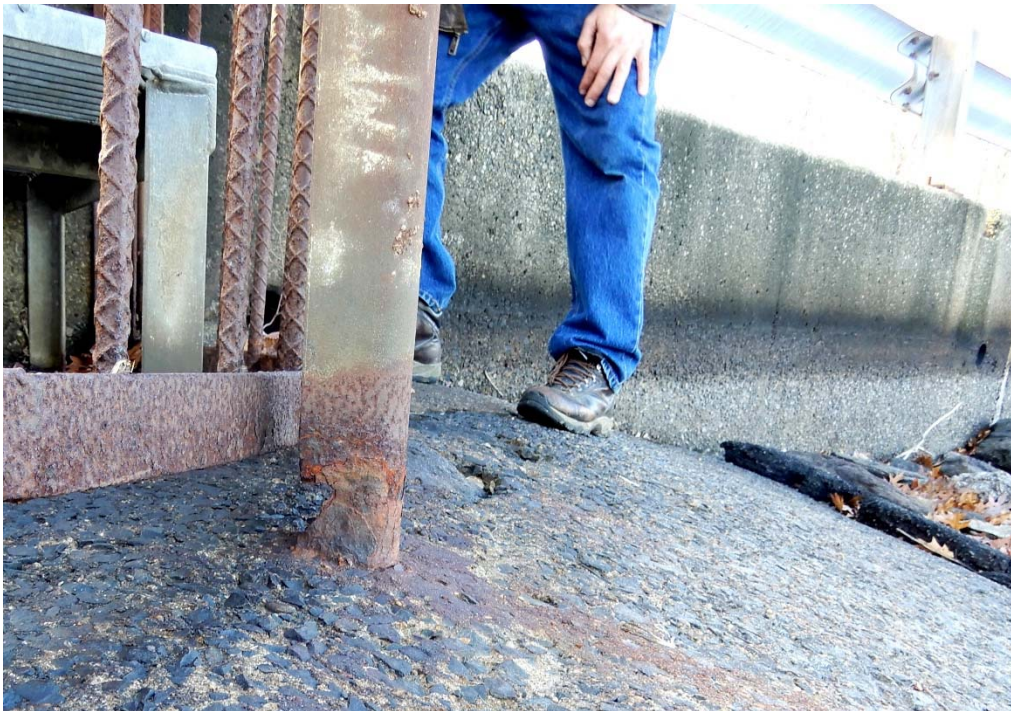
Photo 21r – The base portions of the vertical fence support posts around the upstream spillway approach area are badly deteriorated.
