# **LAKE ASSOCIATION NEWSLETTER**

**WINTER  
2026**

Cedar Lake Owners Association

Phosphorus/Algae Evaluation  
8/25/2025

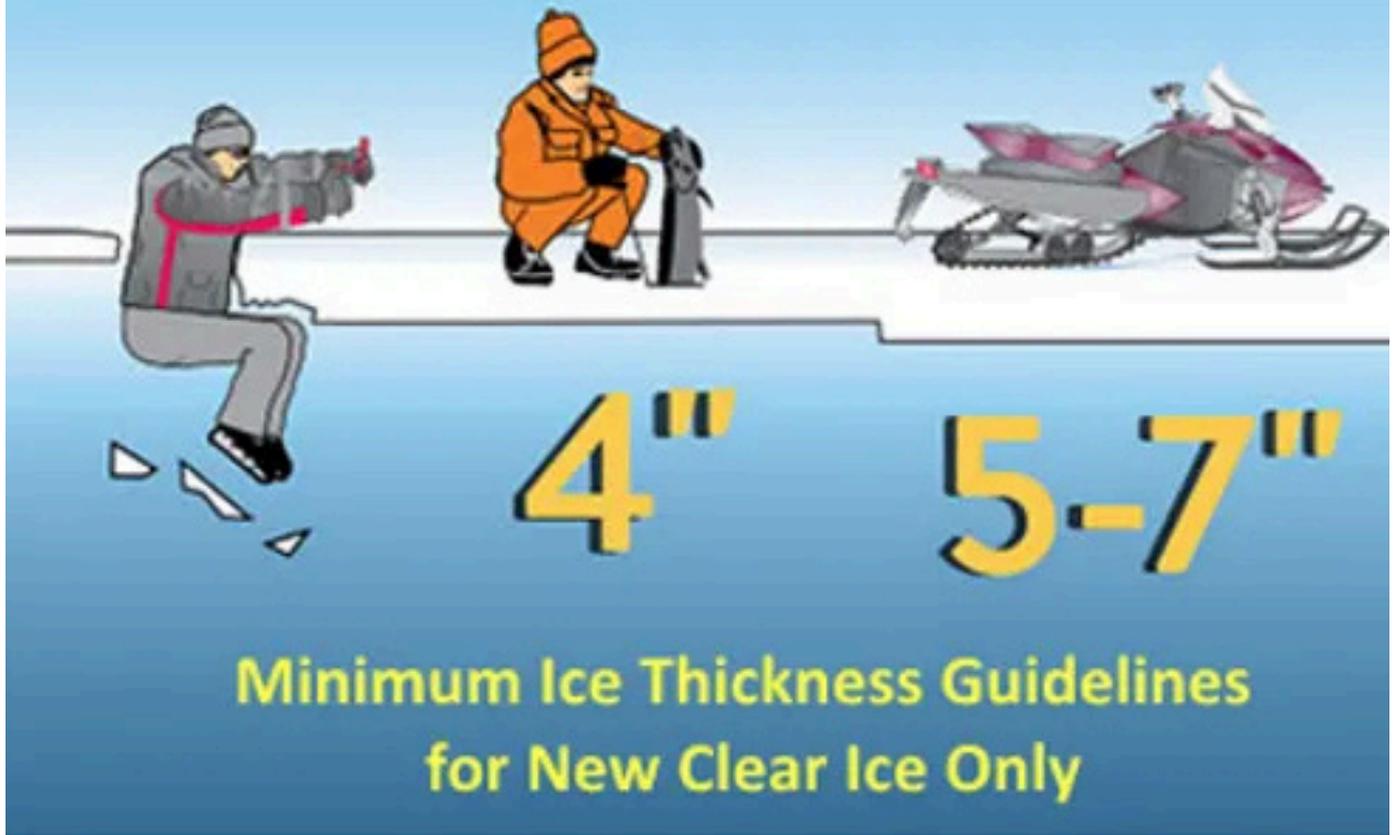
Minimum Ice Thickness Guidelines  
for New Clear Ice Only

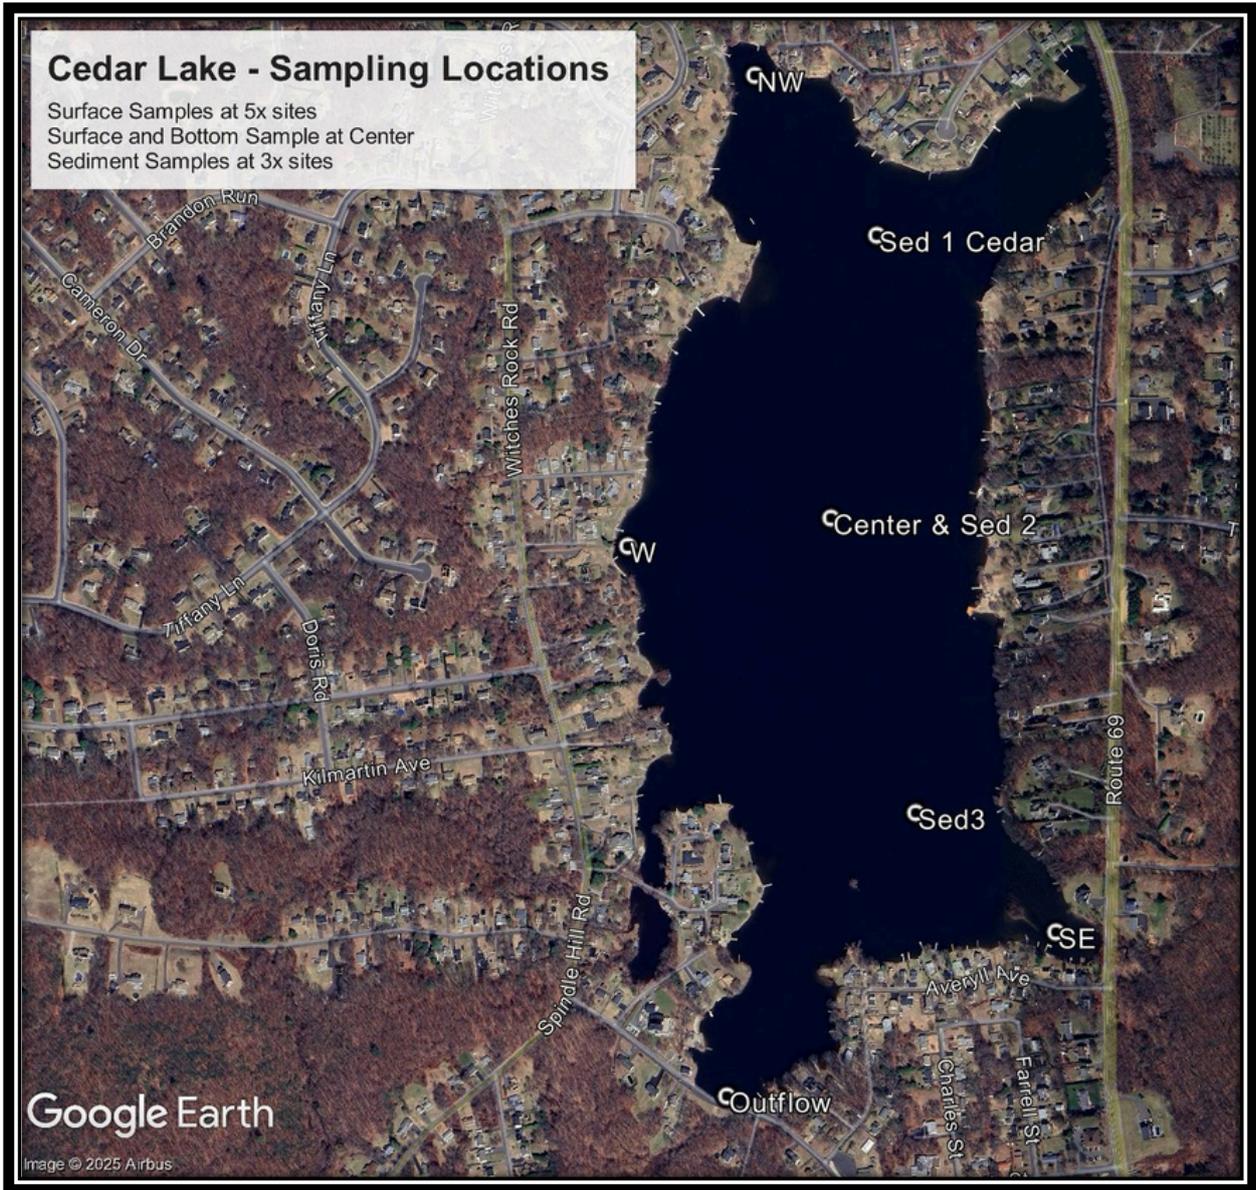
8/25/25 – Sampling locations

To evaluate how much and where phosphorus may be of issue here, six sites were selected in various coves, the lake center (surface & bottom), and the lake outflow to be tested. If Total Phosphorus was drastically different at any one site, that could indicate point-source or localized non-point-source pollution in that area. This also could suggest further testing may be needed in those areas. Surface water samples for Total Phosphorus were uniform throughout all sites during this late August evaluation so no phosphorus input hotspots are suspected at this time. However, this was a dry time of year and phosphorus does tend to build up terrestrially in times of little/no rain. Testing may show more fluctuation in TP throughout the lake after a rain event.

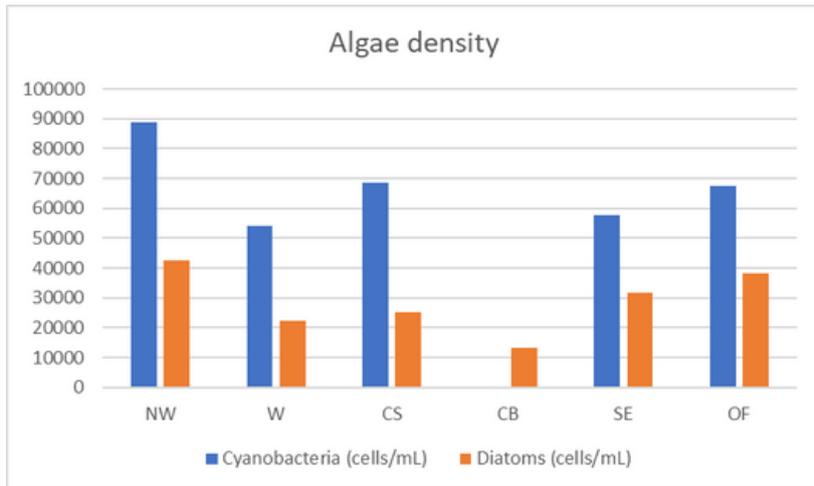
8-25-25 Cedar Lake Bloom Density Sampling Results

The above chart compares how TP at various locations around the lake influences how much Chlorophyll a is found in the water at those sites. Generally,  $>TP \Rightarrow Chl\ a$ . However, the TP test results from all surface locations was found to be at relatively low levels ( $<10\text{ug/L}$ ). This could be explained by the moderate-dense Cyanobacterial bloom that was occurring at the time of testing. This is because as algae grow and reproduce, they accumulate Phosphorus within their cells, lowering what would be reported in a lab test within the water. Algae ID/Enumeration samples showed an average of 67,320 cells/ml of Cyanobacteria throughout the lake. Cyanobacteria do not always show up on a Chl a test as they predominantly rely on different pigments (phycocyanin etc.). The graph below shows that despite low surface TP, a sizable population of Cyanos were present and thriving.

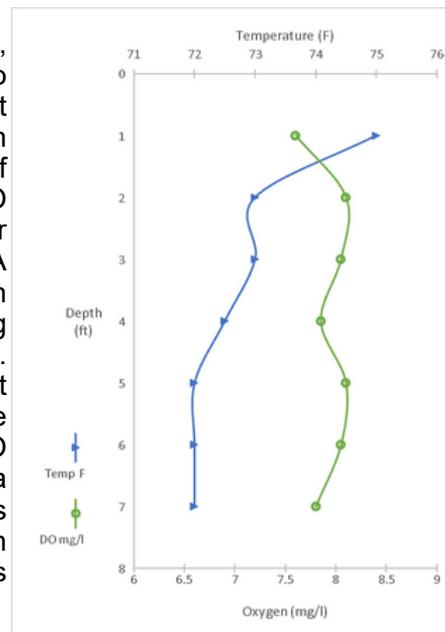
At the time of testing, the lake was found to be well mixed as the below temp/DO profile shows. In deeper lakes, typically the top water and bottom water separate and do not mix through the summer due to a temperature gradient top to bottom. This is not a good/bad lake quality, but can help us interpret the data correctly. There are pros/cons of the lake stratifying but neither is better/worse. The temp/DO graph shows that there is very little change in either parameter as you go deeper down the water column. A stratified temp/DO profile would show a sharp change in both parameters a few meters down with water becoming drastically colder and very low in DO at deeper depths. Another possibility is that the lake is polymictic, meaning it might stratify and remix multiple times throughout the summer. To find out if that is the case, a similar temp/DO profile would need to be done several times per season or a continuous monitor installed. Dissolved Oxygen here is sufficient to sustain aquatic life throughout the water column as >5mg/l can be used as the lower limit for many species and our testing was all >6.5mg/l.

8-25-25 Temp DO Sampling Results

With a relatively shallow maximum depth, Cedar Lake likely does not stratify or only does so periodically through the summer months. Even in this well mixed state, the bottom water sample showed drastically higher (5x) amounts of TP at the bottom than on the surface. This is evidence that Phosphorus is actively being released from the

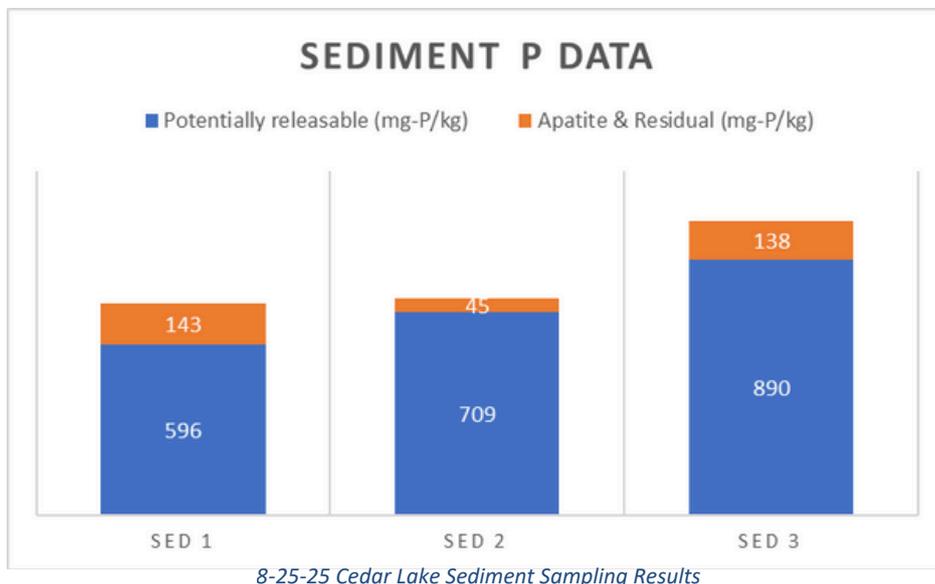
sediment and then used up by algae/cyanos in the presence of light. This sediment release of phosphorus is called internal-loading and is the major driver of algae/poor water quality in many lakes. Direct testing of lake sediment in three locations also confirms a significant amount of phosphorus is found within the sediment. The graph below breaks down the sediment bound phosphorus into two categories. One is the potentially releasable portion and the other is the portion that is more tightly bound and not easily releasable.

The vast majority of phosphorus within the lake sediment is releasable and is doing so based on the bottom water test results.

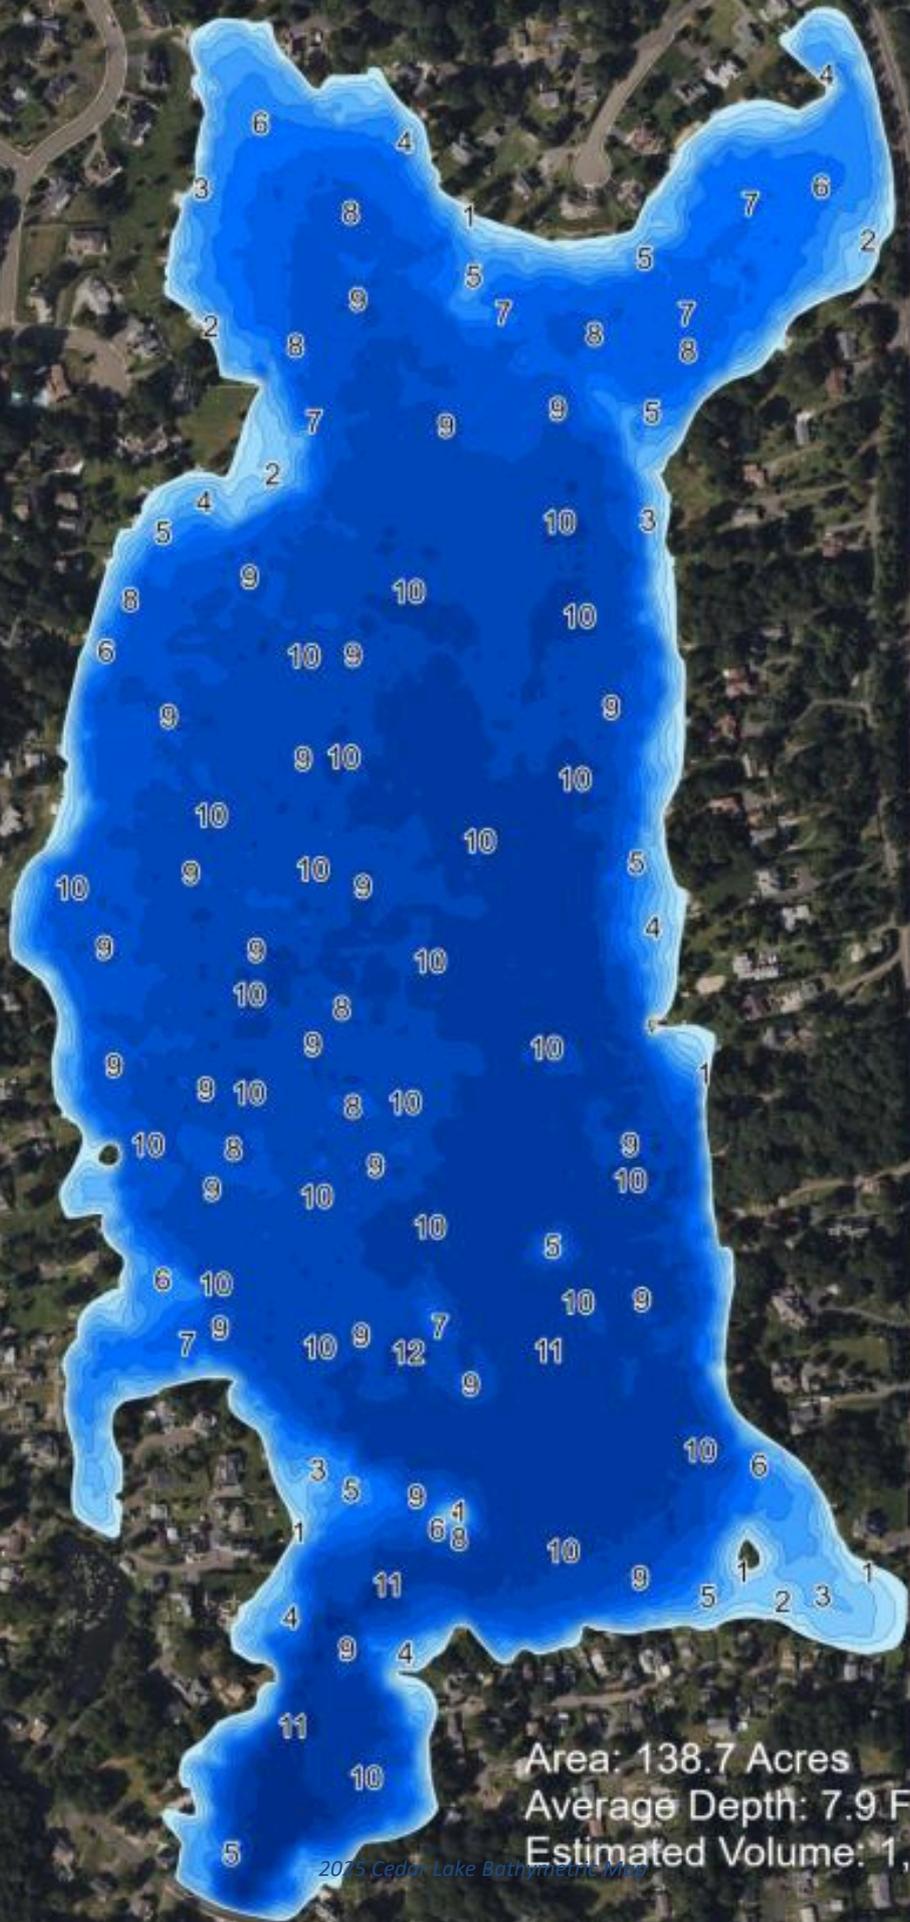
2015 Cedar Lake Bathymetric Map

Depth (ft)

- 1
- 2
- 3
- 4
- 5
- 6
- 7
- 8
- 9
- 10
- 11
- 12
- 13

Area: 138.7 Acres  
 Average Depth: 7.9 Feet  
 Estimated Volume: 1,095.7 Acre-feet
