**CONDITION ASSESSMENT
AND REPAIR EVALUATIONS**

CEDAR LAKE DAM / DEP #16603

NORTH STREET
WOLCOTT, CONNECTICUT

INSPECTION REPORT

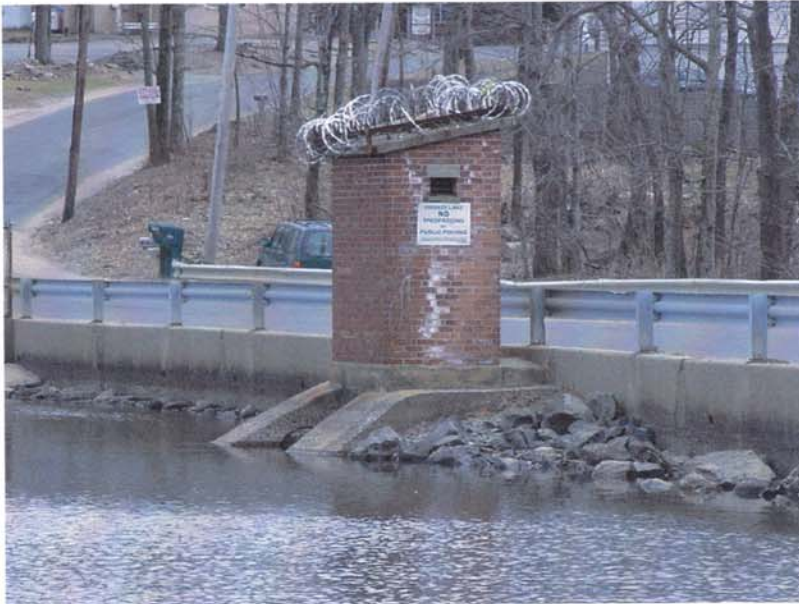
Photo 16 - The gatehouse for the low level outlet at the upstream center of the dam, as seen from the right upstream abutment area.

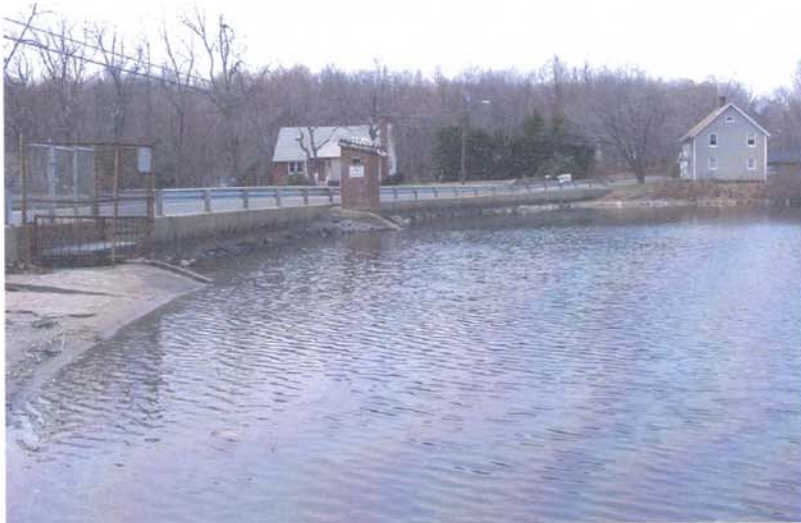
Photo 26 - An overview of the upstream side of the dam as seen from the left abutment area.
