INSPECTION REPORT

CEDAR LAKE DAM CT DEEP #16603

NORTH STREET
MAD RIVER
WOLCOTT, CONNECTICUT

DECEMBER 2019

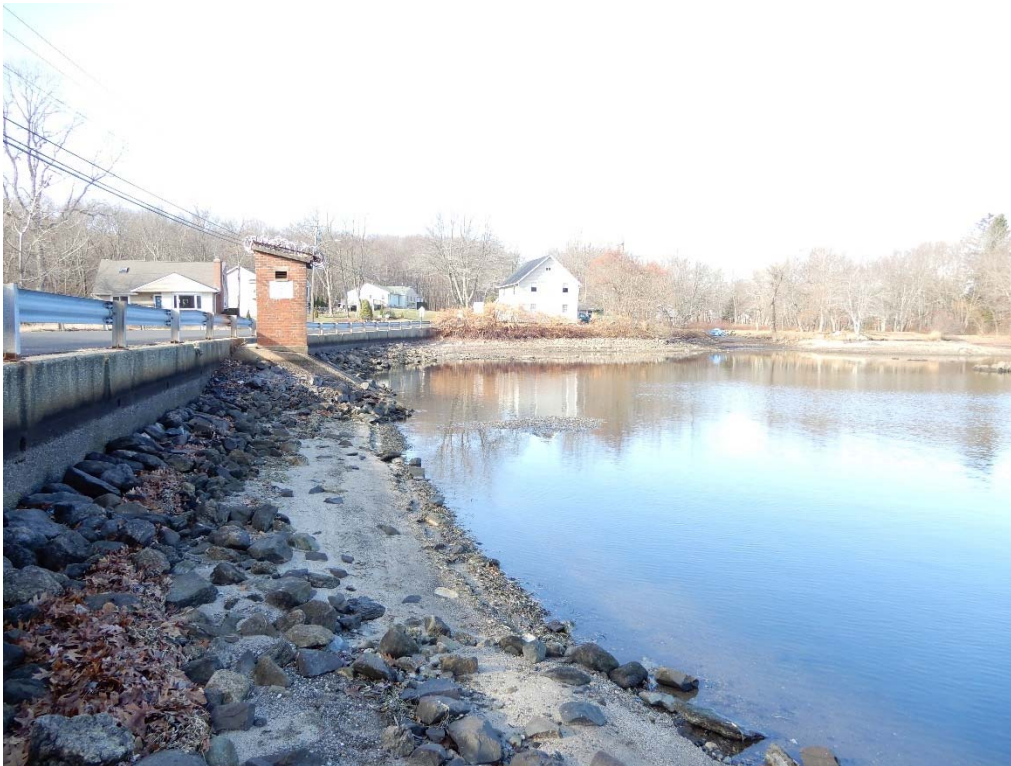
Photo 1d – An overview of Cedar Lake Dam, again as seen from the left side upstream abutment, this time during the winter drawdown period. The riprap apron in the foreground and along the upstream slope is in satisfactory condition.

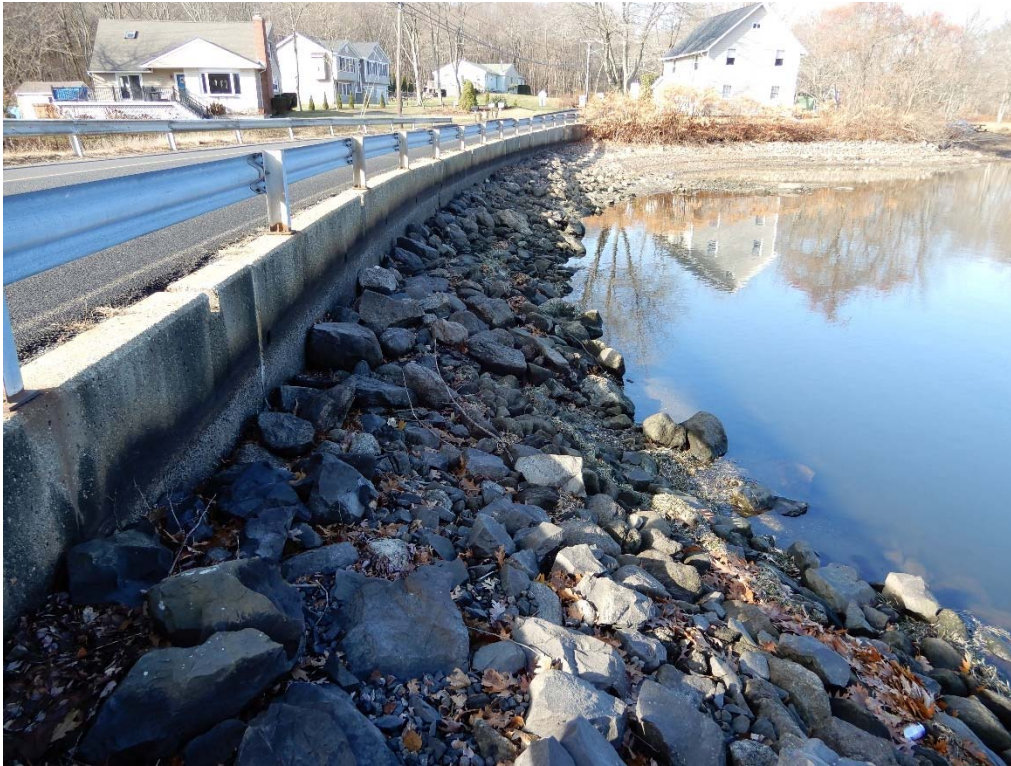
Photo 3c – Riprap lining the upstream embankment slope on the right side of the gatehouse, during the annual winter drawdown.

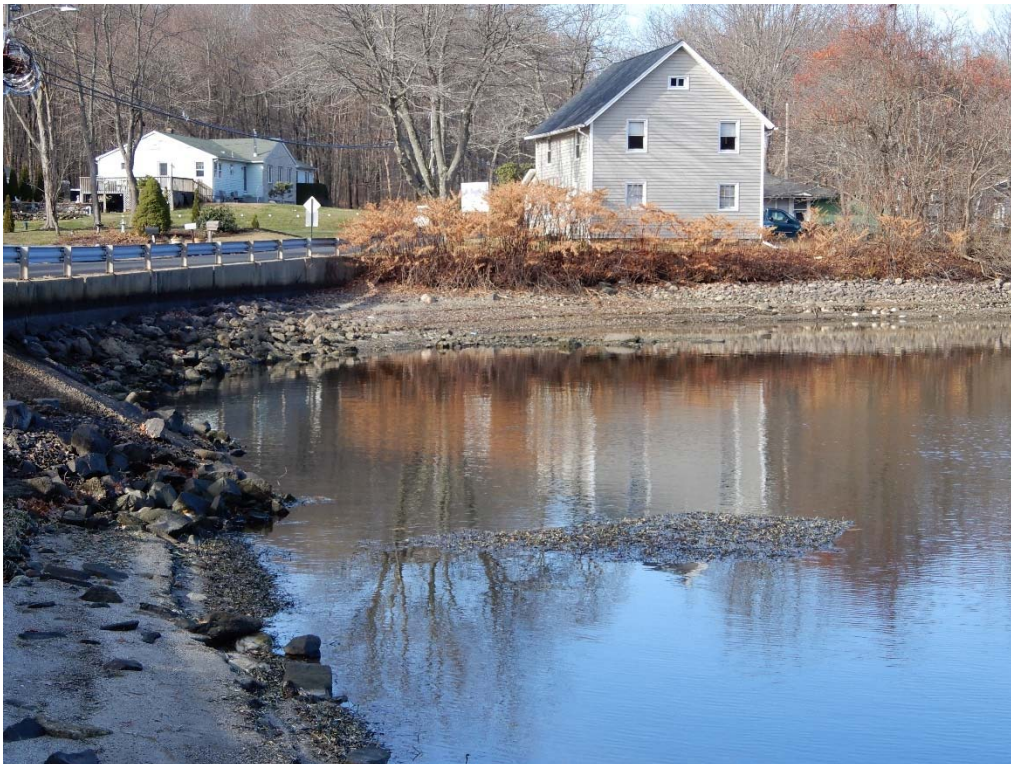
Photo 3d – The right end of the upstream embankment during the winter period, again in satisfactory condition. The intake training wall at the gatehouse can be seen at the center-left of the photo.

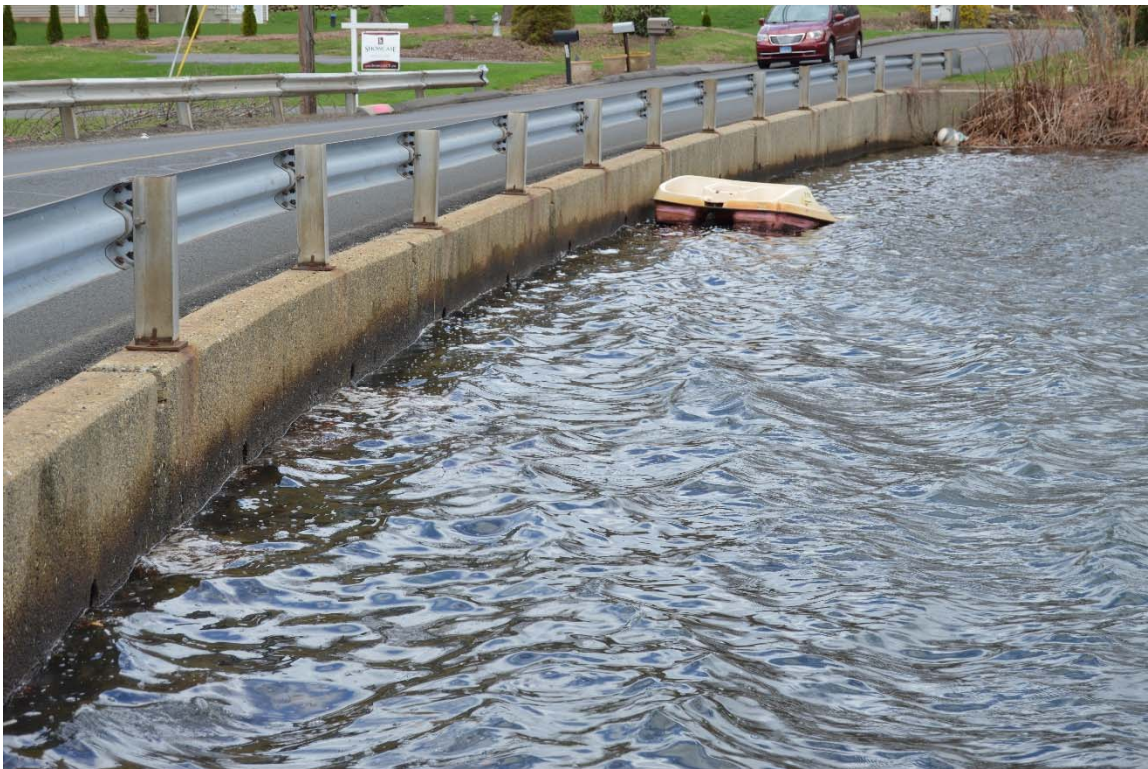
Photo 4d – The right upstream side of the dam, as seen from the left looking right. The concrete retaining wall is generally in good, stable condition here and along the breadth of the upstream side.

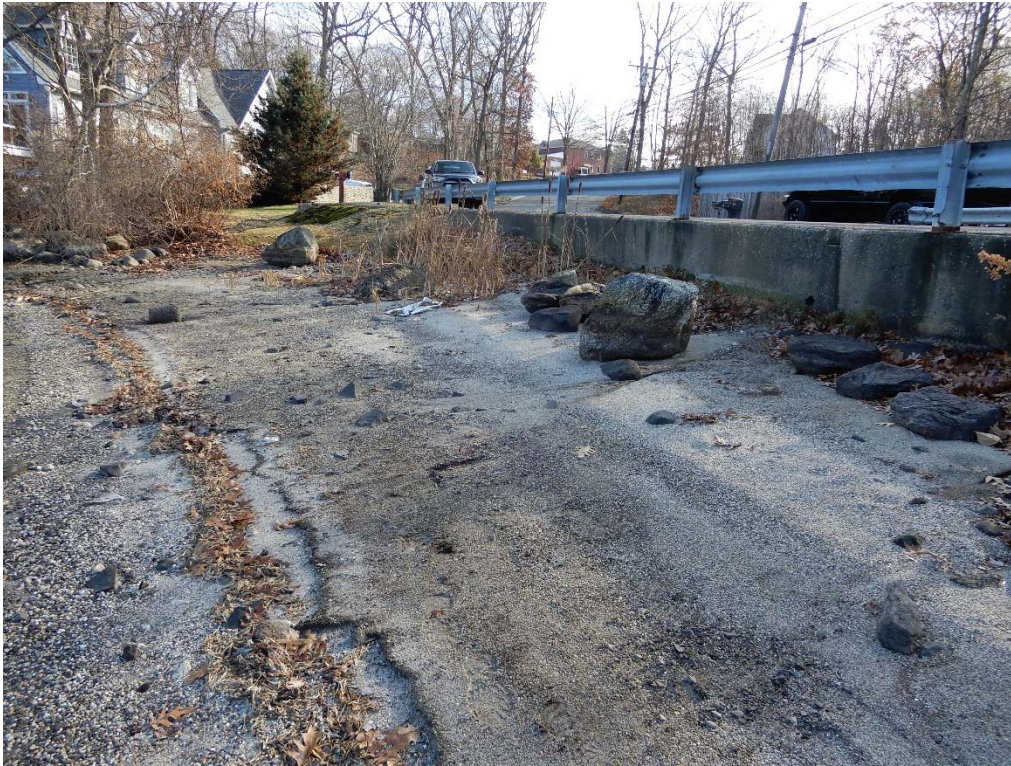
Photo 4g – The upstream embankment slope to the left of the spillway. The concrete wall here is in stable condition.

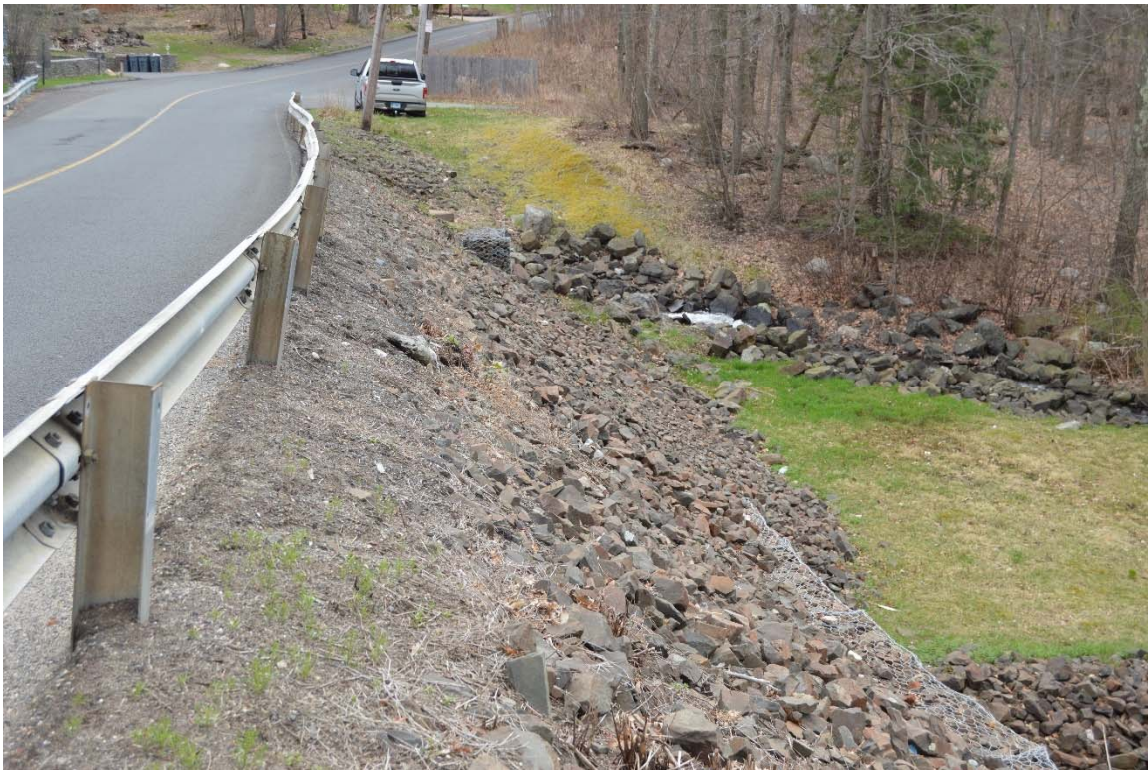
Photo 7c – The stone-lined face of the downstream embankment. This area has been maintained clear of vegetative growth between the stones. The discharge channel at the right-center of the photo emanates from the spillway.

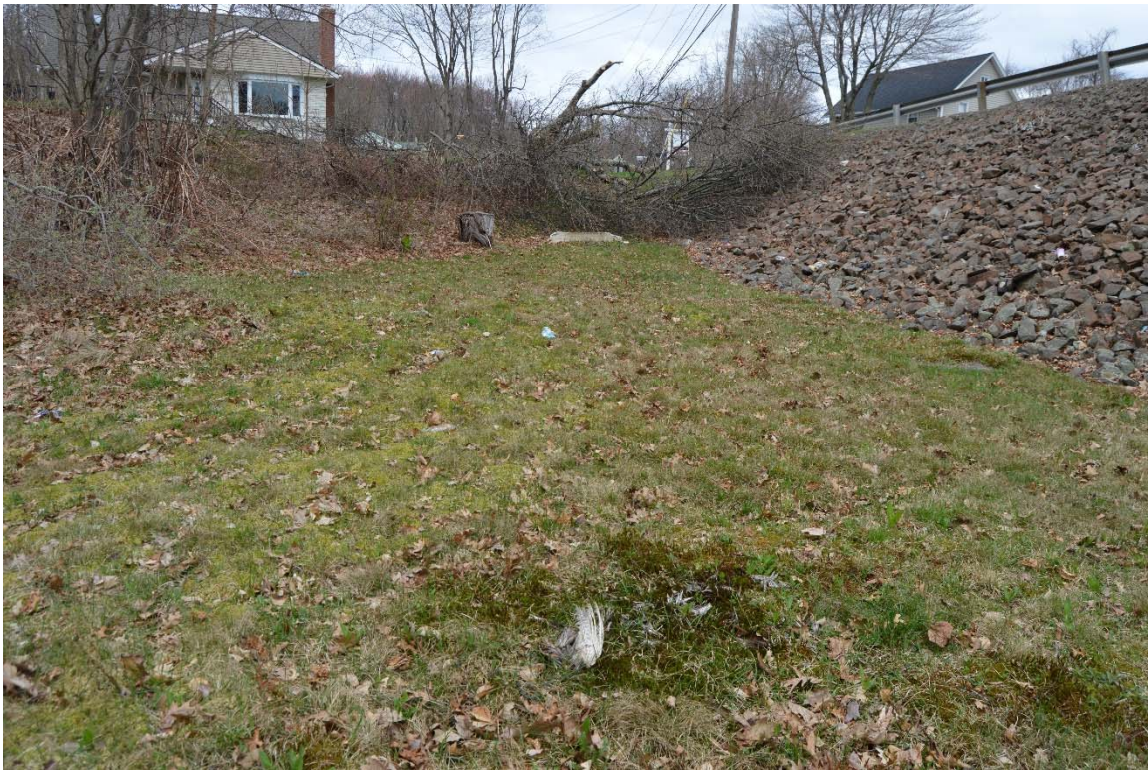
Photo 7e – The right end of the downstream embankment and toe area. The downed tree at the abutment has been removed.

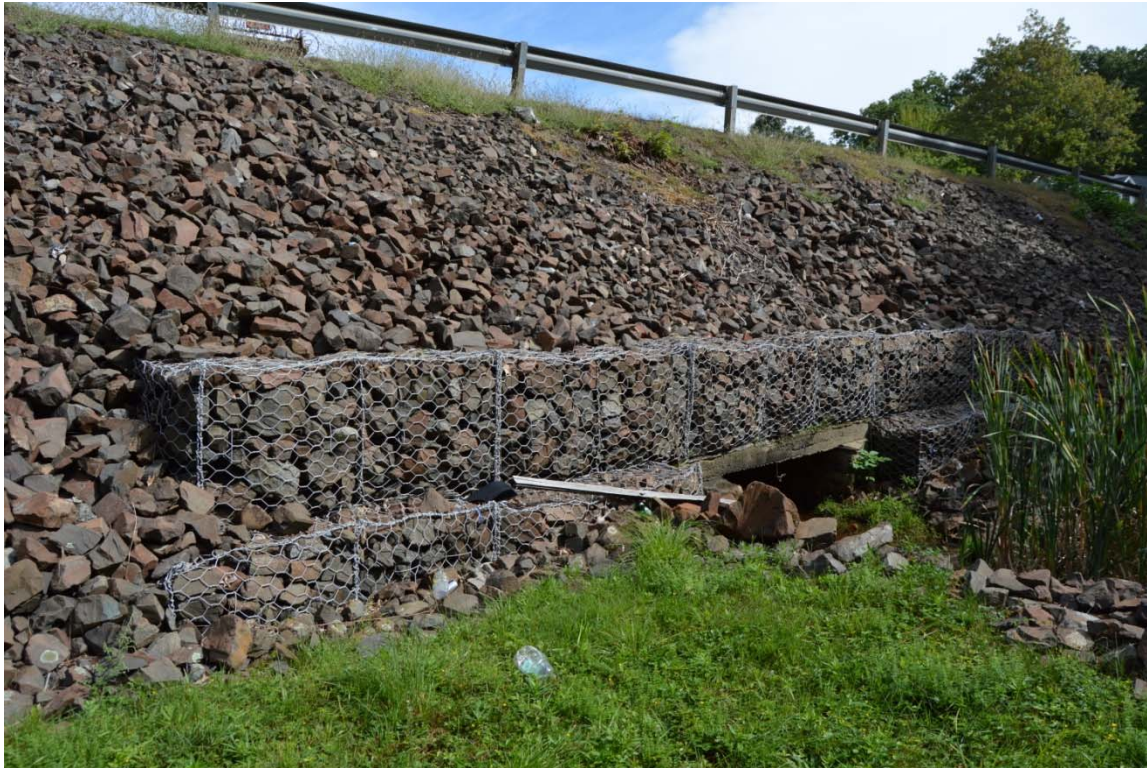
Other: The gabions along the base of the downstream embankment are in good condition, with no signs of significant corrosion along the wire cages.

Photo 7g – The central section of the downstream embankment. The stone cover is stable in this area (note the gabion metal mesh cages placed to prevent sloughing of embankment stones).

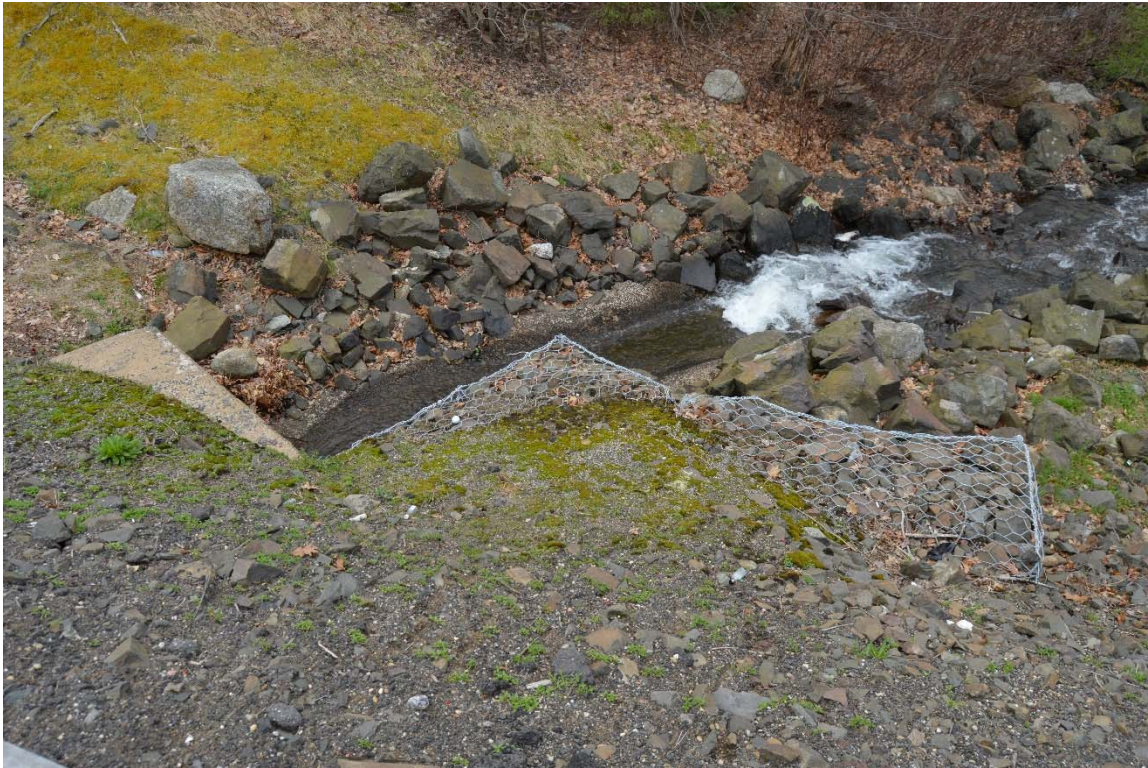
Photo 8b – In the top left corner of the photo is visible the toe of the left-most section of the downstream embankment, east of the spillway outlet channel. Note gabion placement for slope stability at the right side outlet of the spillway discharge tunnel beneath North Street (see also next photo).

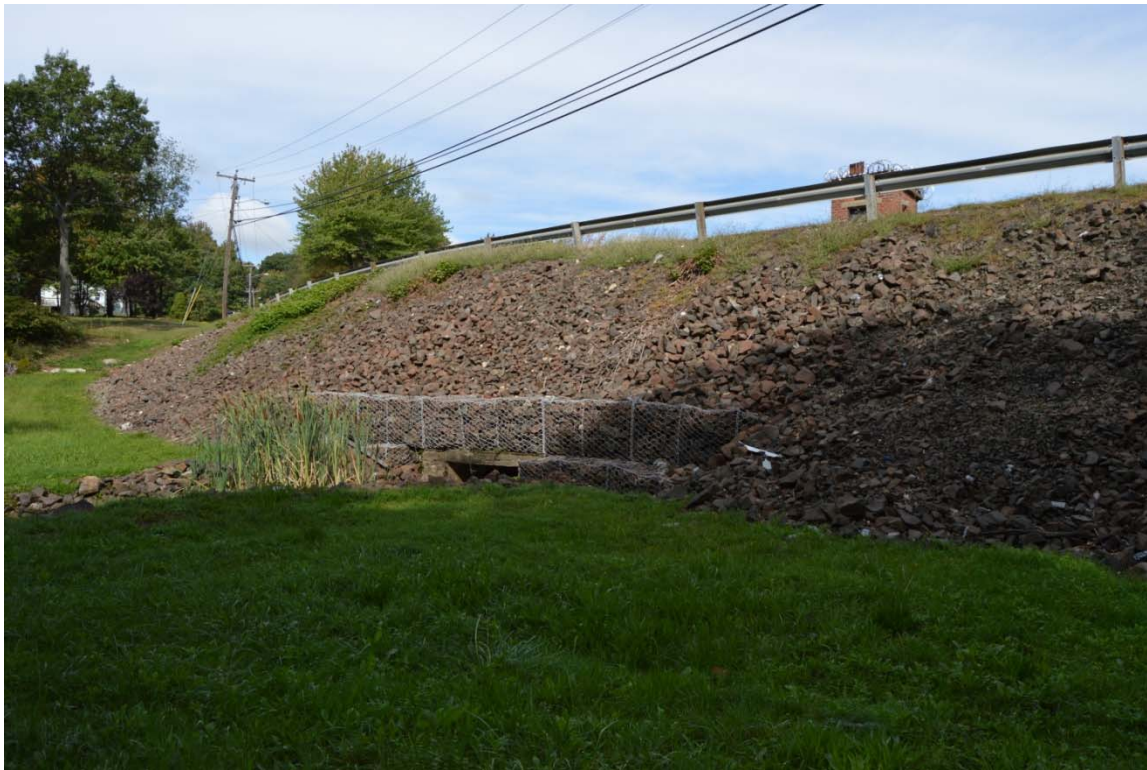
Photo 8d – A panoramic view of the central and right side downstream embankment, in good and stable condition in 2016.

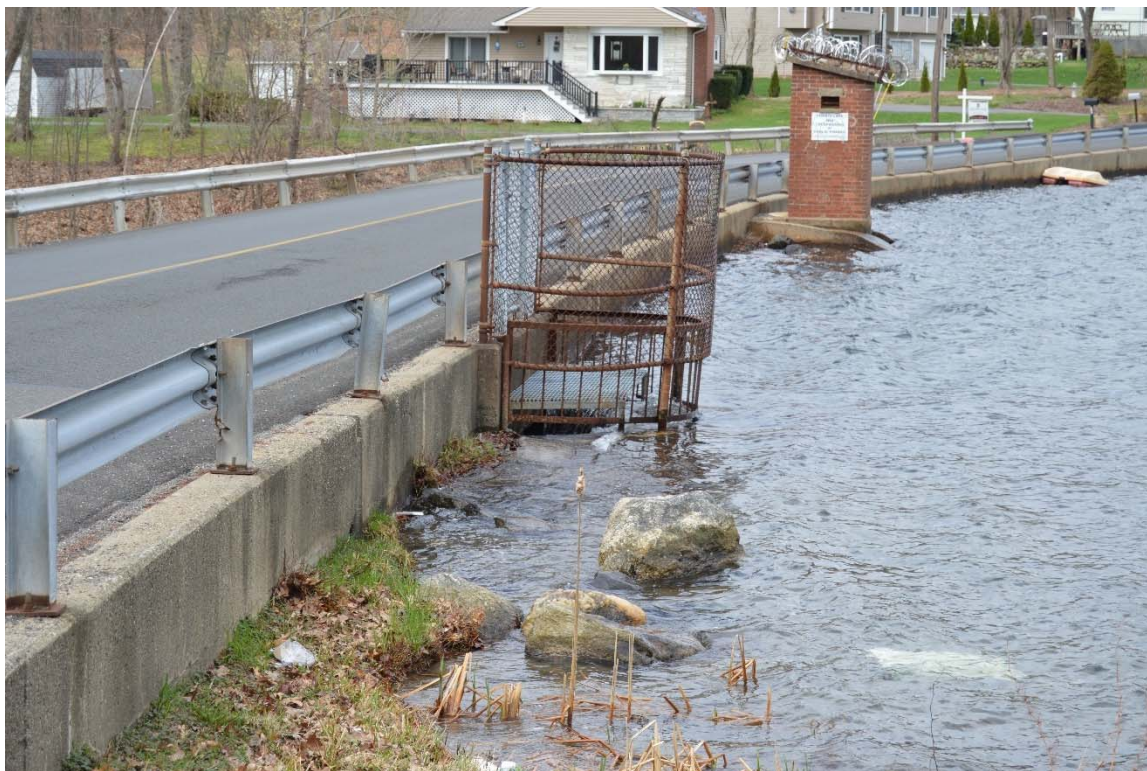
Photo 9a – An overview of the spillway and its approach area, as seen from the left side.

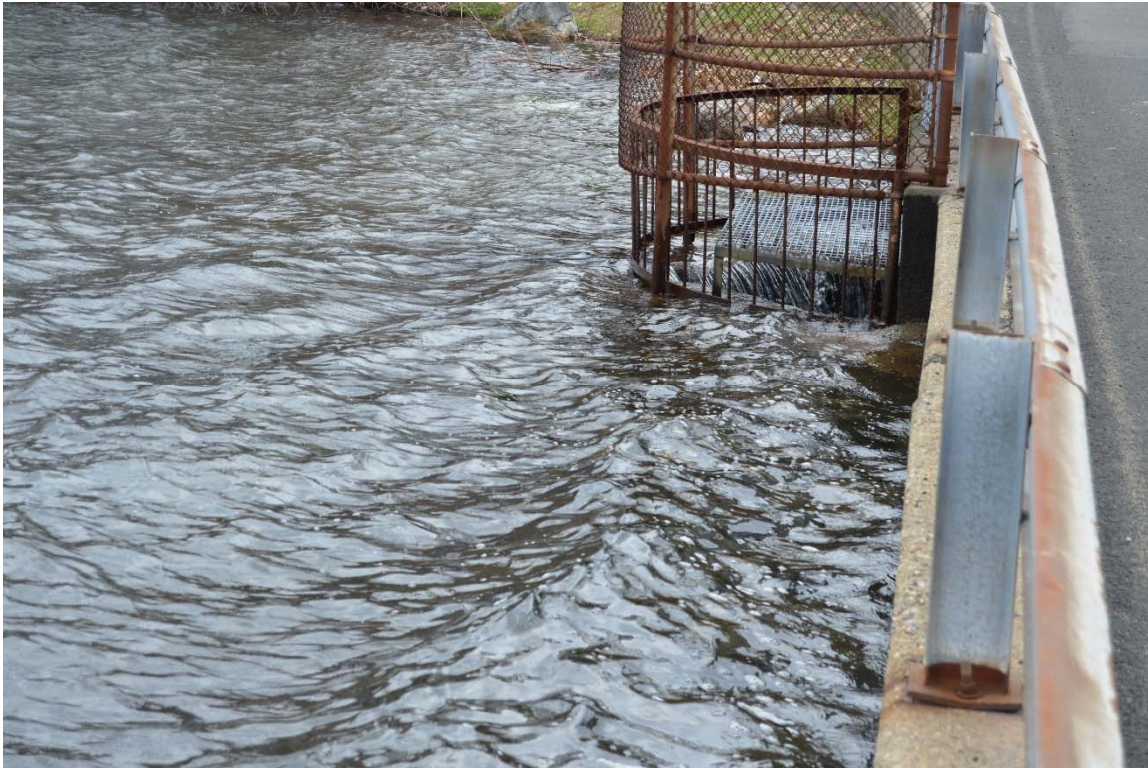
Photo 9b – Looking at the spillway from its right side. There was substantial flow on the date of the first inspection.

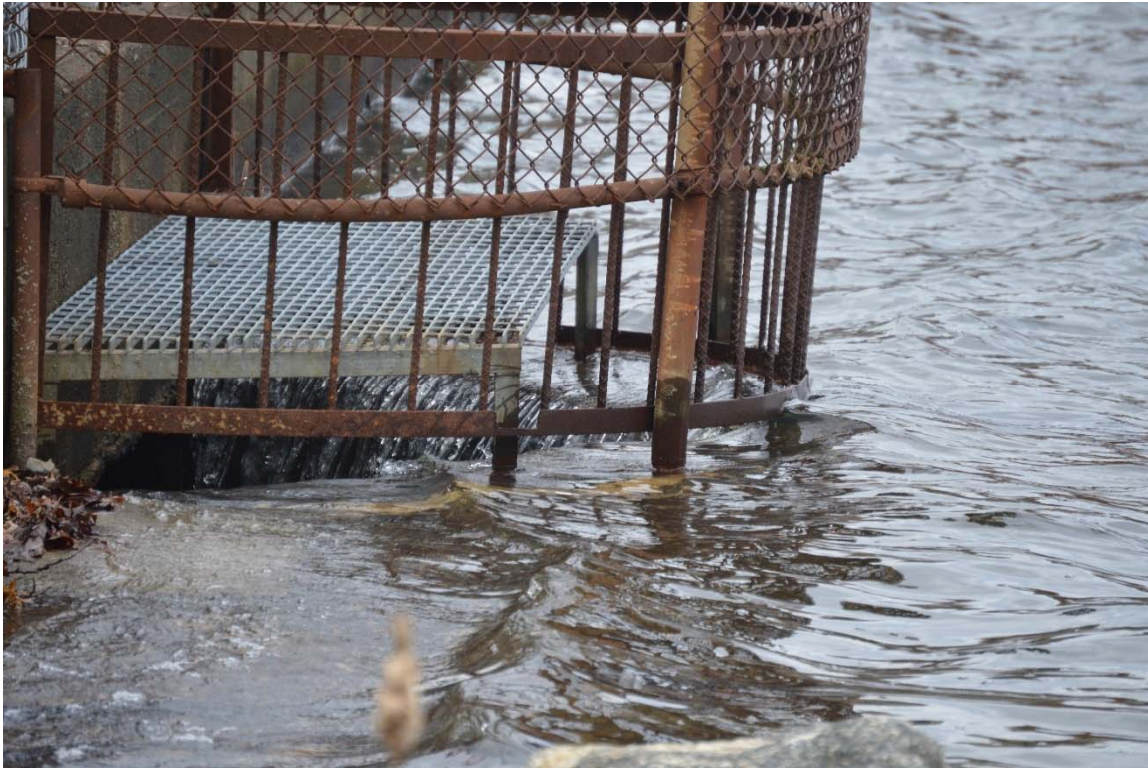
Photo 9c – A closer view of the spillway from the left side, with the trash rack visible. The rack is in good condition, but the fencing around the spillway exhibits progressive corrosion.

Photo 9d – A close up of the spillway approach, with conditions noted in the prior photo again visible.

The fall 2019 follow-up inspection at low water level revealed that several of the support posts for the spillway security fencing were corroded at the post bottoms. As such, it is recommended that fencing be replaced, keeping in mind to allow for unimpeded flow along the lower portions of the fencing.

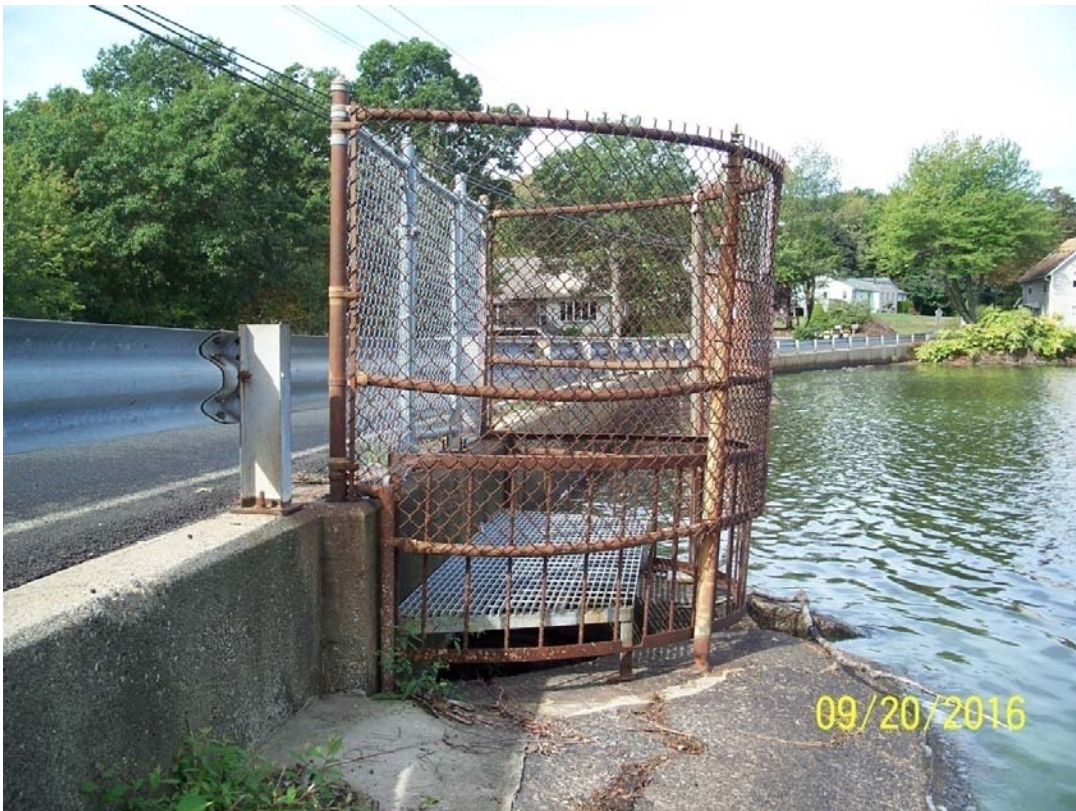
Photo 9e – The spillway and appurtenances as seen from the left side looking westward at a lower flow period in 2016. Note the concrete approach pad on the left side.

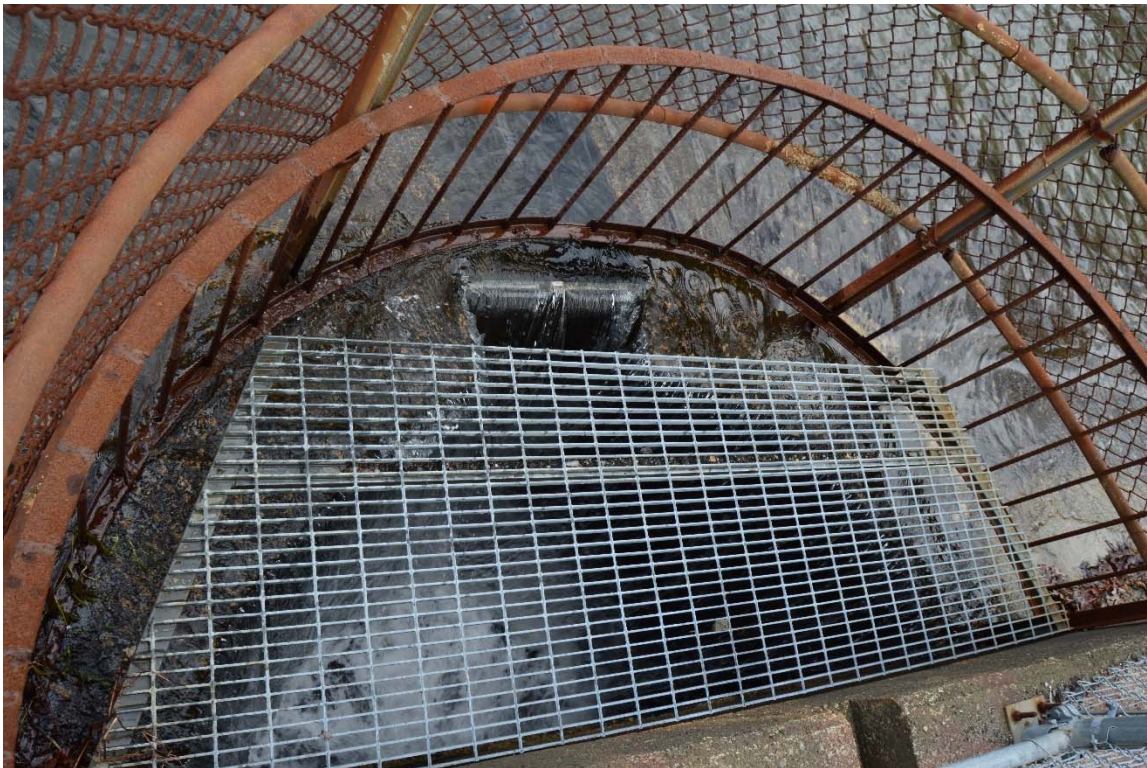
Photo 10a – A view of the spillway as seen from the immediate downstream (looking downward from the adjacent roadway).

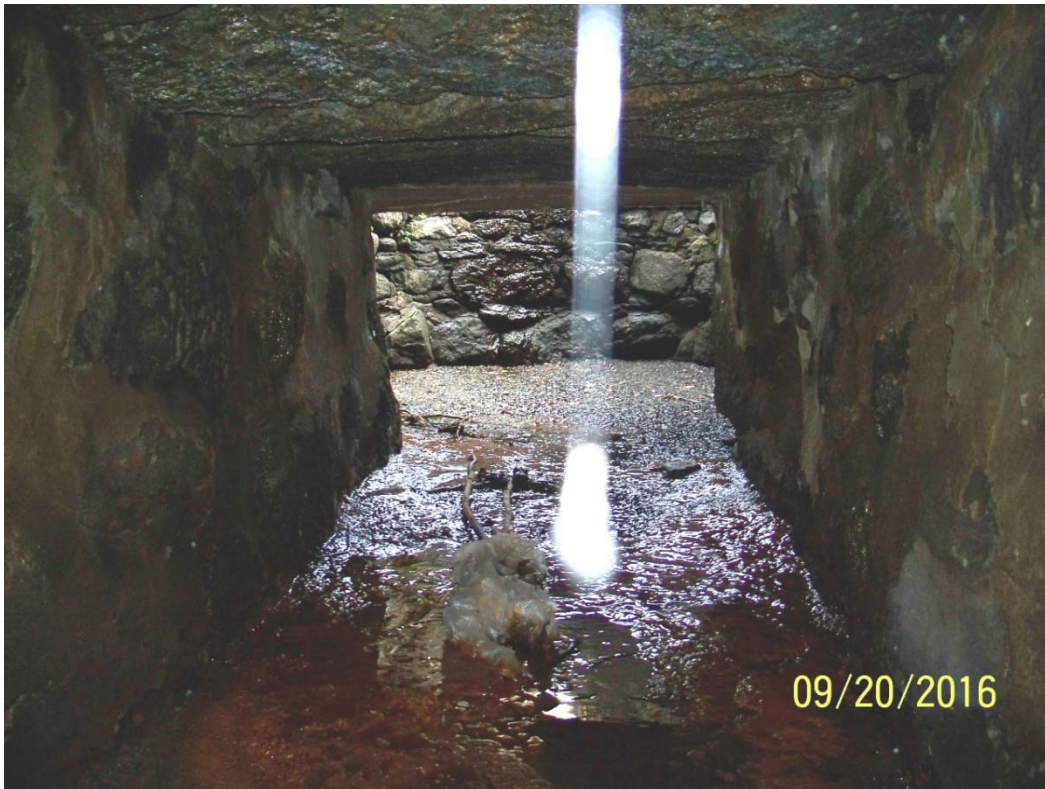
Photo 10b – Looking upstream from within the discharge channel to the base of the drop inlet spillway.

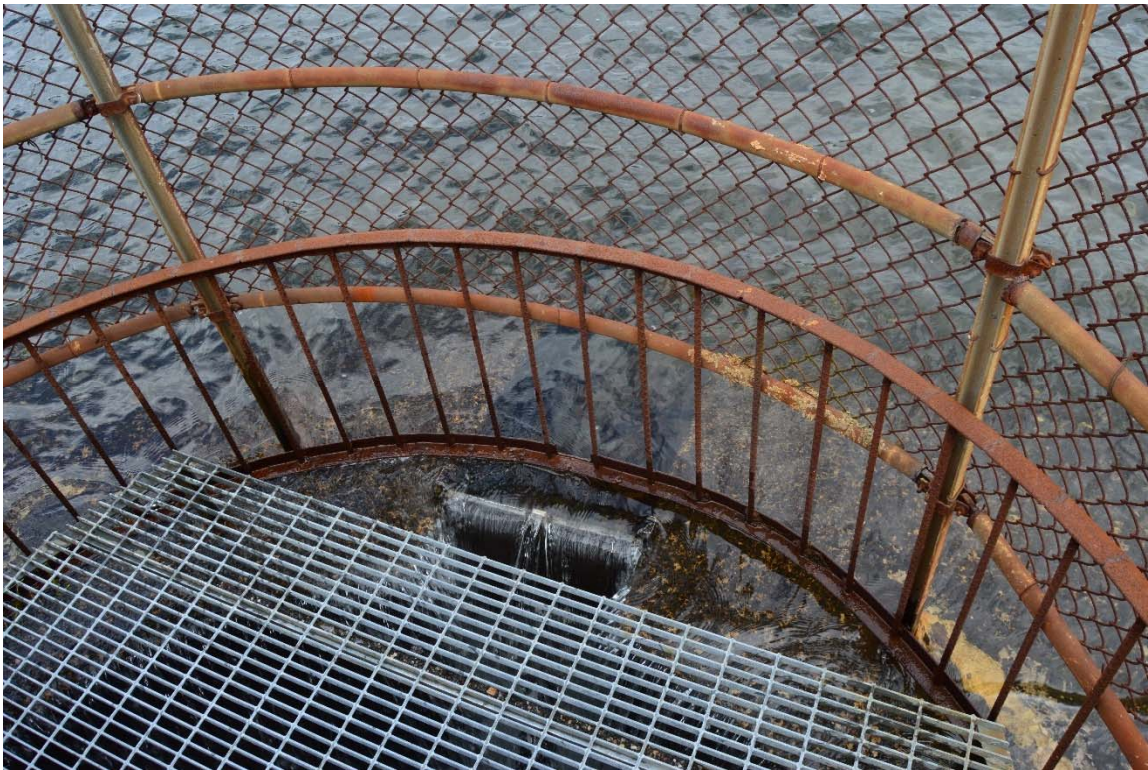
Photo 13a - Looking down at the spillway weir; the weir board slot is situated in the center.

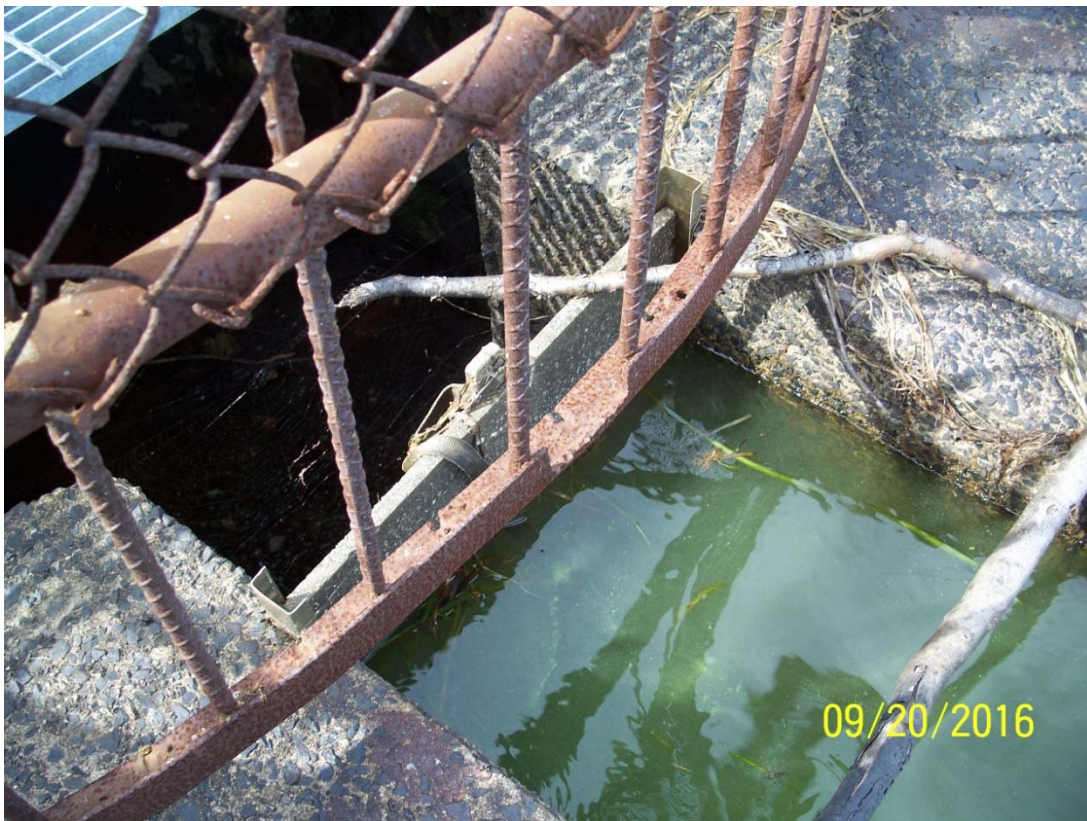
Photo 13b – The spillway weir, with weir boards in place, as seen through the protective fencing in 2016.

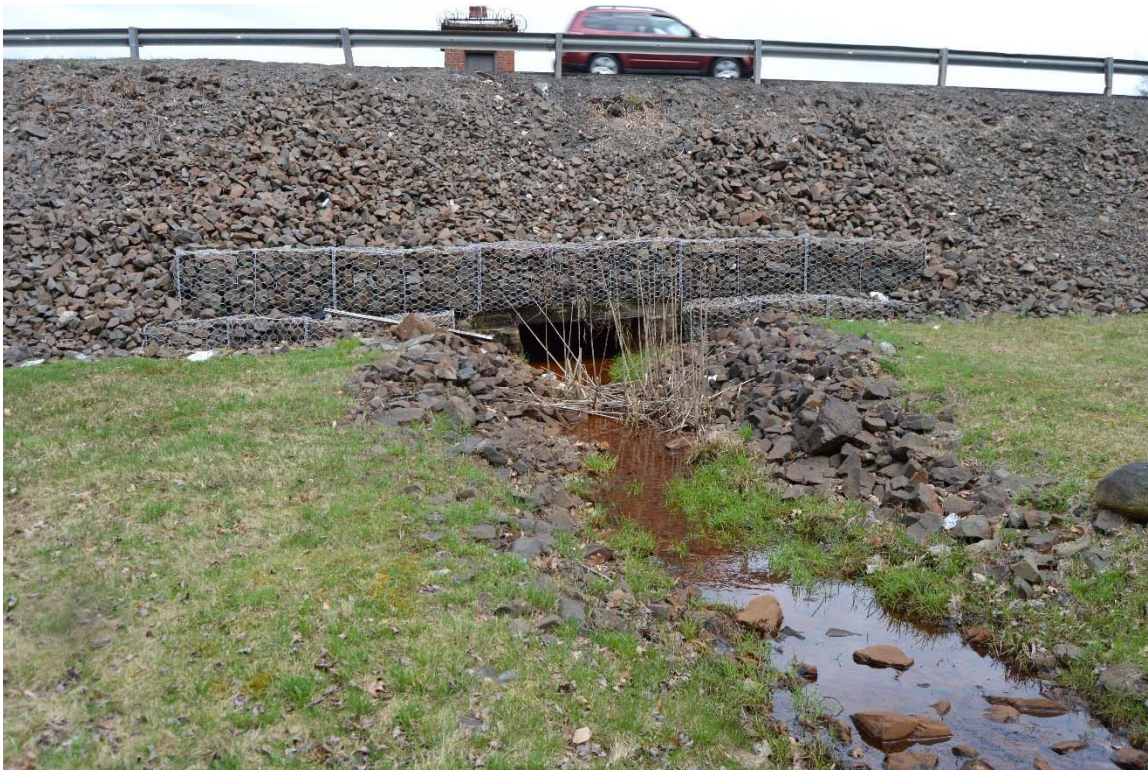
Photo 14a – An overview of the stilling basin at the low level outlet discharge.

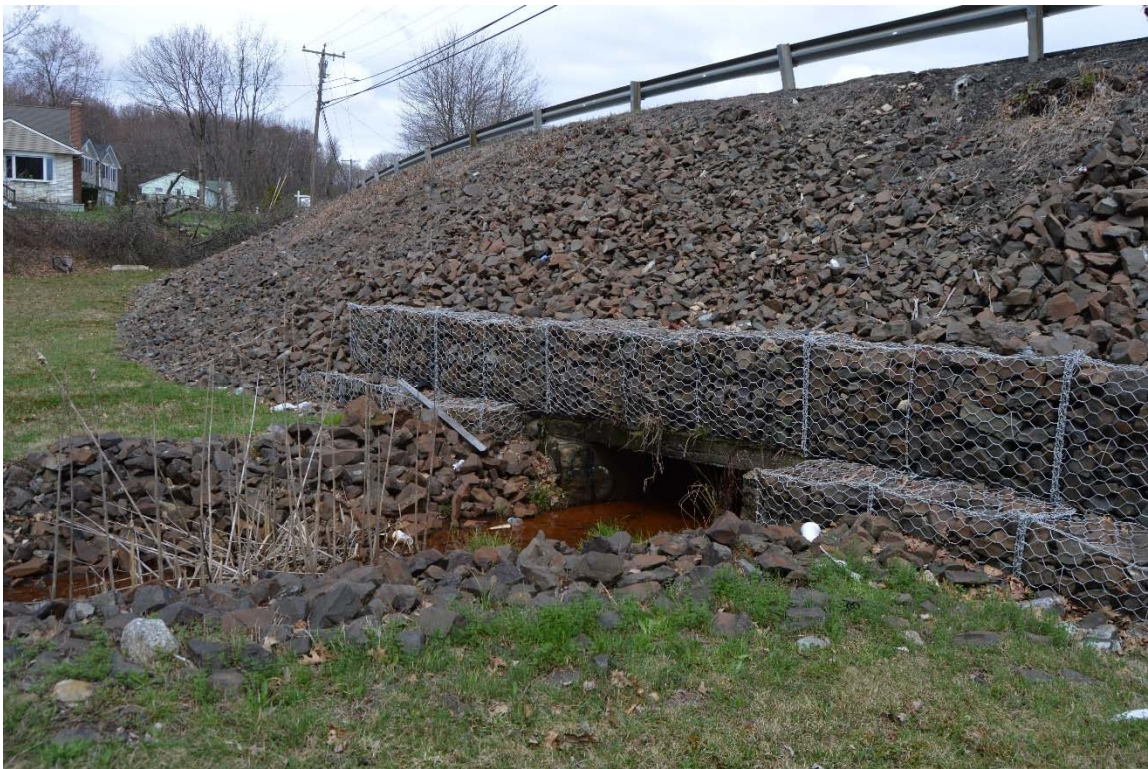
Photo 14b – The same discharge area as seen in the prior photo, taken from its left side. Although minor vegetative growth is visible in the channel, it is typically cleaned out on a seasonal basis.

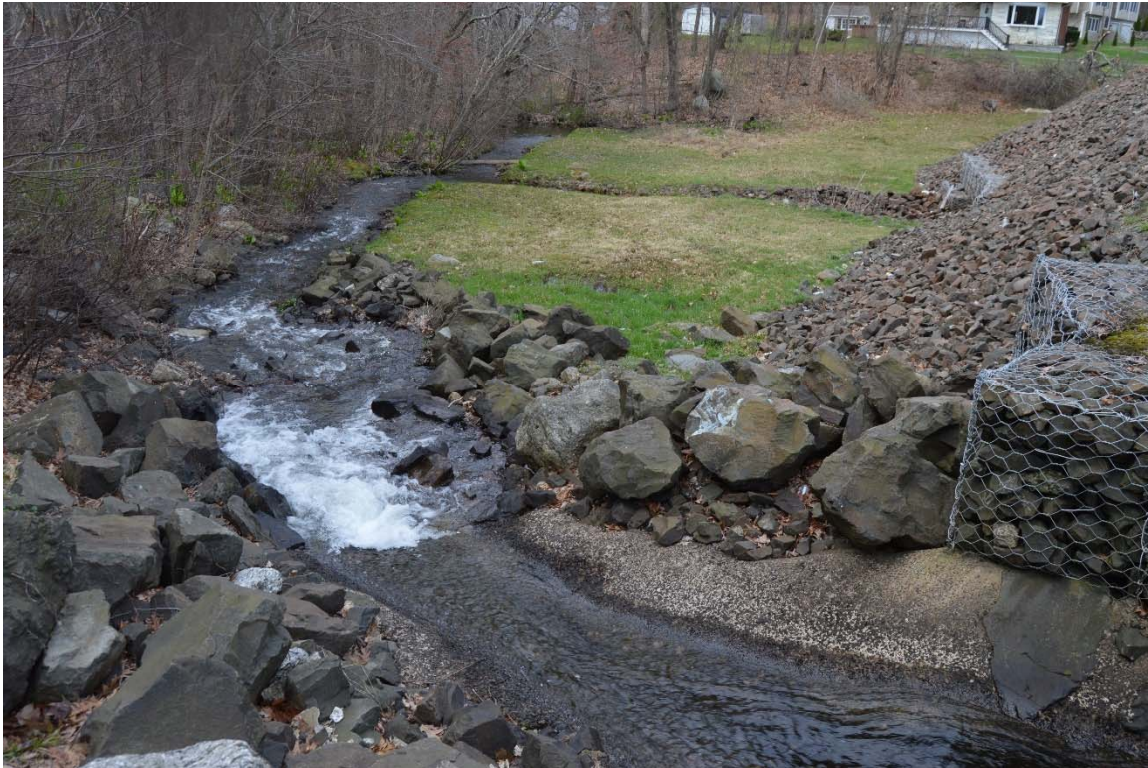
Photo 14c – The concrete splash pad at the main spillway discharge outlet, with riprap lined channel and side slopes extending further downstream.

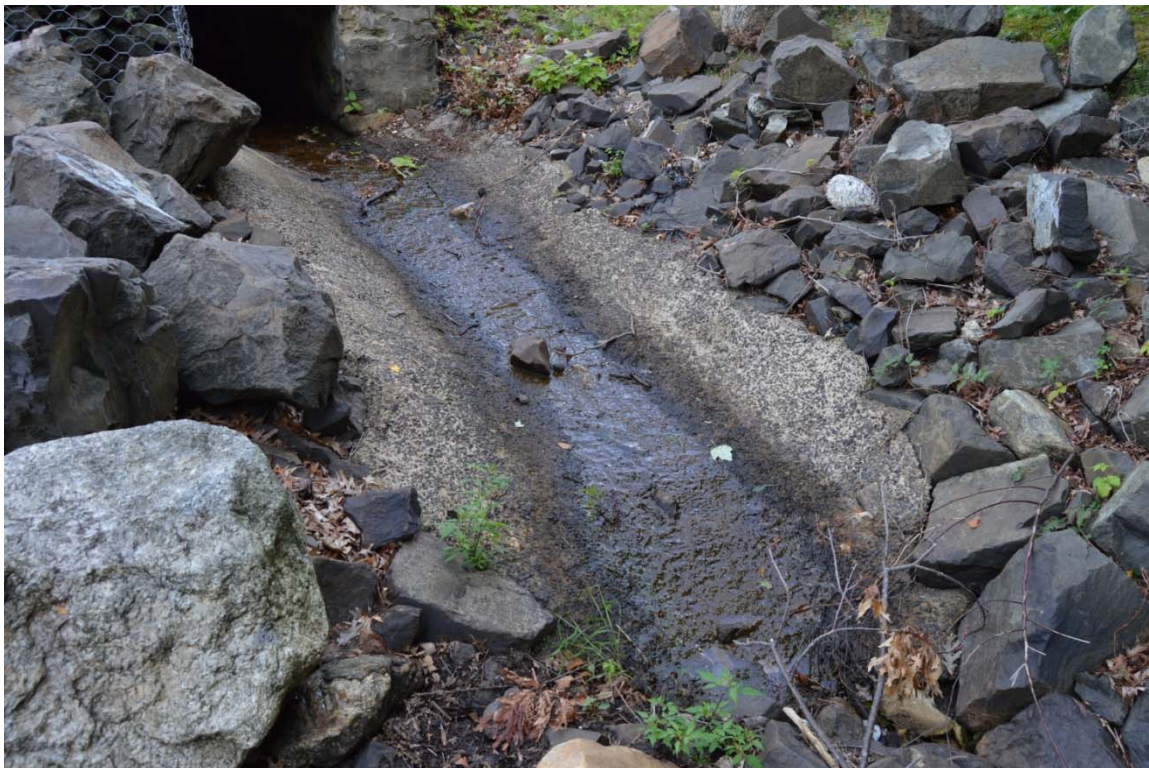
Photo 14d – The spillway chute discharge, at the exit of the tunnel area beneath North Street, with riprap side slopes.

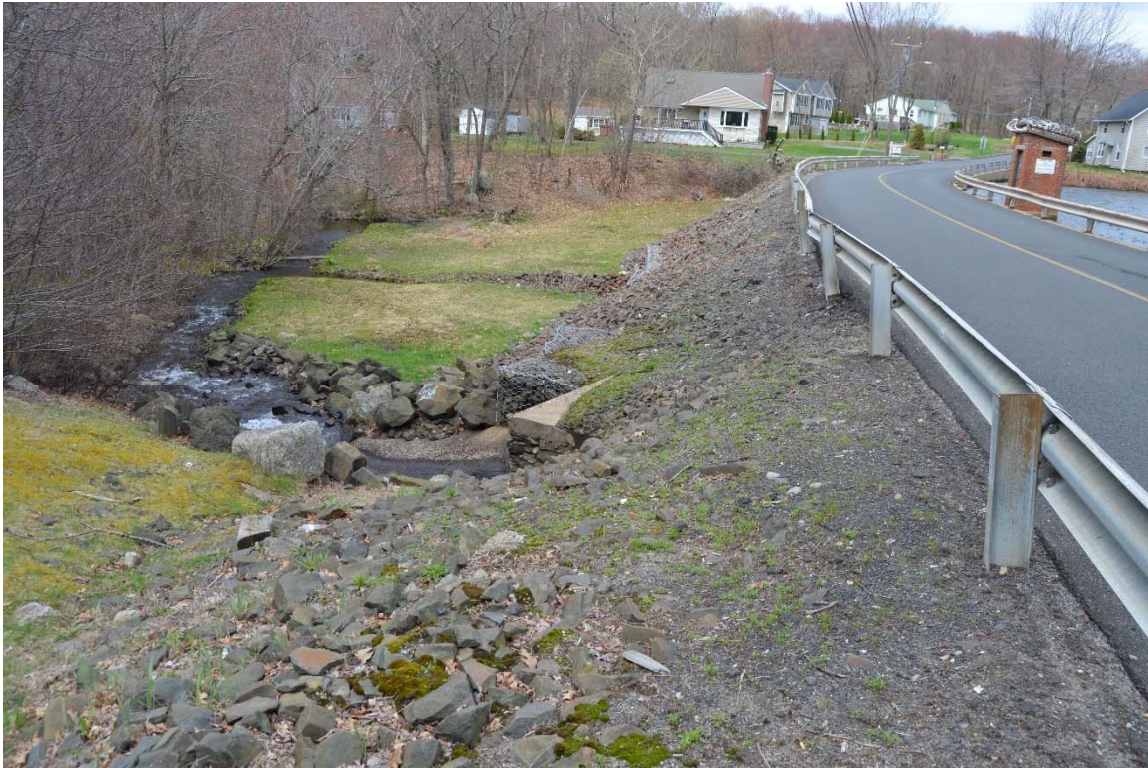
Photo 15a – An overview of the downstream area, with the downstream spillway channel and its junction with the low level discharge channel visible in the left center of the photo.

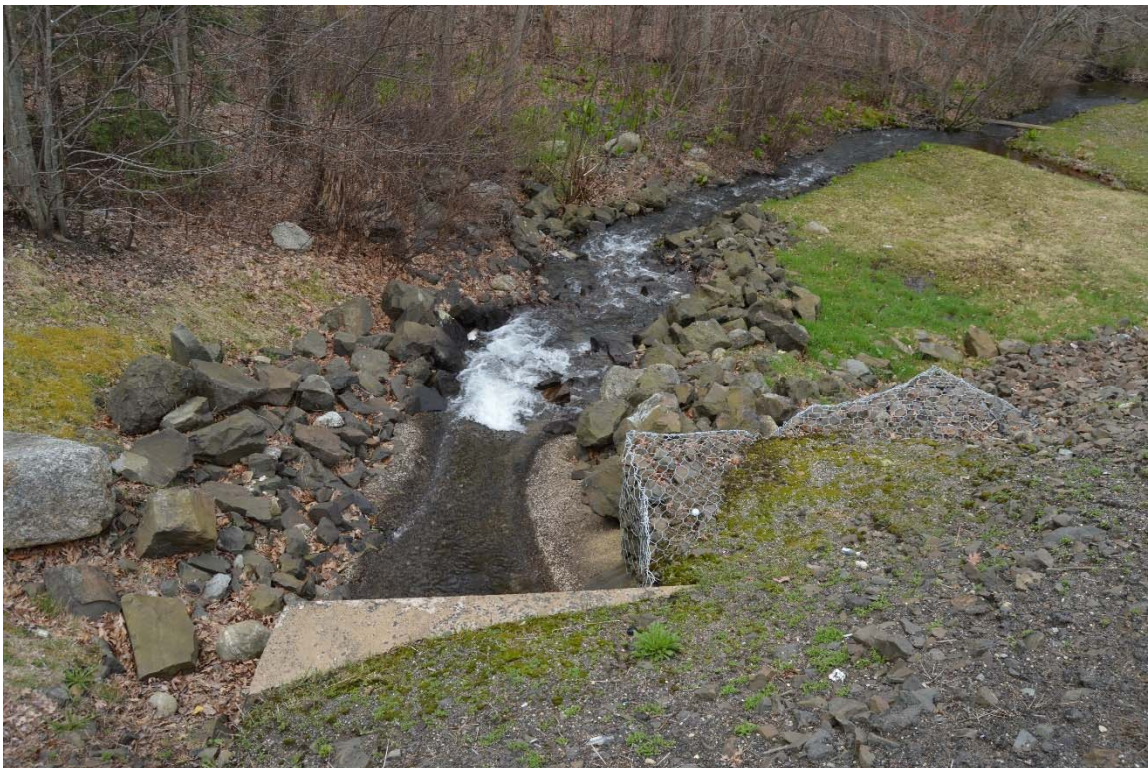
Photo 15b – The upper section of the discharge channel, exiting the spillway tunnel outlet. The riprap along the sides of the channel is stable and generally clear of vegetative growth.

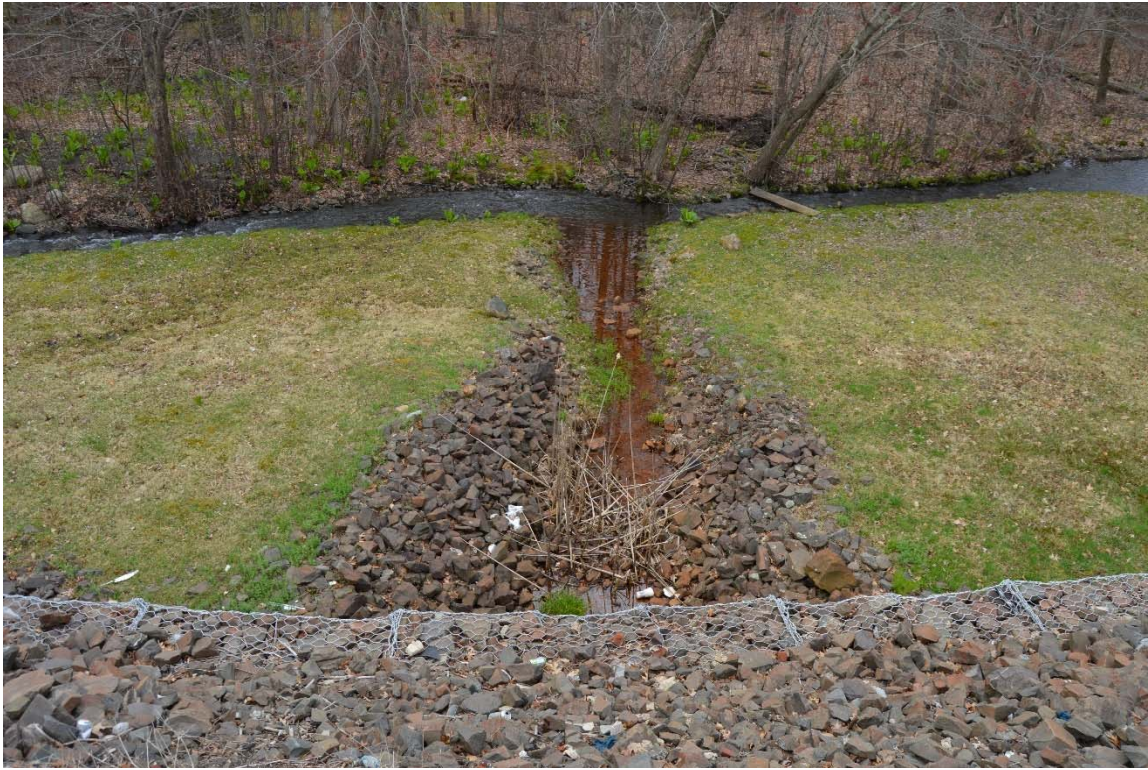
Photo 15c – The low level outlet discharge channel, from the pipe end to the junction of the channel with the main stream (Mad River) in the center background of the photo.
