INSPECTION REPORT

CEDAR LAKE DAM CT DEEP #16603

NORTH STREET
MAD RIVER
WOLCOTT, CONNECTICUT

DECEMBER 2019

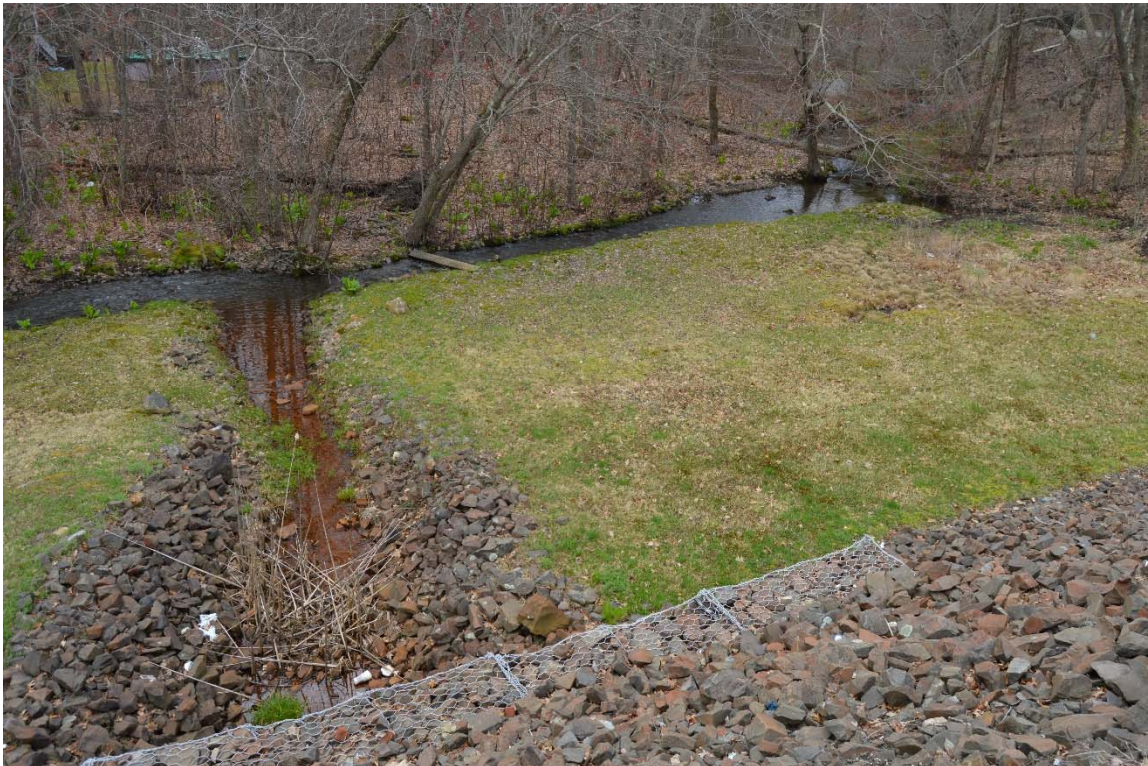
Photo 15d – Panning rightward from the perspective of the previous photo, this view shows the progress of the river heading further downstream.

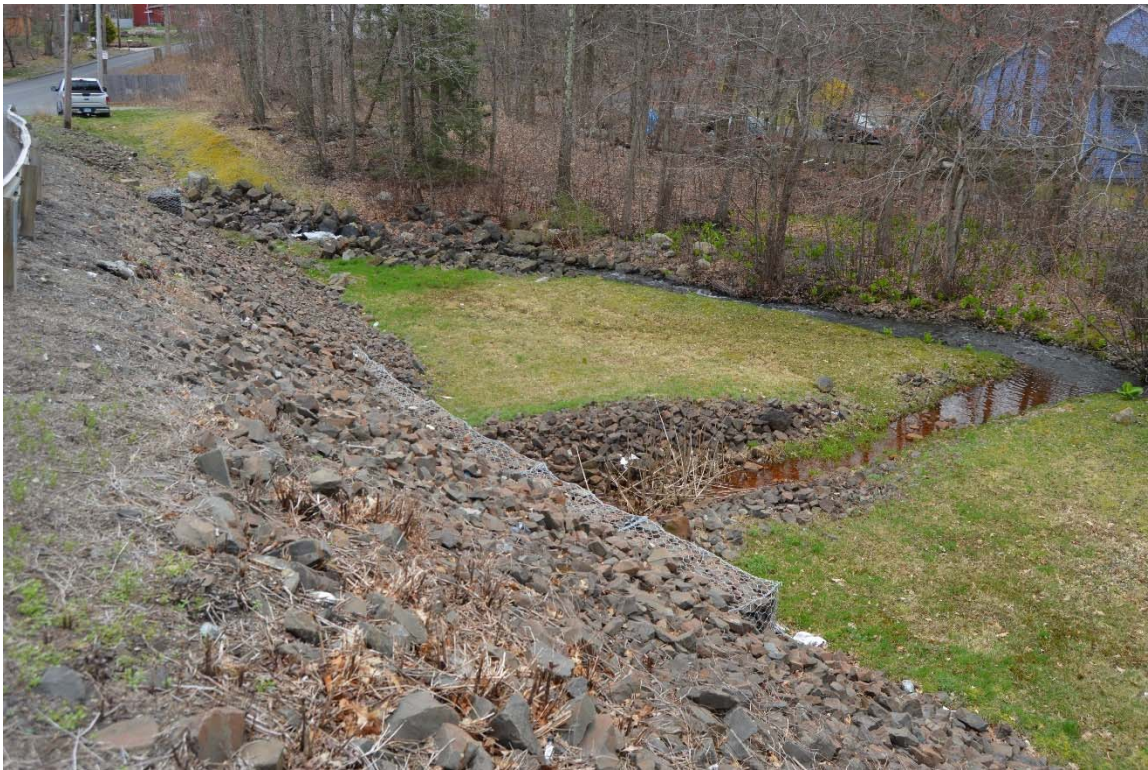
Photo 15e – The upper channel sections, as seen from the right side dam crest.

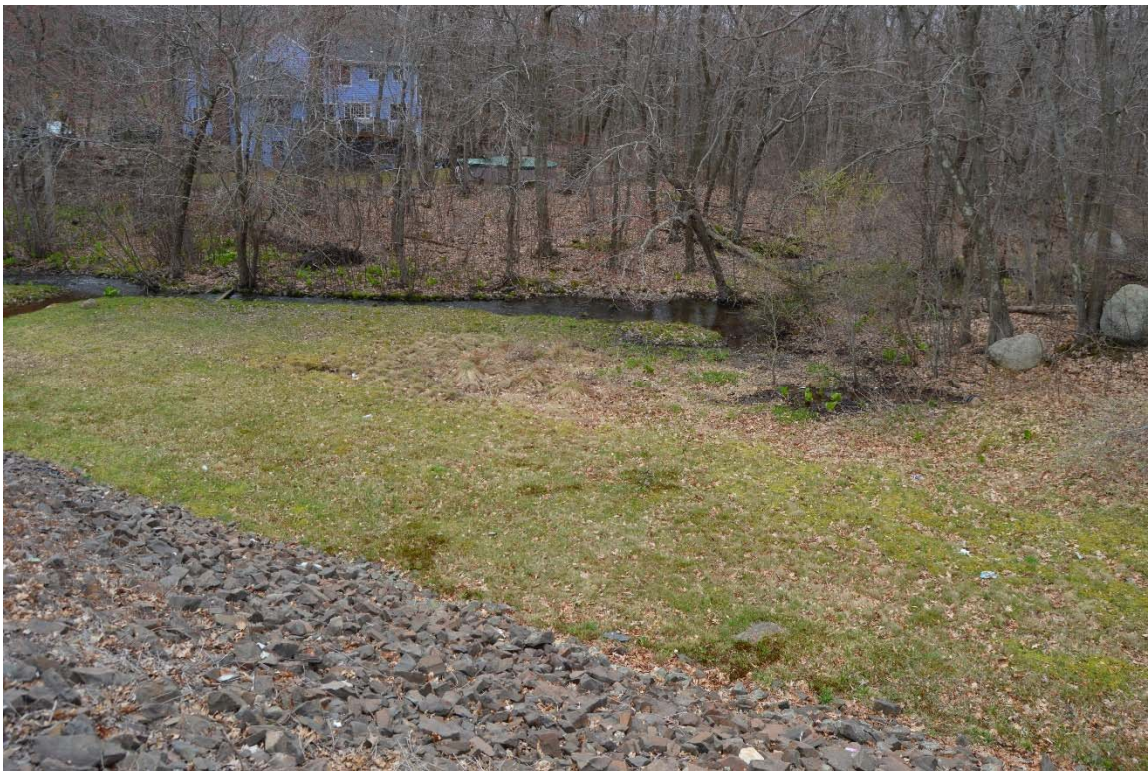
Photo 15f – The lower reaches of the downstream channel, continuing southward as the Mad River.

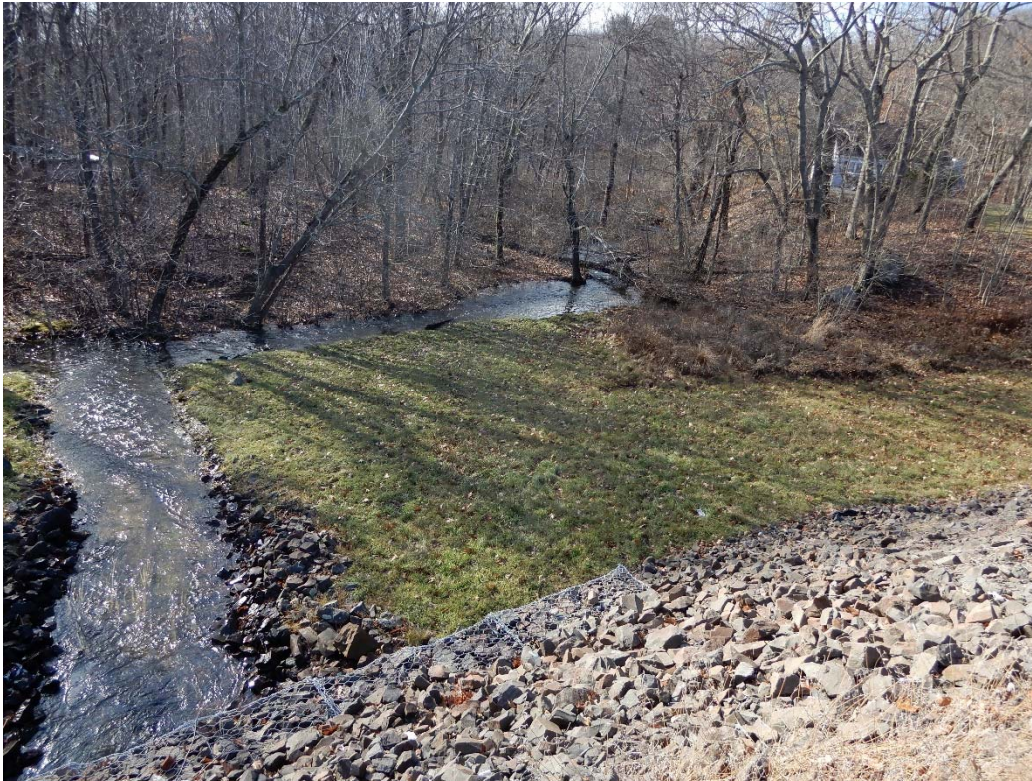
Photo 15g – A view of the lower sections of the downstream channel in November of 2019, with the low level outlet valve open.

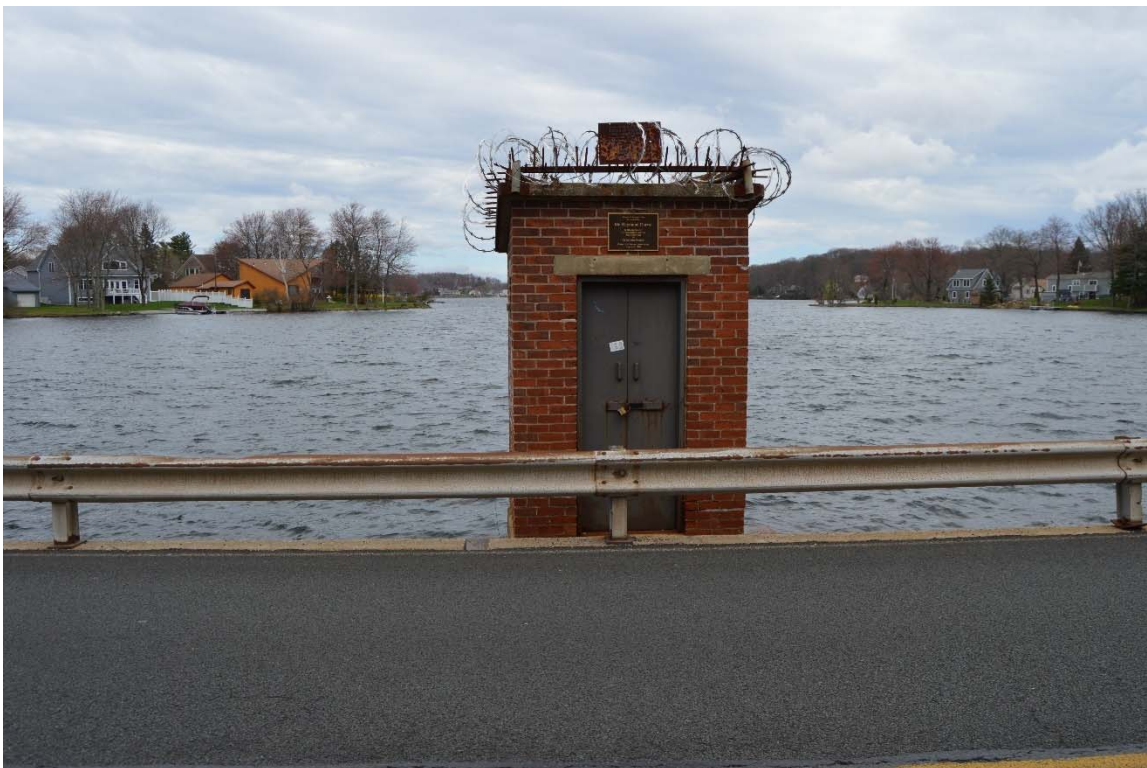
Photo 16a – Looking upstream at the gatehouse, from North Street.

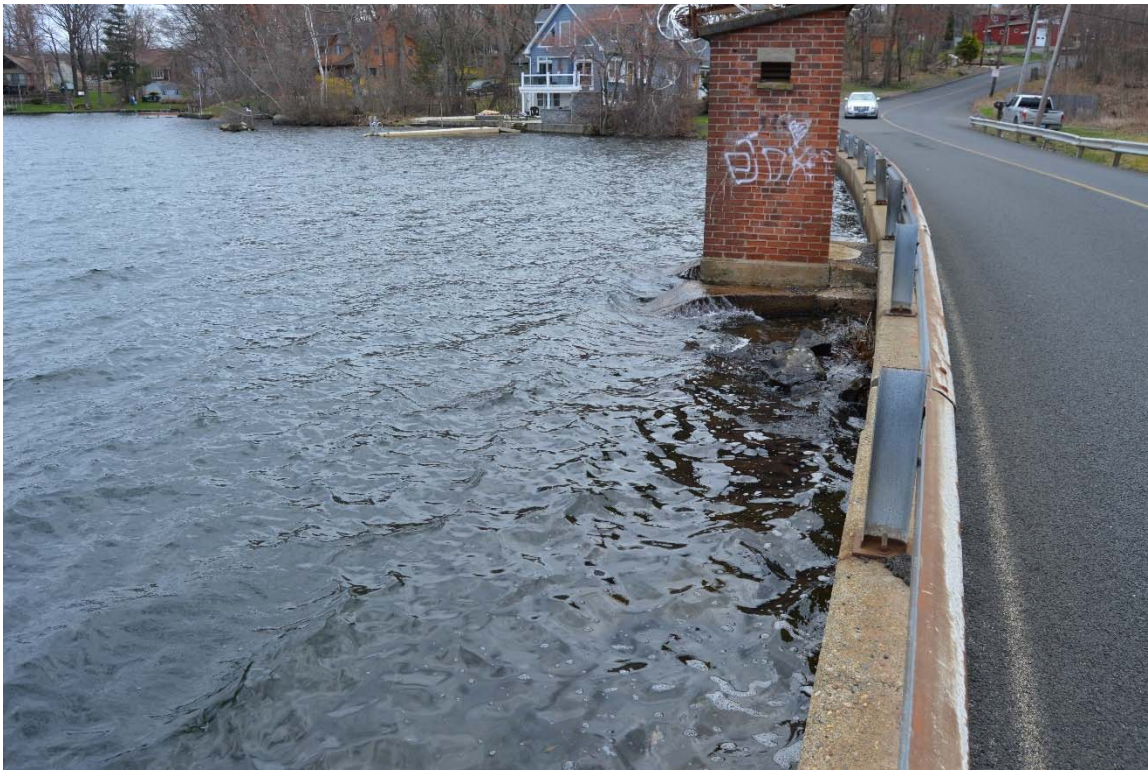
Photo 16b – The exterior of the gatehouse and its environs, as seen from the right side of the building.

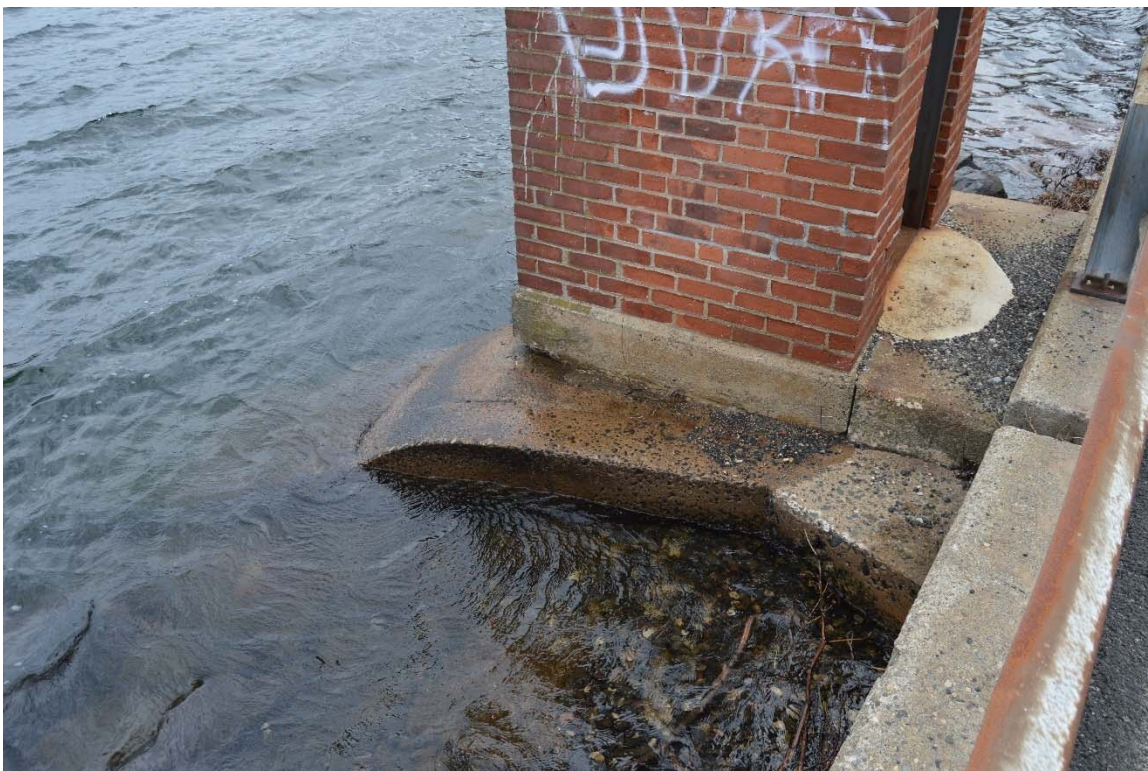
Photo 16c – Again taken from the right side, this close up view shows the foundation of the gatehouse sitting atop the inlet channel sidewalls. The concrete is in sound condition.

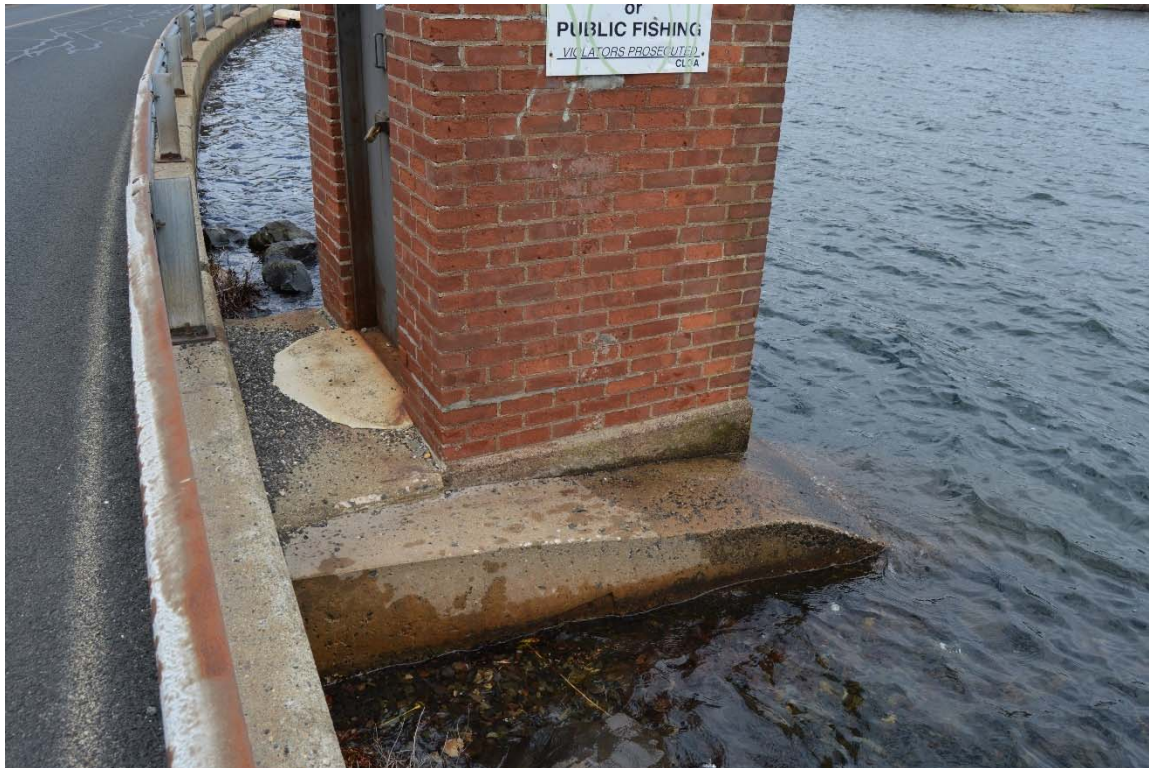
Photo 16d – The left side of the gatehouse and foundation, in a similar condition to the right side.

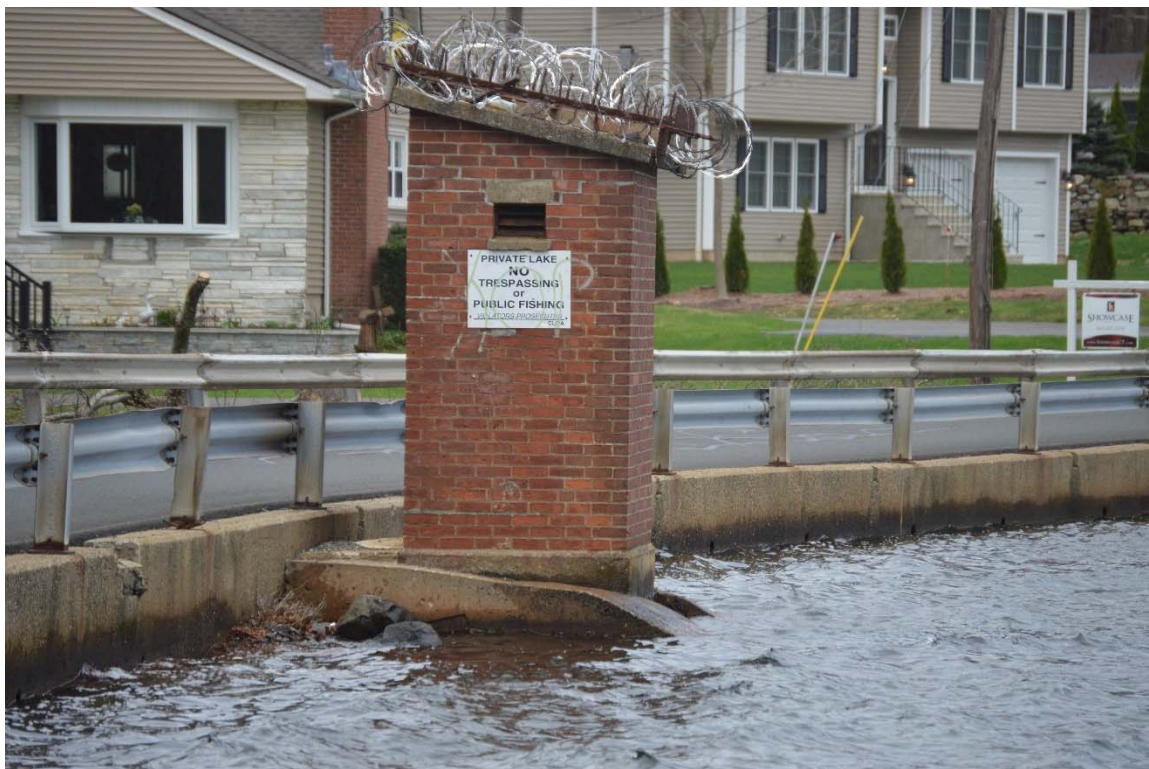
Photo 16e – An overview of the gatehouse as seen from the left upstream side.

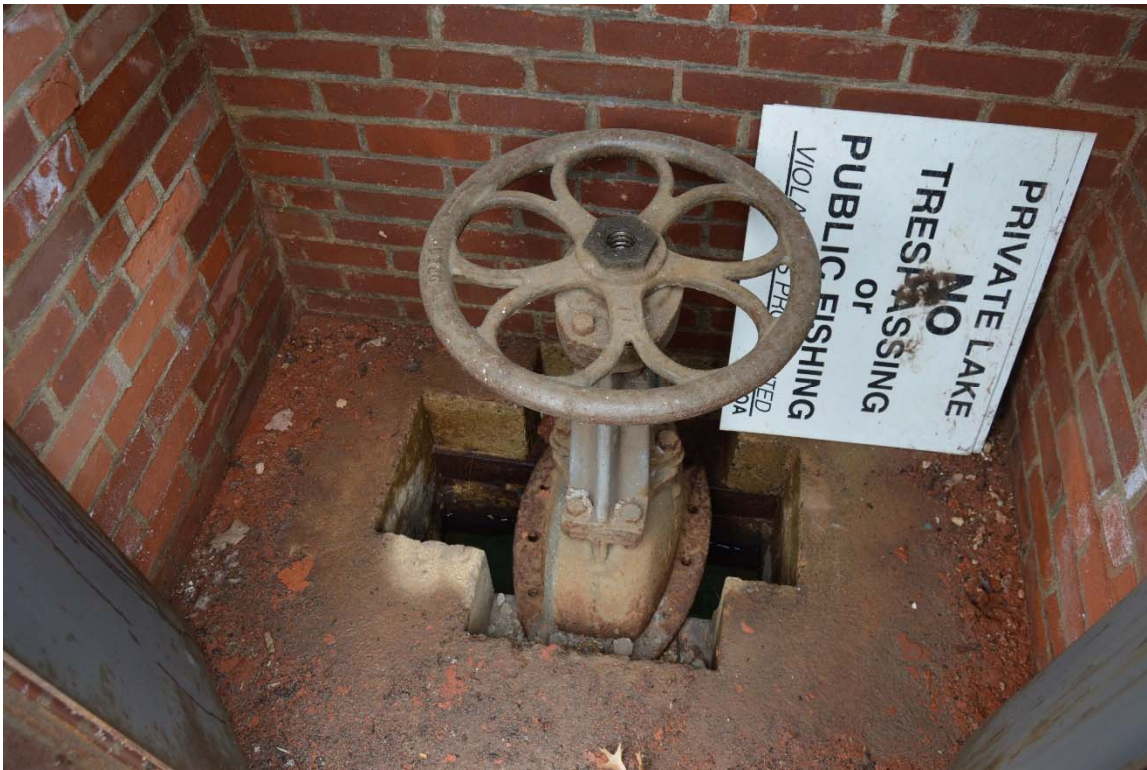
Photo 17a & 18a – The interior of the gatehouse and the operator for the sluice gate at the low level outlet.

4. Fence, Railing & Control Valve - (From the 2012 Report, this section remains applicable): **"Metal Corrosion** – *Features such as fencing at the spillway, the interior valve controls at the gatehouse, and the gatehouse door frame should be cleaned of surface corrosion and recoated with appropriate steel paint products (minimum 2 coats), to stem further deterioration while they are still in structurally sound condition."* In addition, as observed during difficult operation of the control valve this year, the valve stem and packing need to be serviced to assure continued operation at critical times. The valve should be operated through a full close and open cycle on a regular schedule to clear the operating stem and interior fixtures.

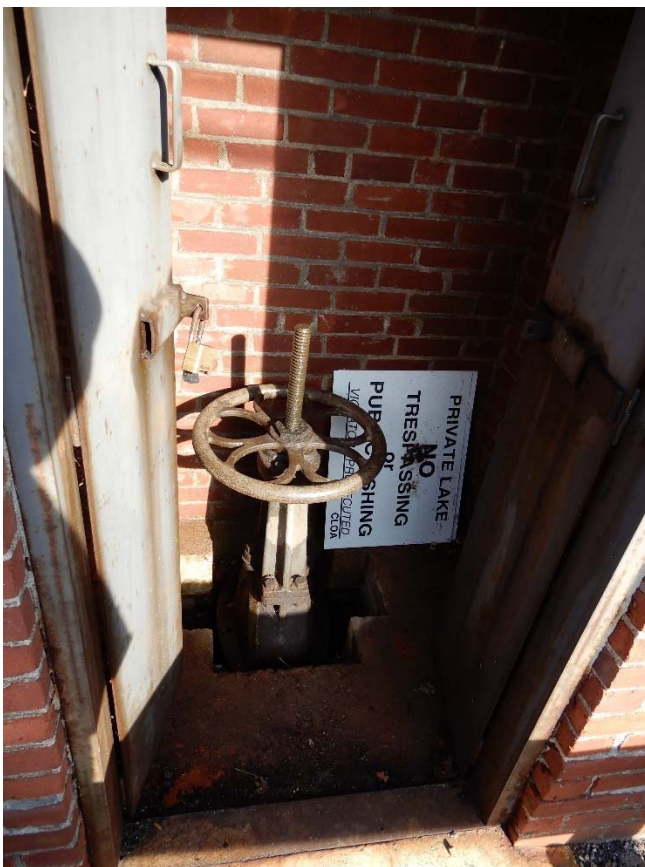
Photo 17b & 18b – Another look at the interior of the gatehouse and the operator in the fall of 2019, this time with the stem in a raised position with the sluice gate open.

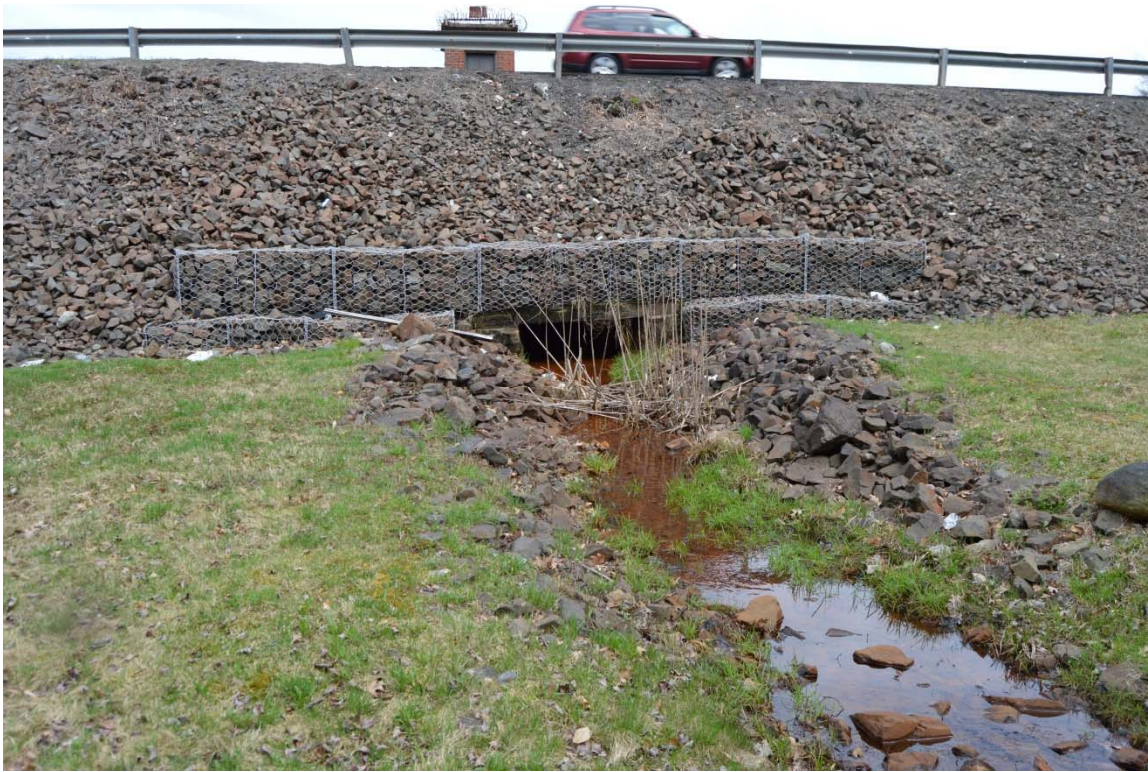
Photo 19a – The downstream end of the low level outlet discharge structure.

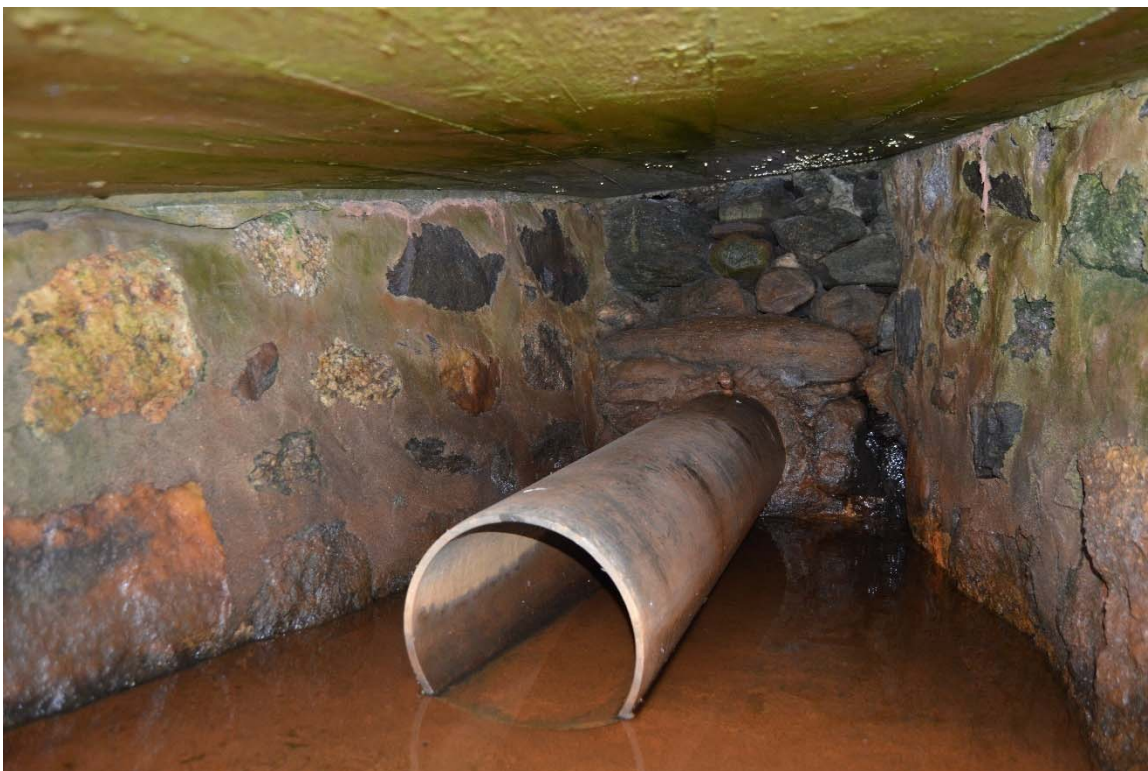
Photo 19b – A head-on view of the low level outlet pipe discharge. The coupling or connection fitting with the remaining outlet pipe is unknown.

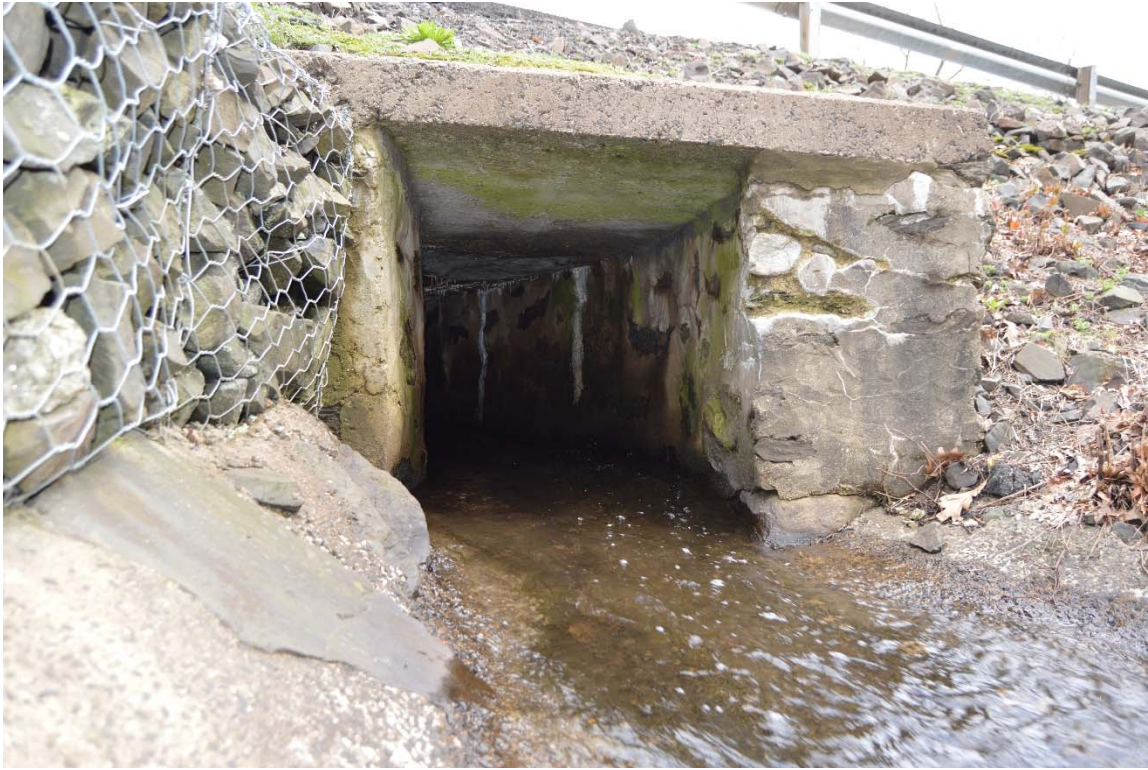
Photo 19c – The downstream end of the tunnel conveying the spillway discharge flow.

8. **Spillway Discharge Tunnel** – Although the outlet tunnel is currently stable, we continue to recommend its replacement, based on past and current assessments (see prior reports). We are particularly concerned with the condition of the interior tunnel roof as previously pointed out.

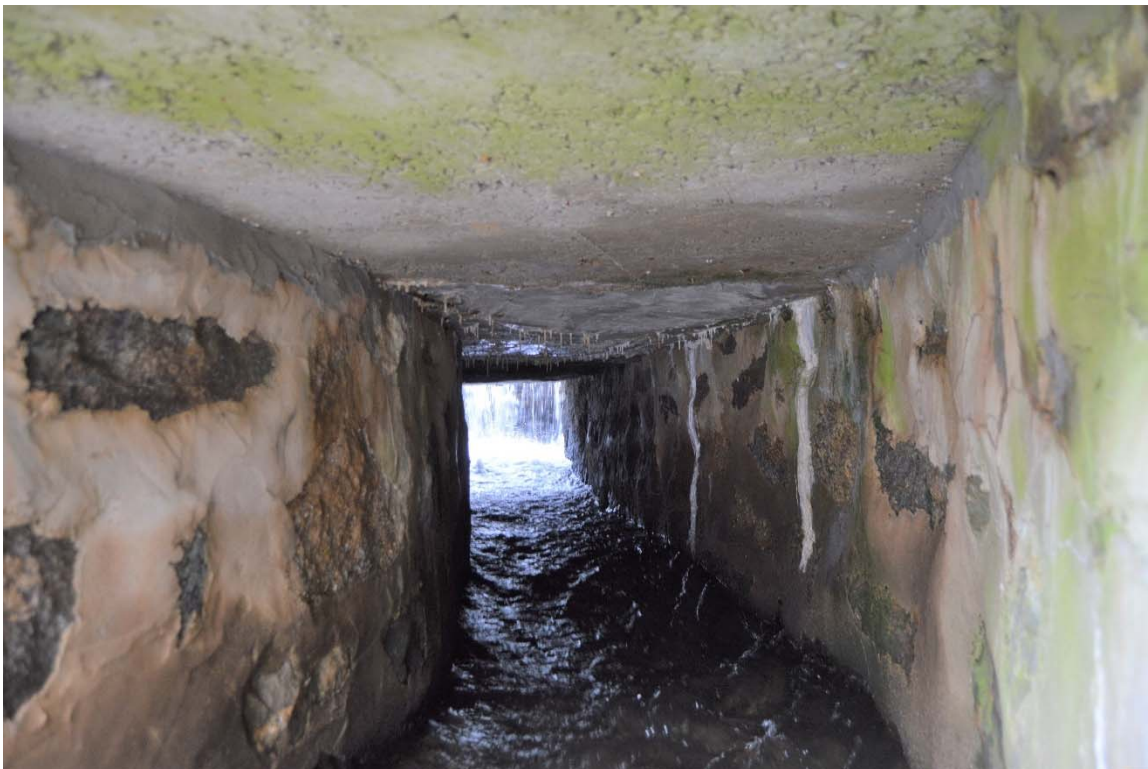
Photo 19d – Progressing upstream through the spillway discharge tunnel. The masonry sides of the tunnel are covered with a cementitious coating; the roof appears to have been cast rather than coated. The concrete roof extends only halfway up the tunnel from the downstream end; the rest is open stone – see Photo 19e.

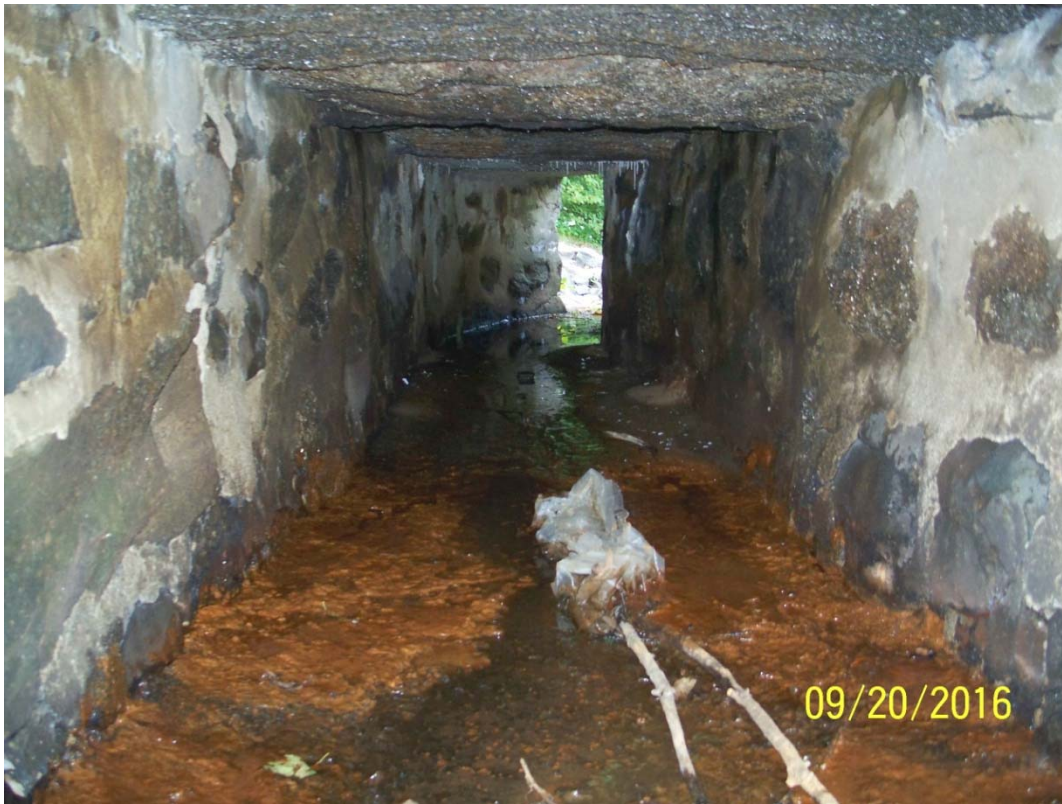
Photo 19e – The upstream section of the spillway discharge channel, which runs under North Street, as seen in 2016 from the upstream end. Note the roof in this area is open stone masonry – slabs spanning its width.

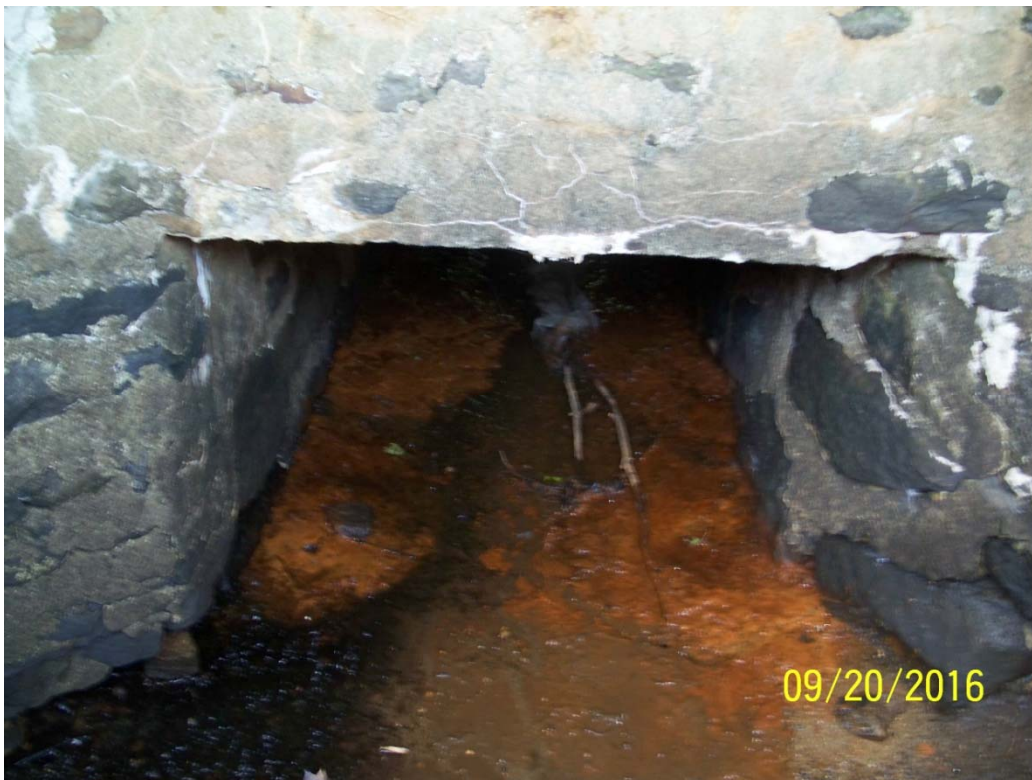
Photo 19f – A view of the entrance to the discharge channel, taken from the base of the spillway and looking in a downstream direction in 2016.

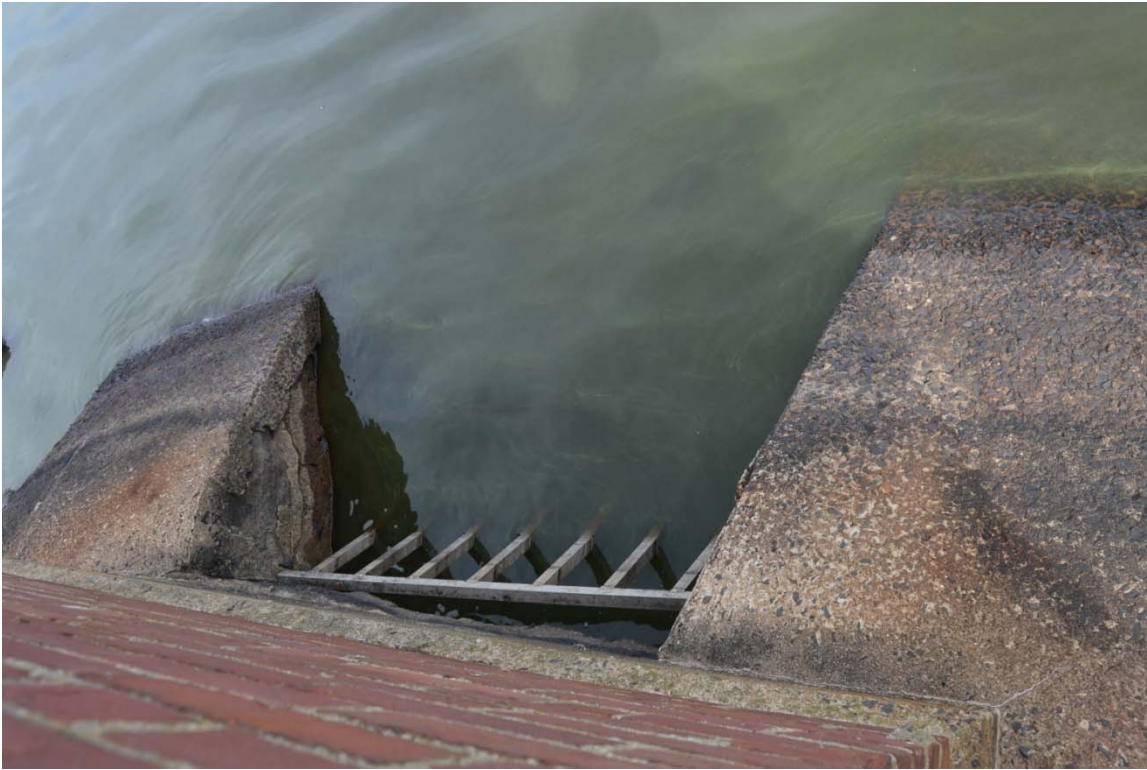
Photo 19g – The intake for the low level outlet pipe on the upstream side of the gatehouse. The trash rack covering the opening appears to be in good condition judging from the visible portion above water level.

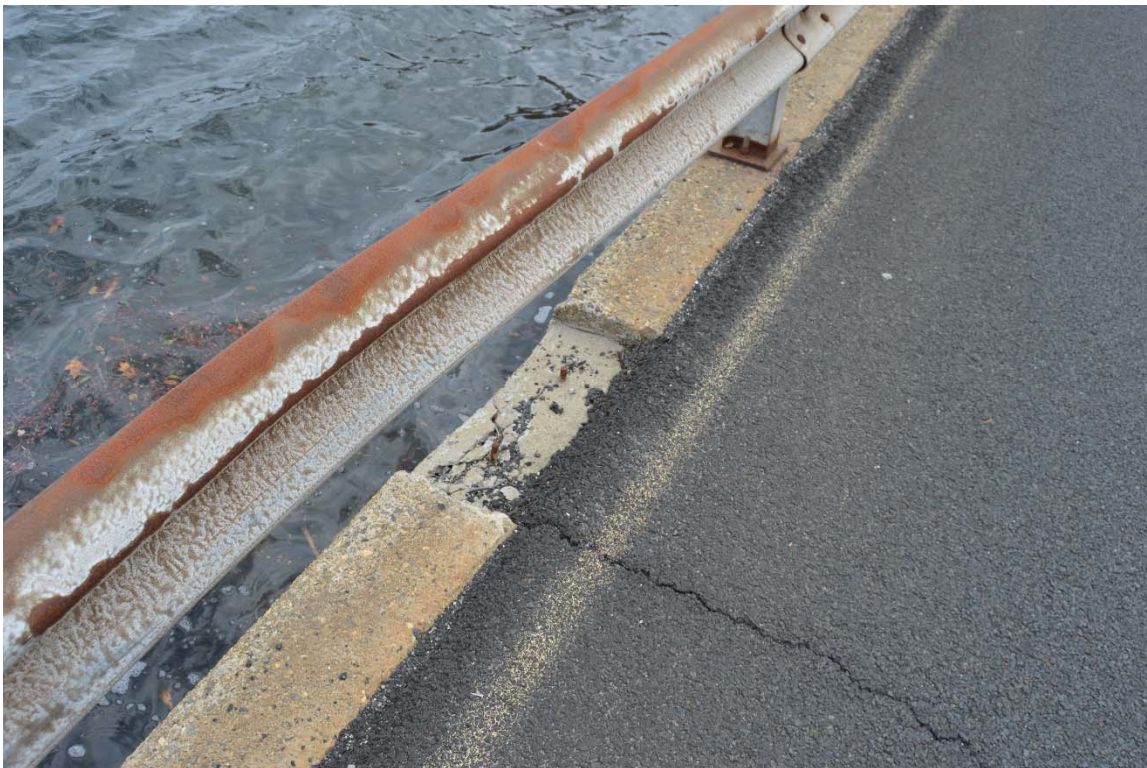
Photo 19h – A curb cut on the north (upstream side) of North Street, facilitating the discharge of flow runoff from the road into the impoundment on the north side of the road.

5. North Street – Although in general good condition during this inspection, some small cracks were noted in proximity to leakoffs along the north side of the road. These should be monitored on a regular basis to avoid infiltration of runoff into the embankment. Likewise, minor erosion was noted on the south side of the road (along the downstream embankment crest) behind the guardrails, as this is an area where pedestrians walk to avoid the narrow roadway with no safety shoulder.

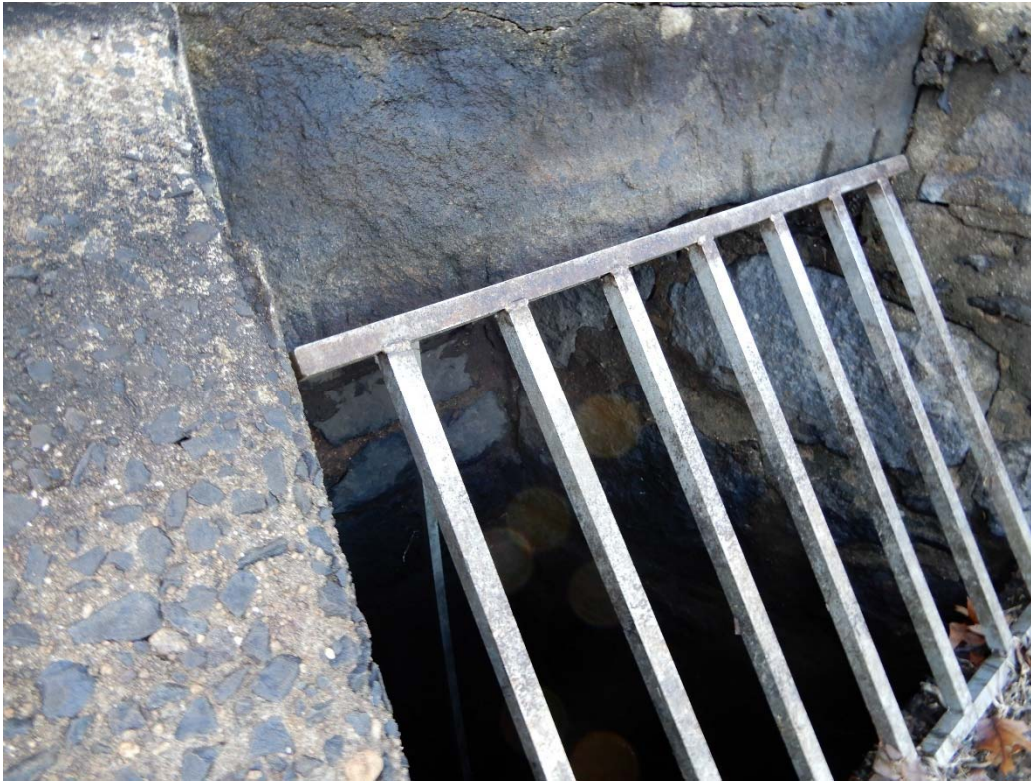
Photo 19i – A close up view of the trash rack at the low level intake, taken during the low water level period in the fall of 2019.

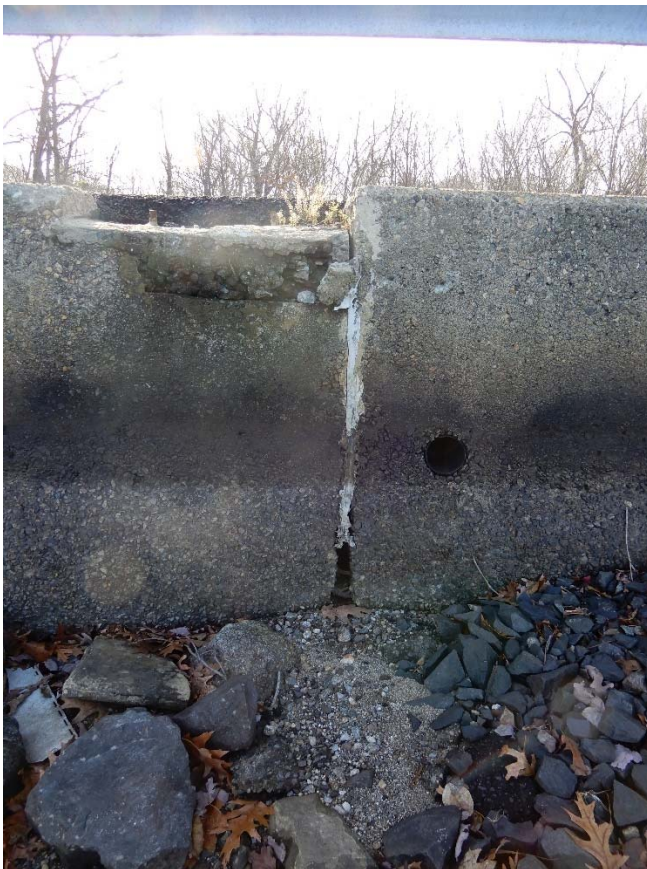
Photo 19j – A curb cut facilitating the flow of road drainage into the lake, along with the drain outlet adjacent thereto, for the same purpose.

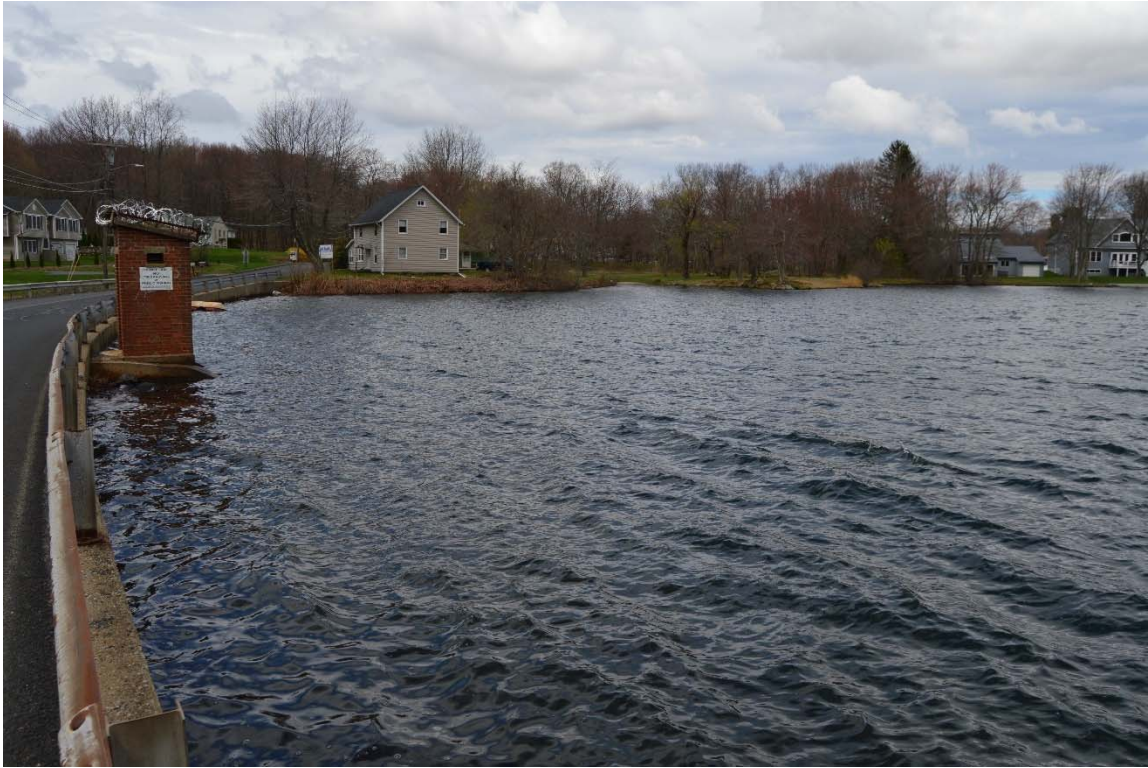
Photo 20a – The lower reaches of Cedar Lake, looking toward the right upstream side of the dam.

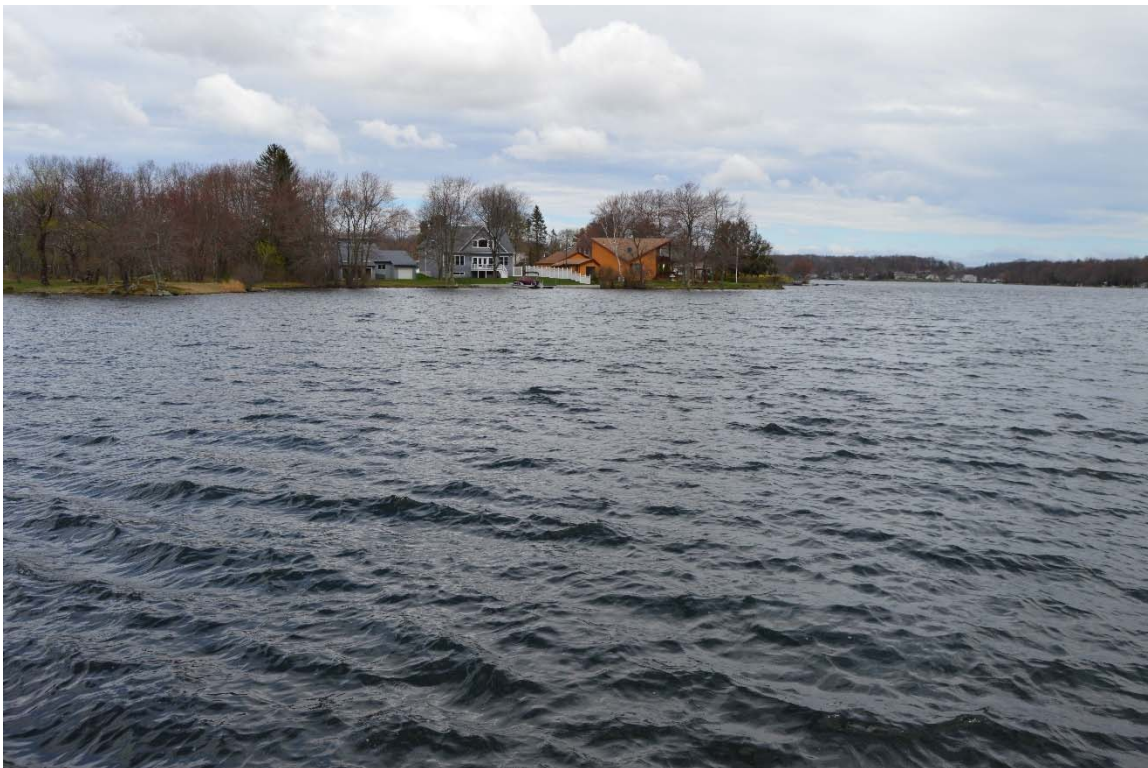
Photo 20b – Panning northward from the previous photo, with the upper reaches of the lake in the upper right background.

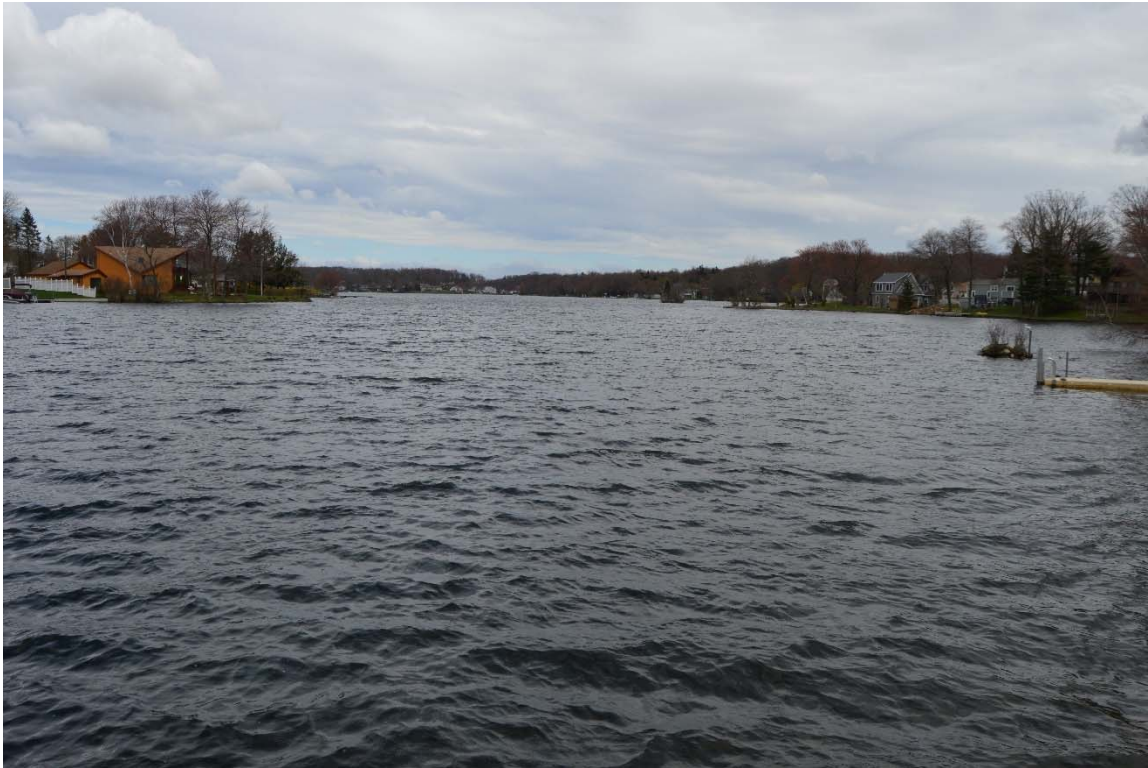
Photo 20c – Looking directly upstream at Cedar Lake.

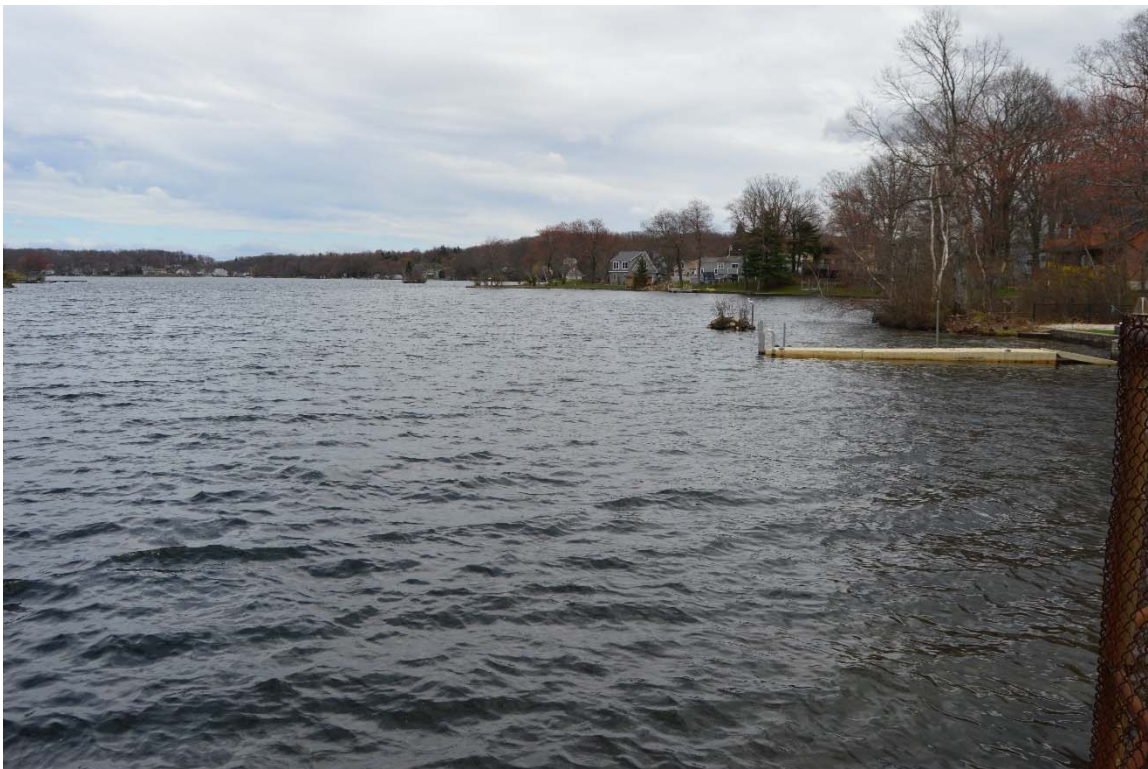
Photo 20d – The eastern section of the lake. Note the dock on the right of the photo (also visible in Photo 20c) for reference.
