INSPECTION REPORT

CEDAR LAKE DAM CT DEEP #16603

NORTH STREET
MAD RIVER
WOLCOTT, CONNECTICUT

DECEMBER 2019

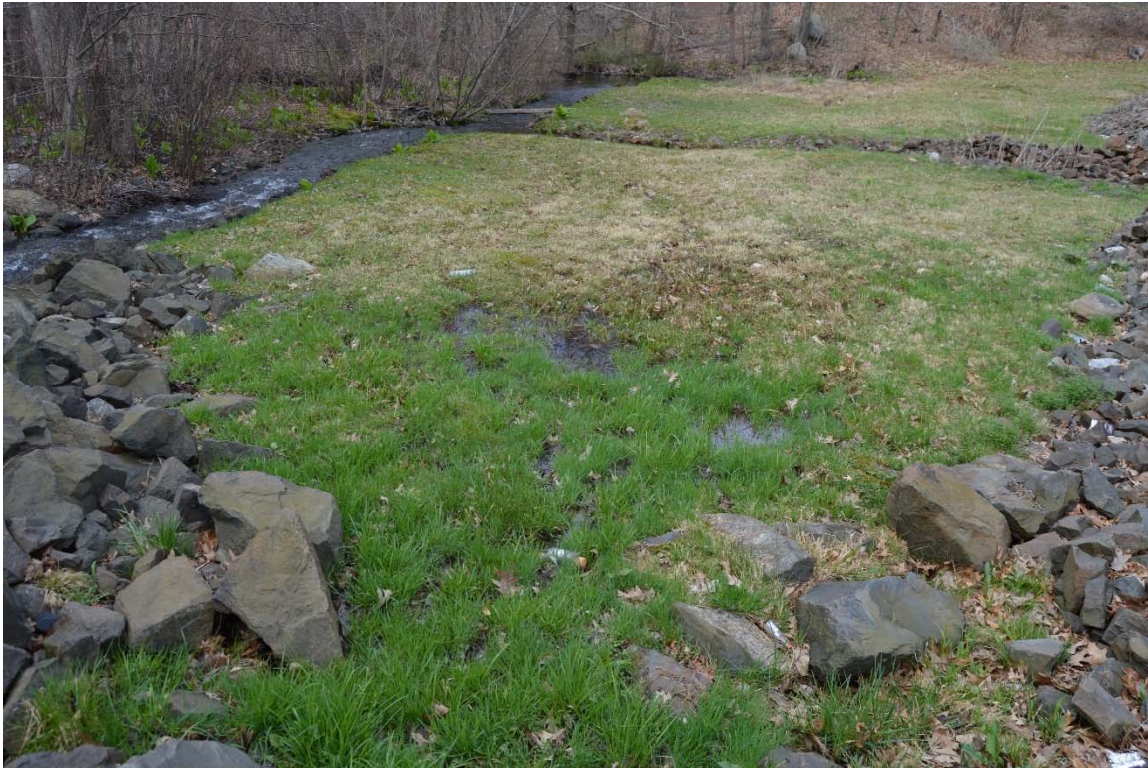
Photo 21c – Saturated ground between the toe of the left downstream embankment and the downstream channel.
