EMERGENCY ACTION PLAN

CEDAR LAKE DAM DEEP #16603 / HAZARD CLASS "B"

NORTH STREET
MAD RIVER
WOLCOTT, CONNECTICUT

NOVEMBER 2020

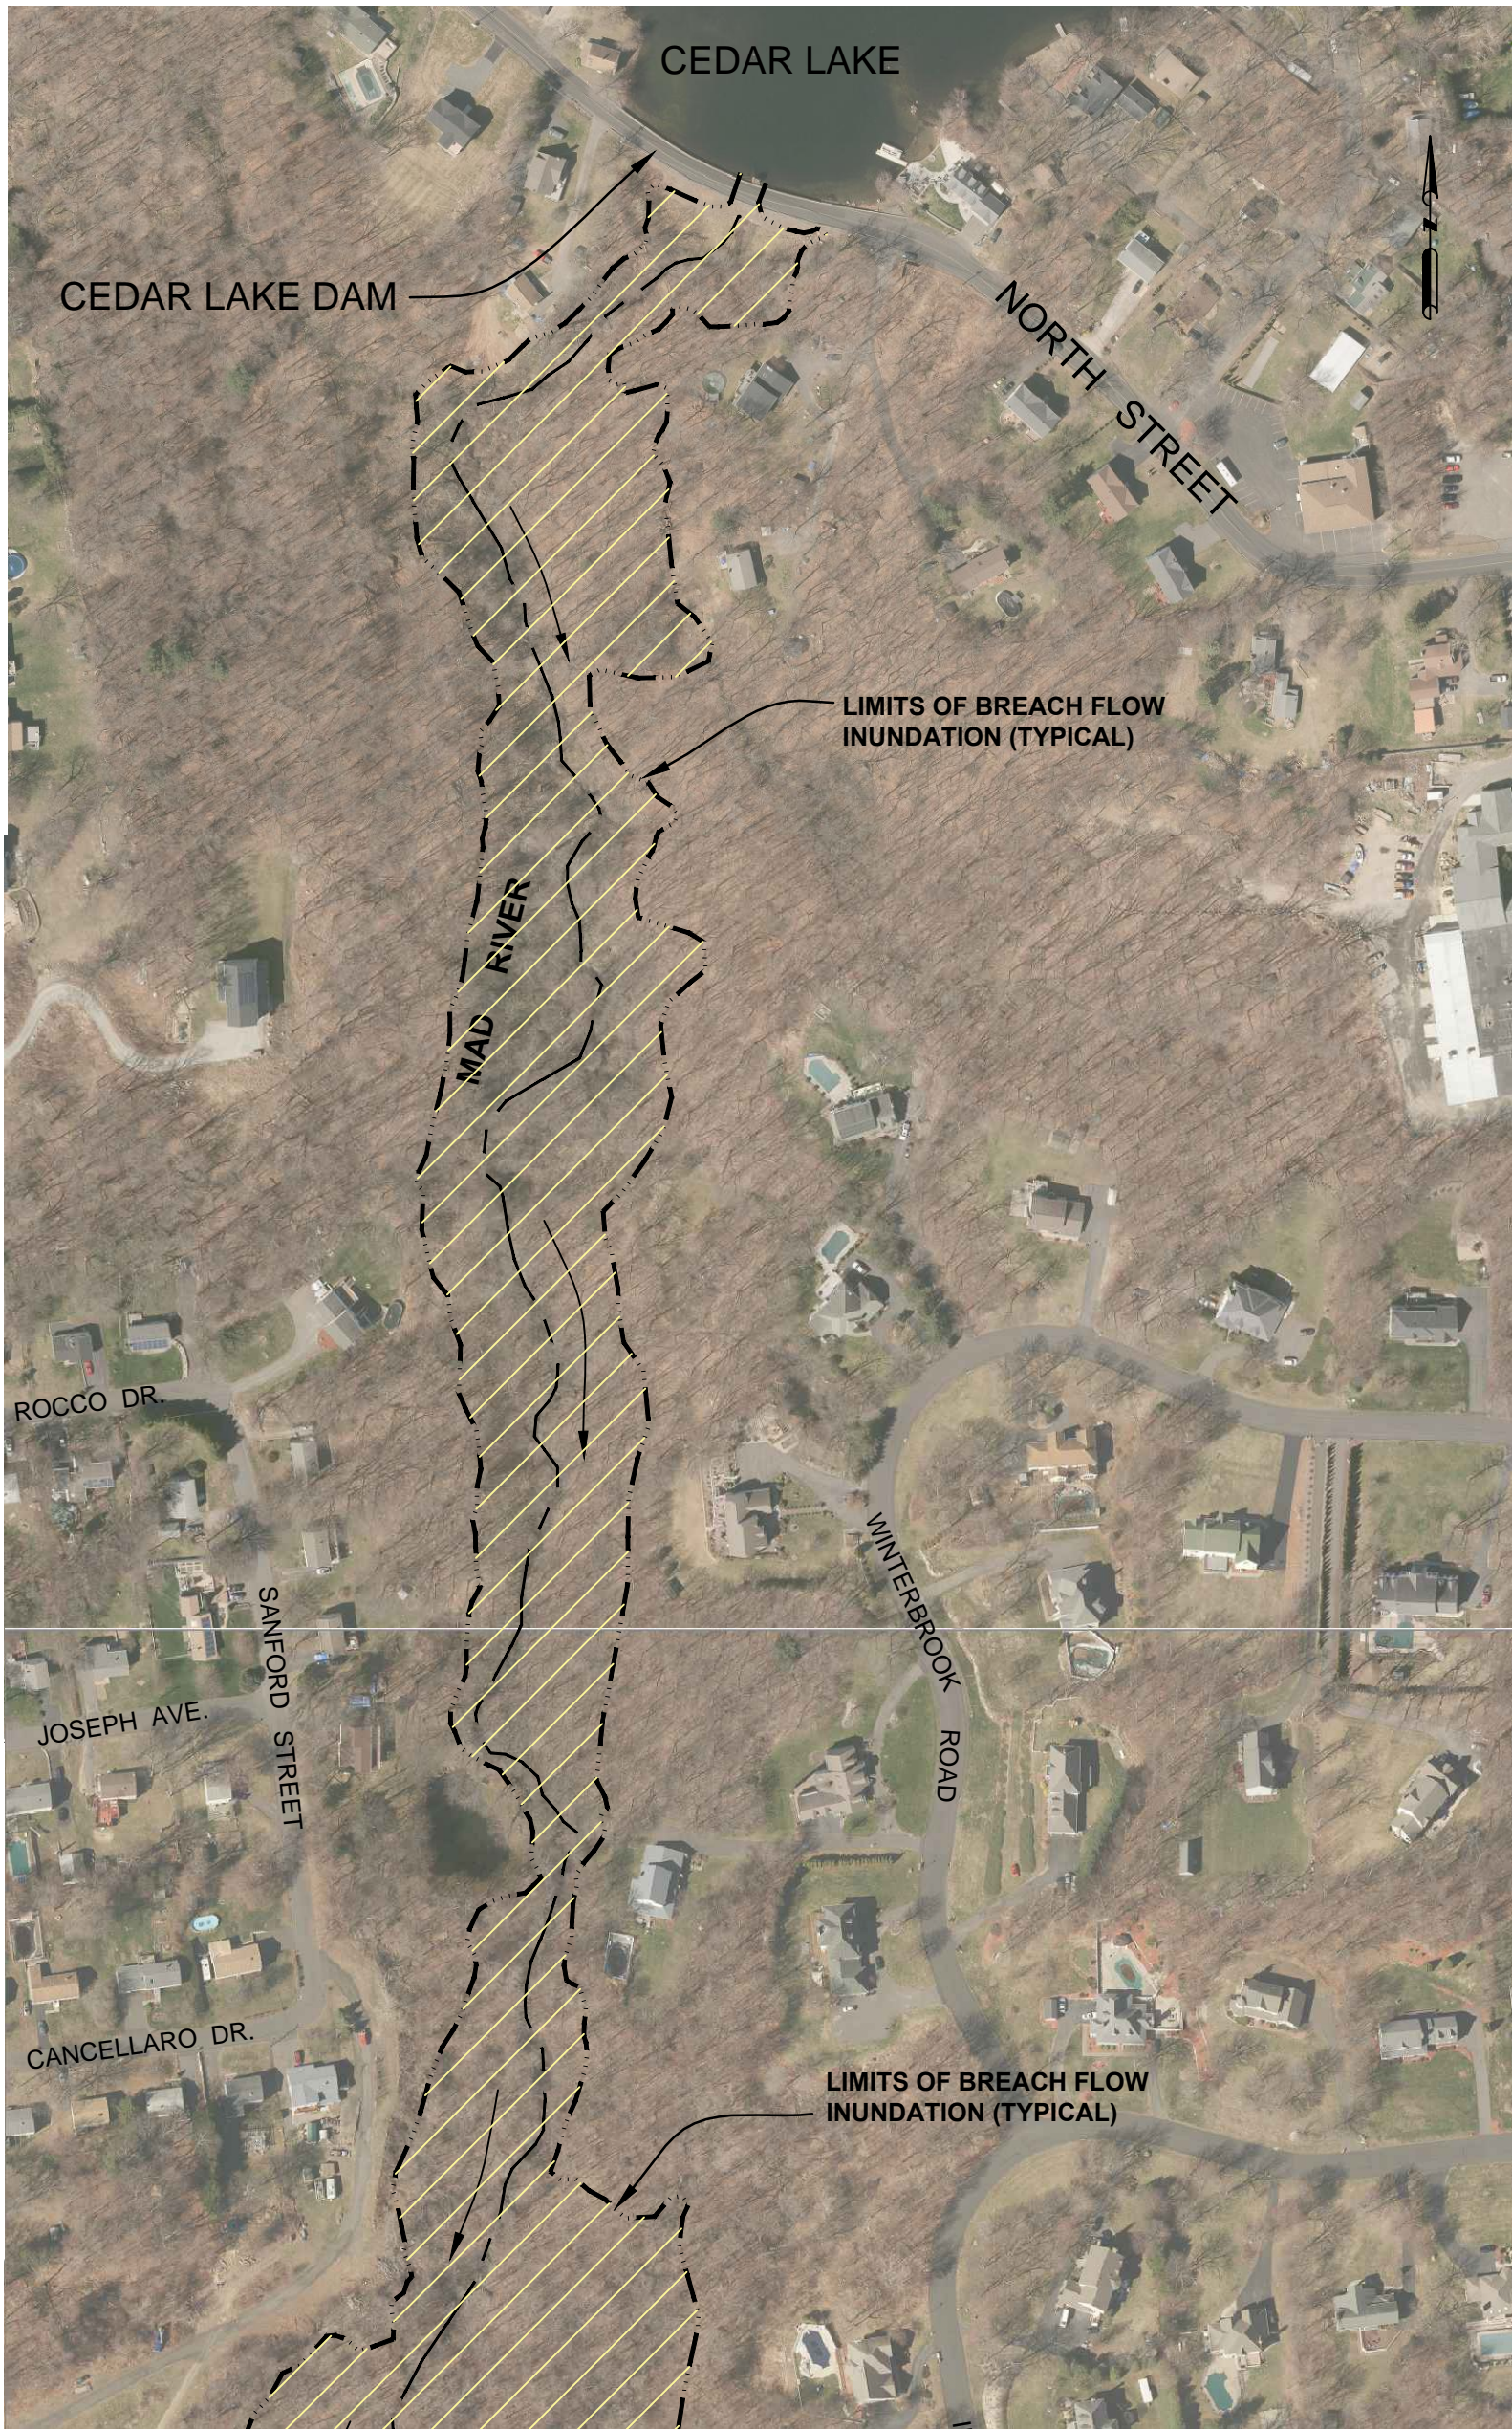
**LIMITS OF POTENTIAL DAM BREACH IMPACT AREA
 CEDAR LAKE DAM / WOLCOTT, CONNECTICUT
 DEEP #16603 / HAZARD CLASS "B"**

SCALE: 1" = 200'

The following eight pages include maps of the approximate inundation areas

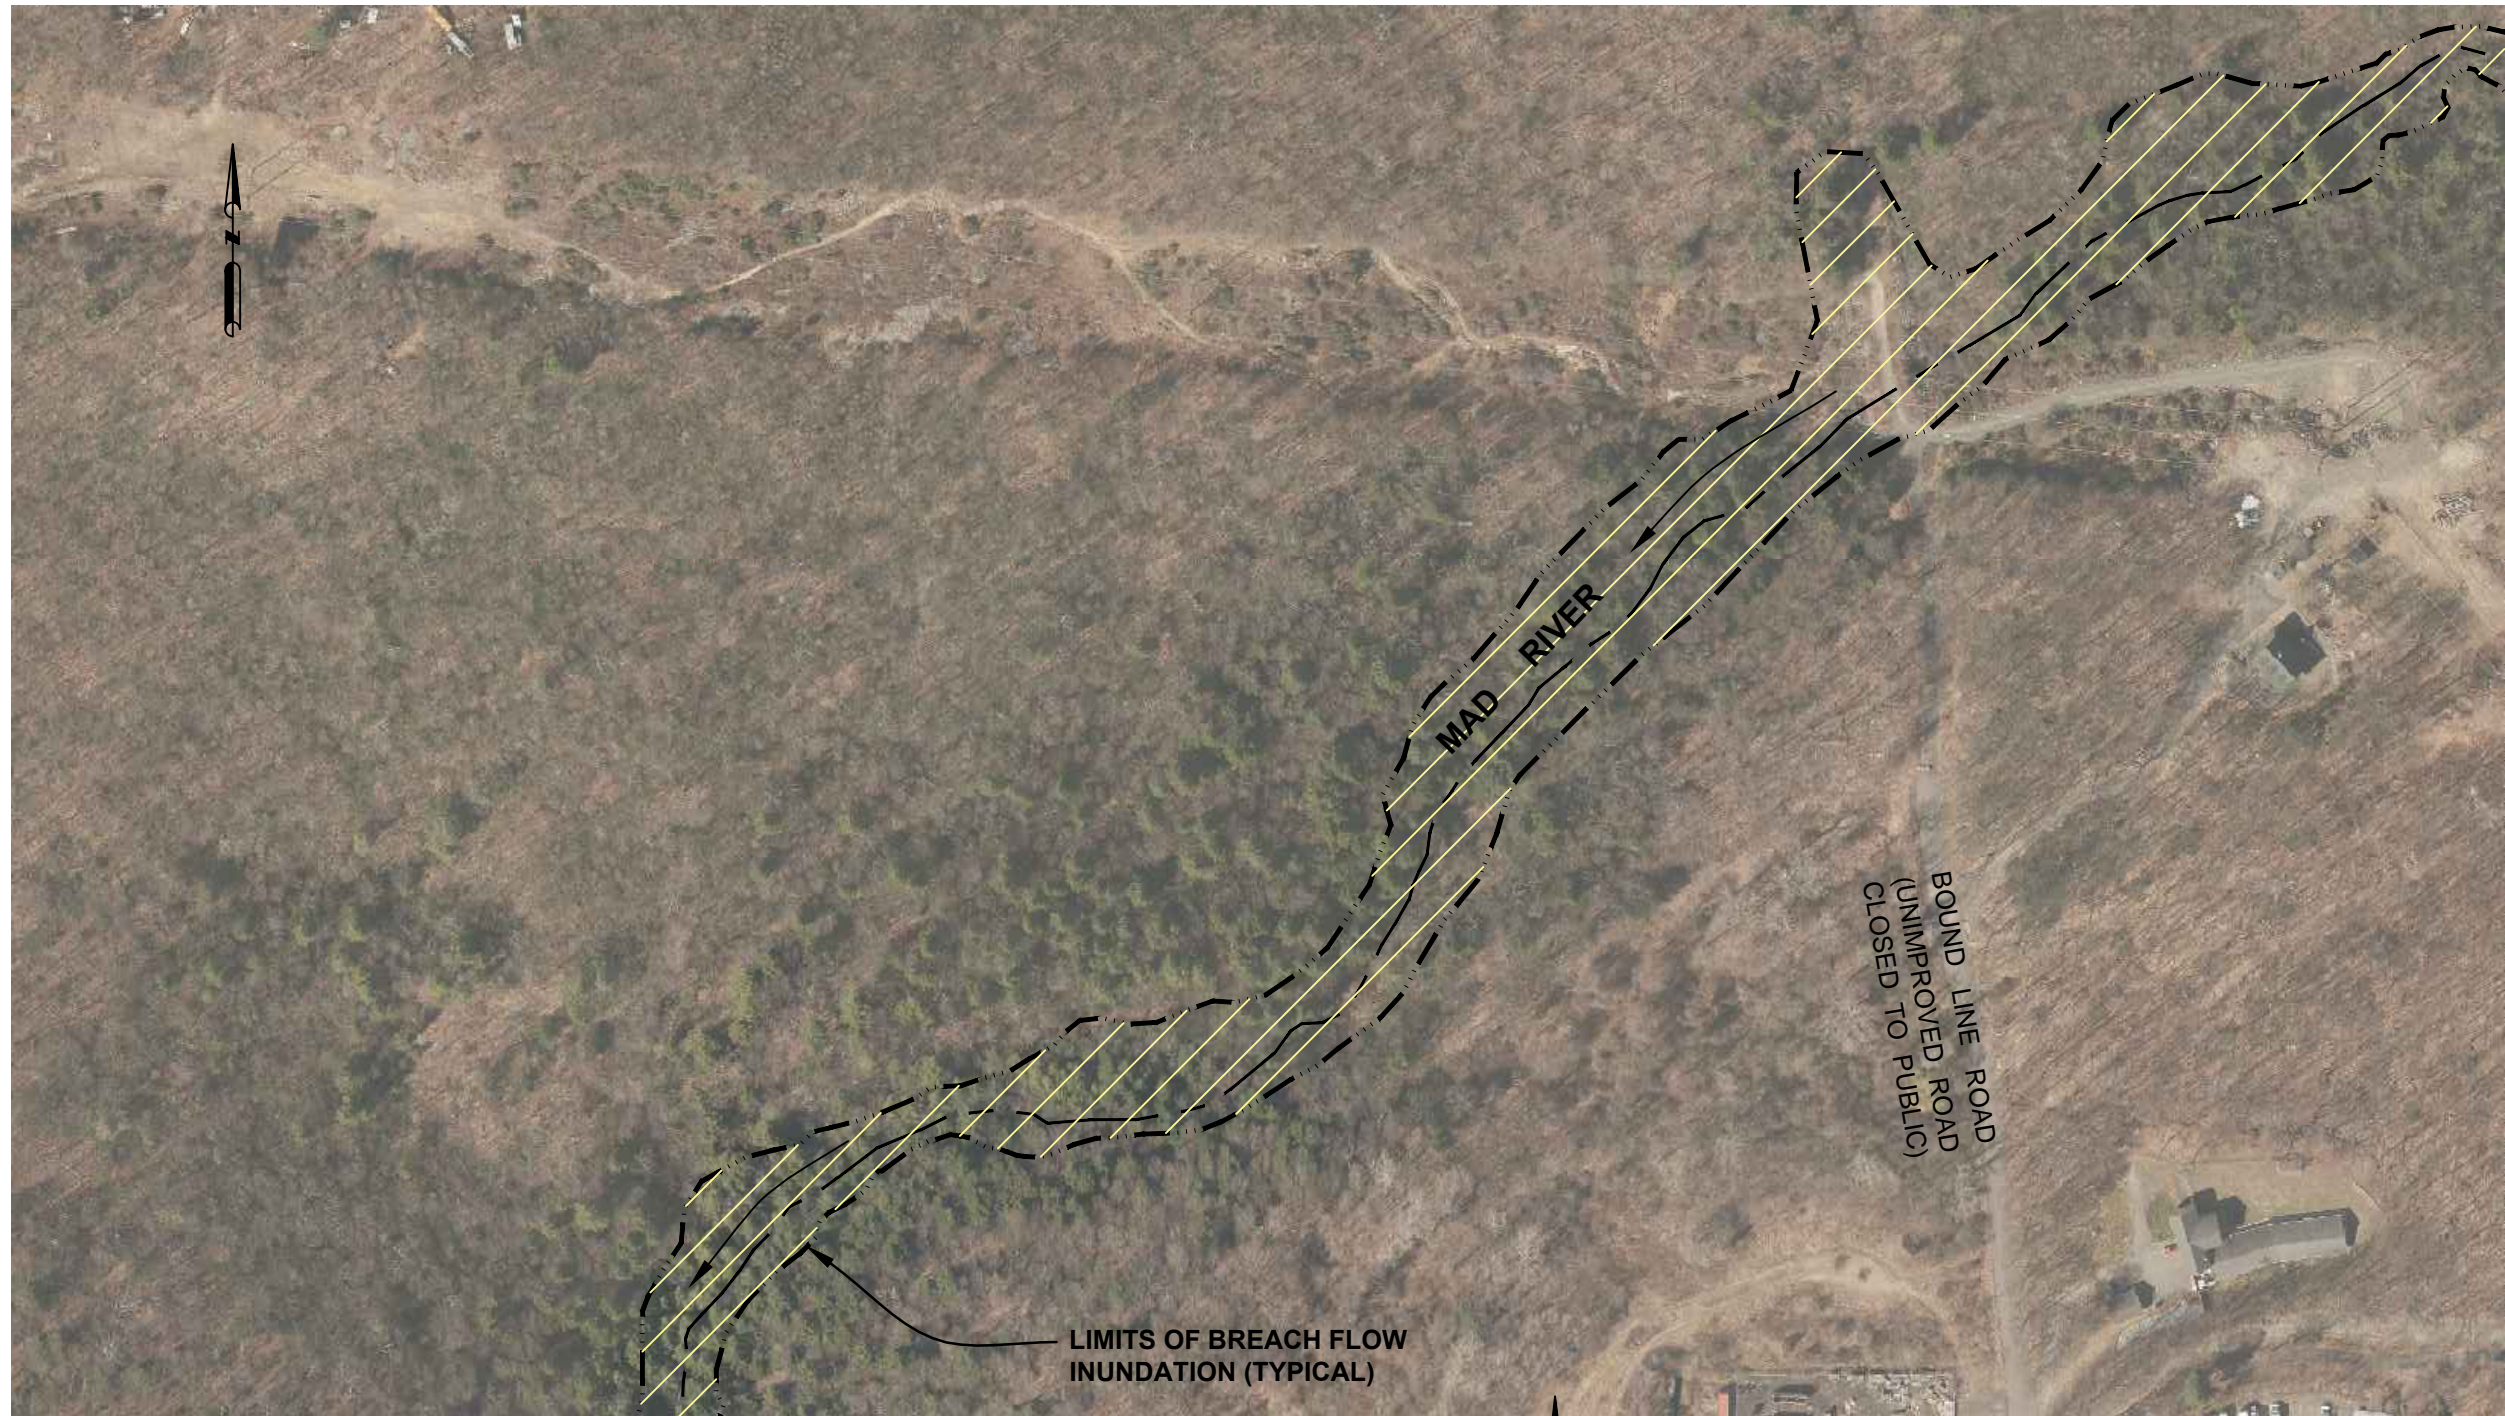
LIMITS OF POTENTIAL DAM BREACH IMPACT AREA
CEDAR LAKE DAM / WOLCOTT, CONNECTICUT
DEEP #16603 / HAZARD CLASS "B"

SCALE: 1" = 200'

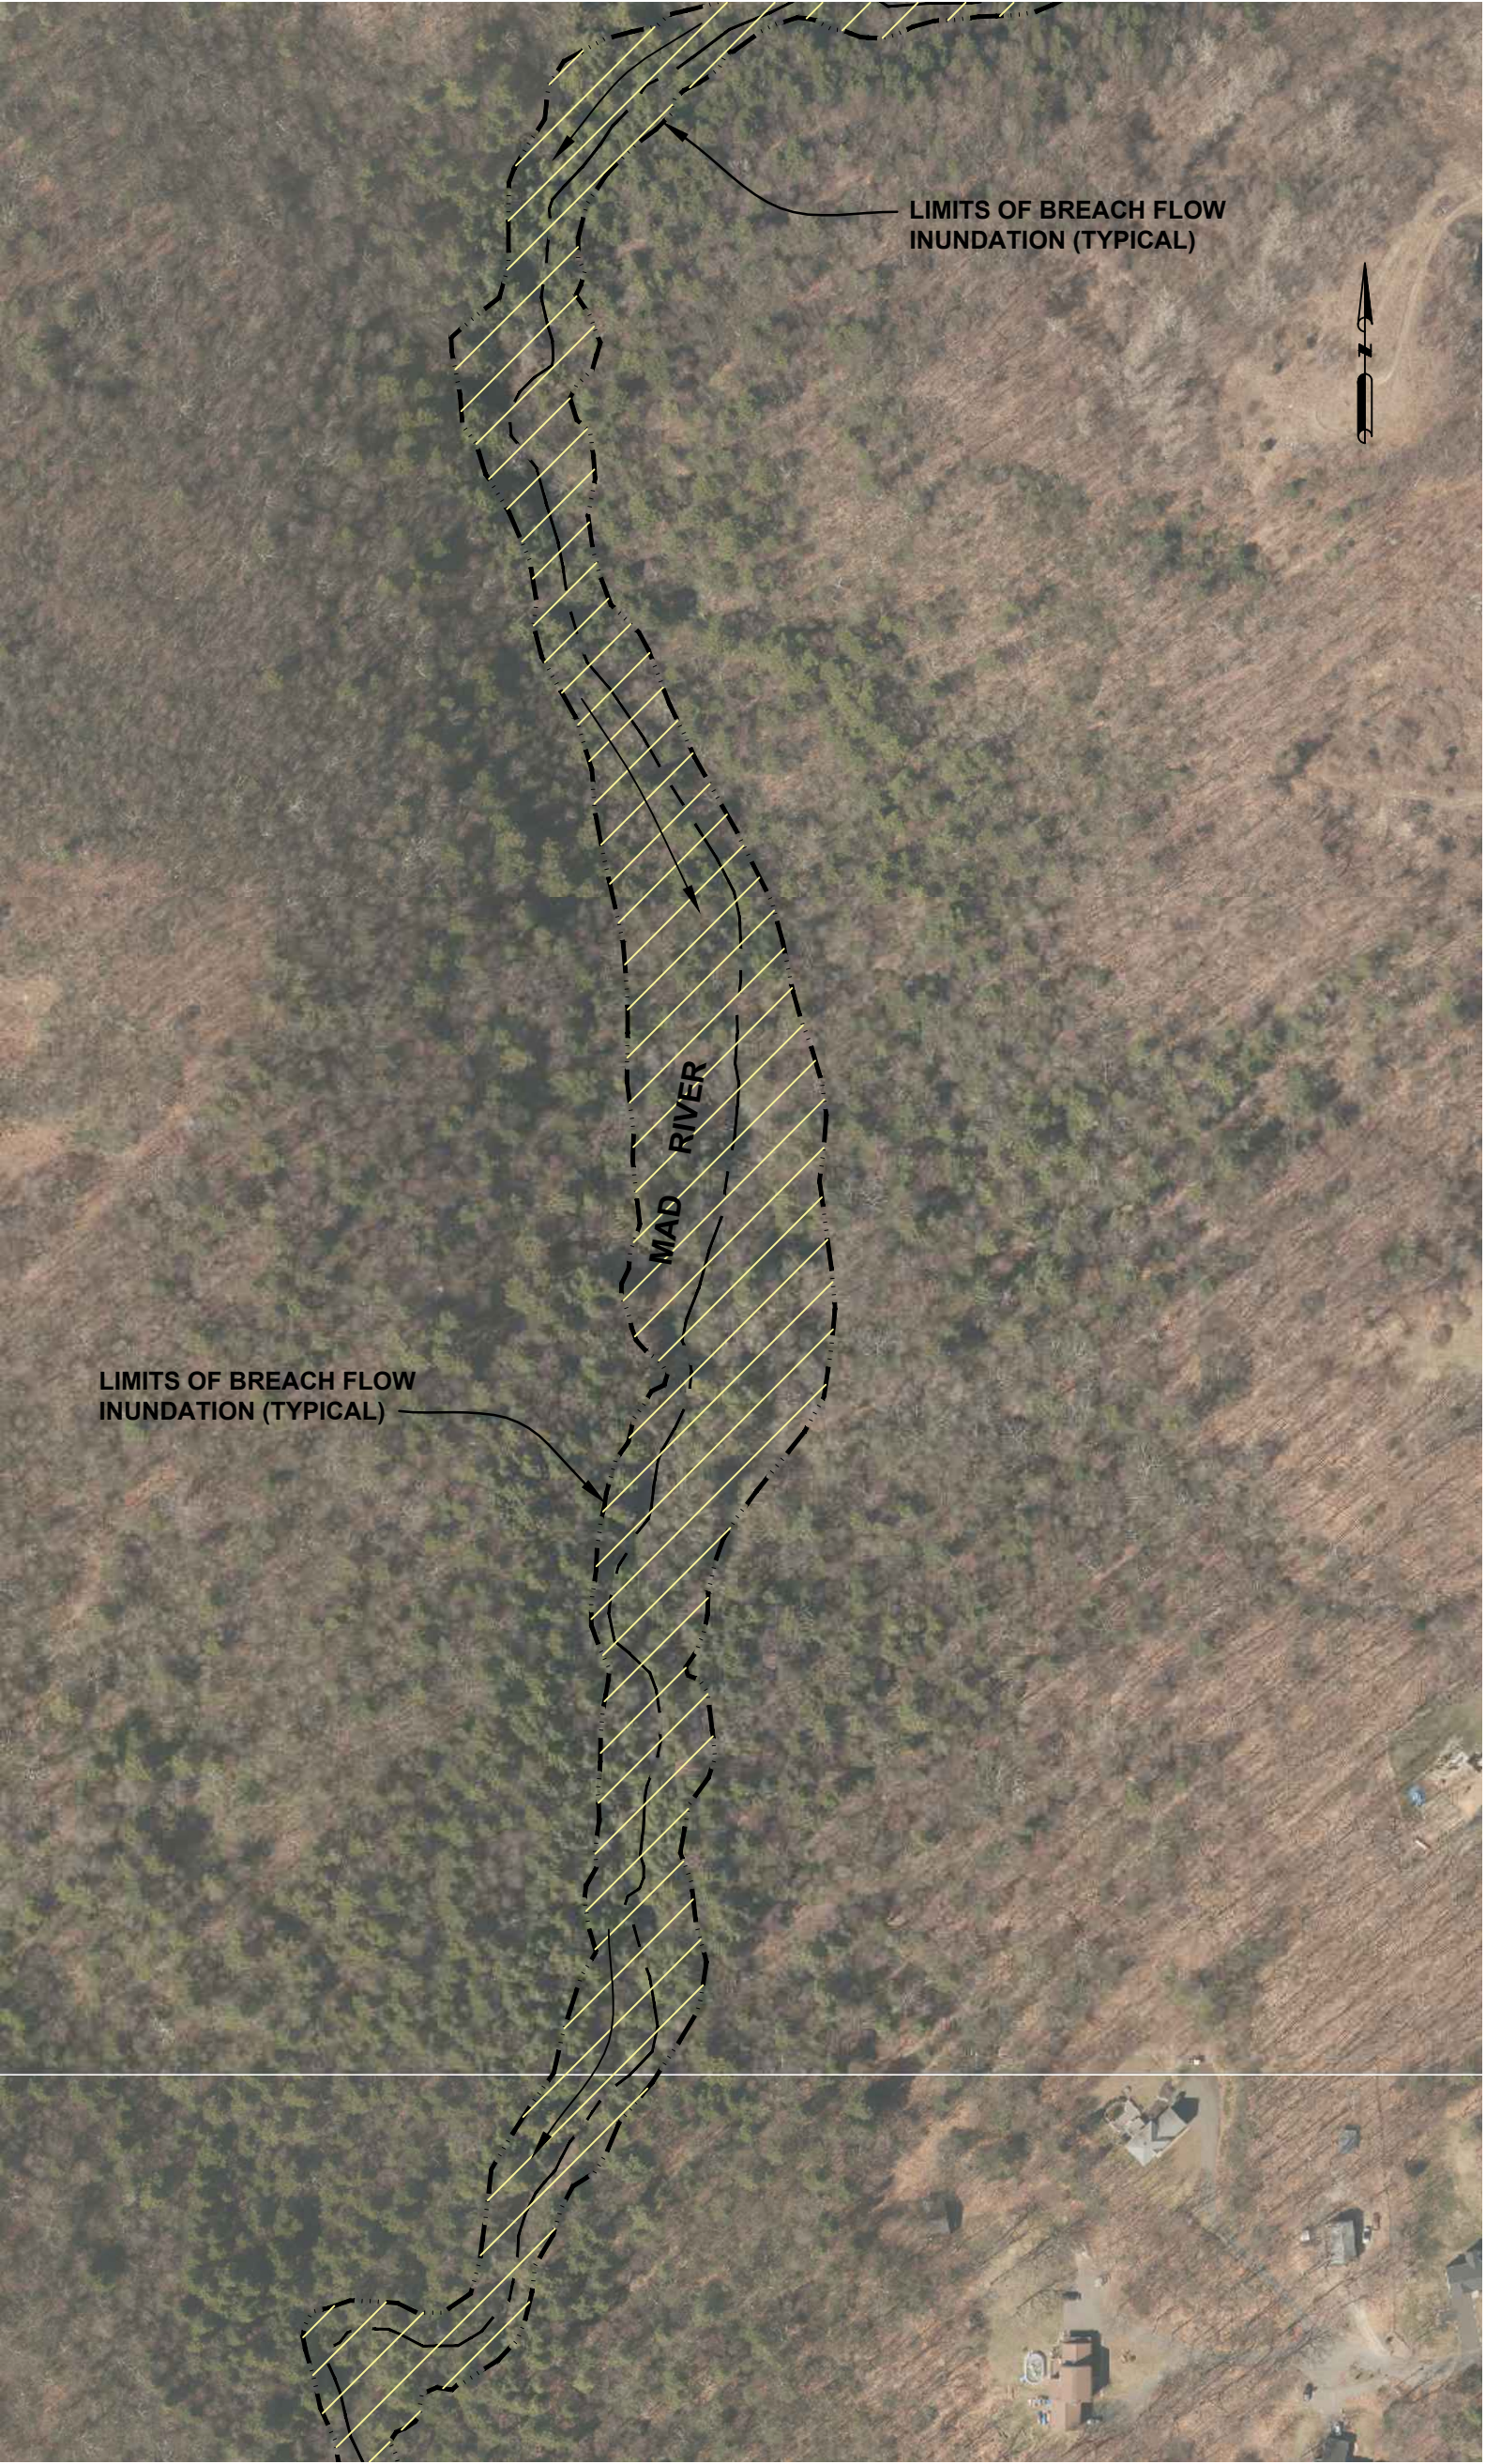
LIMITS OF POTENTIAL DAM BREACH IMPACT AREA
CEDAR LAKE DAM / WOLCOTT, CONNECTICUT
DEEP #16603 / HAZARD CLASS "B"

SCALE: 1" = 200'

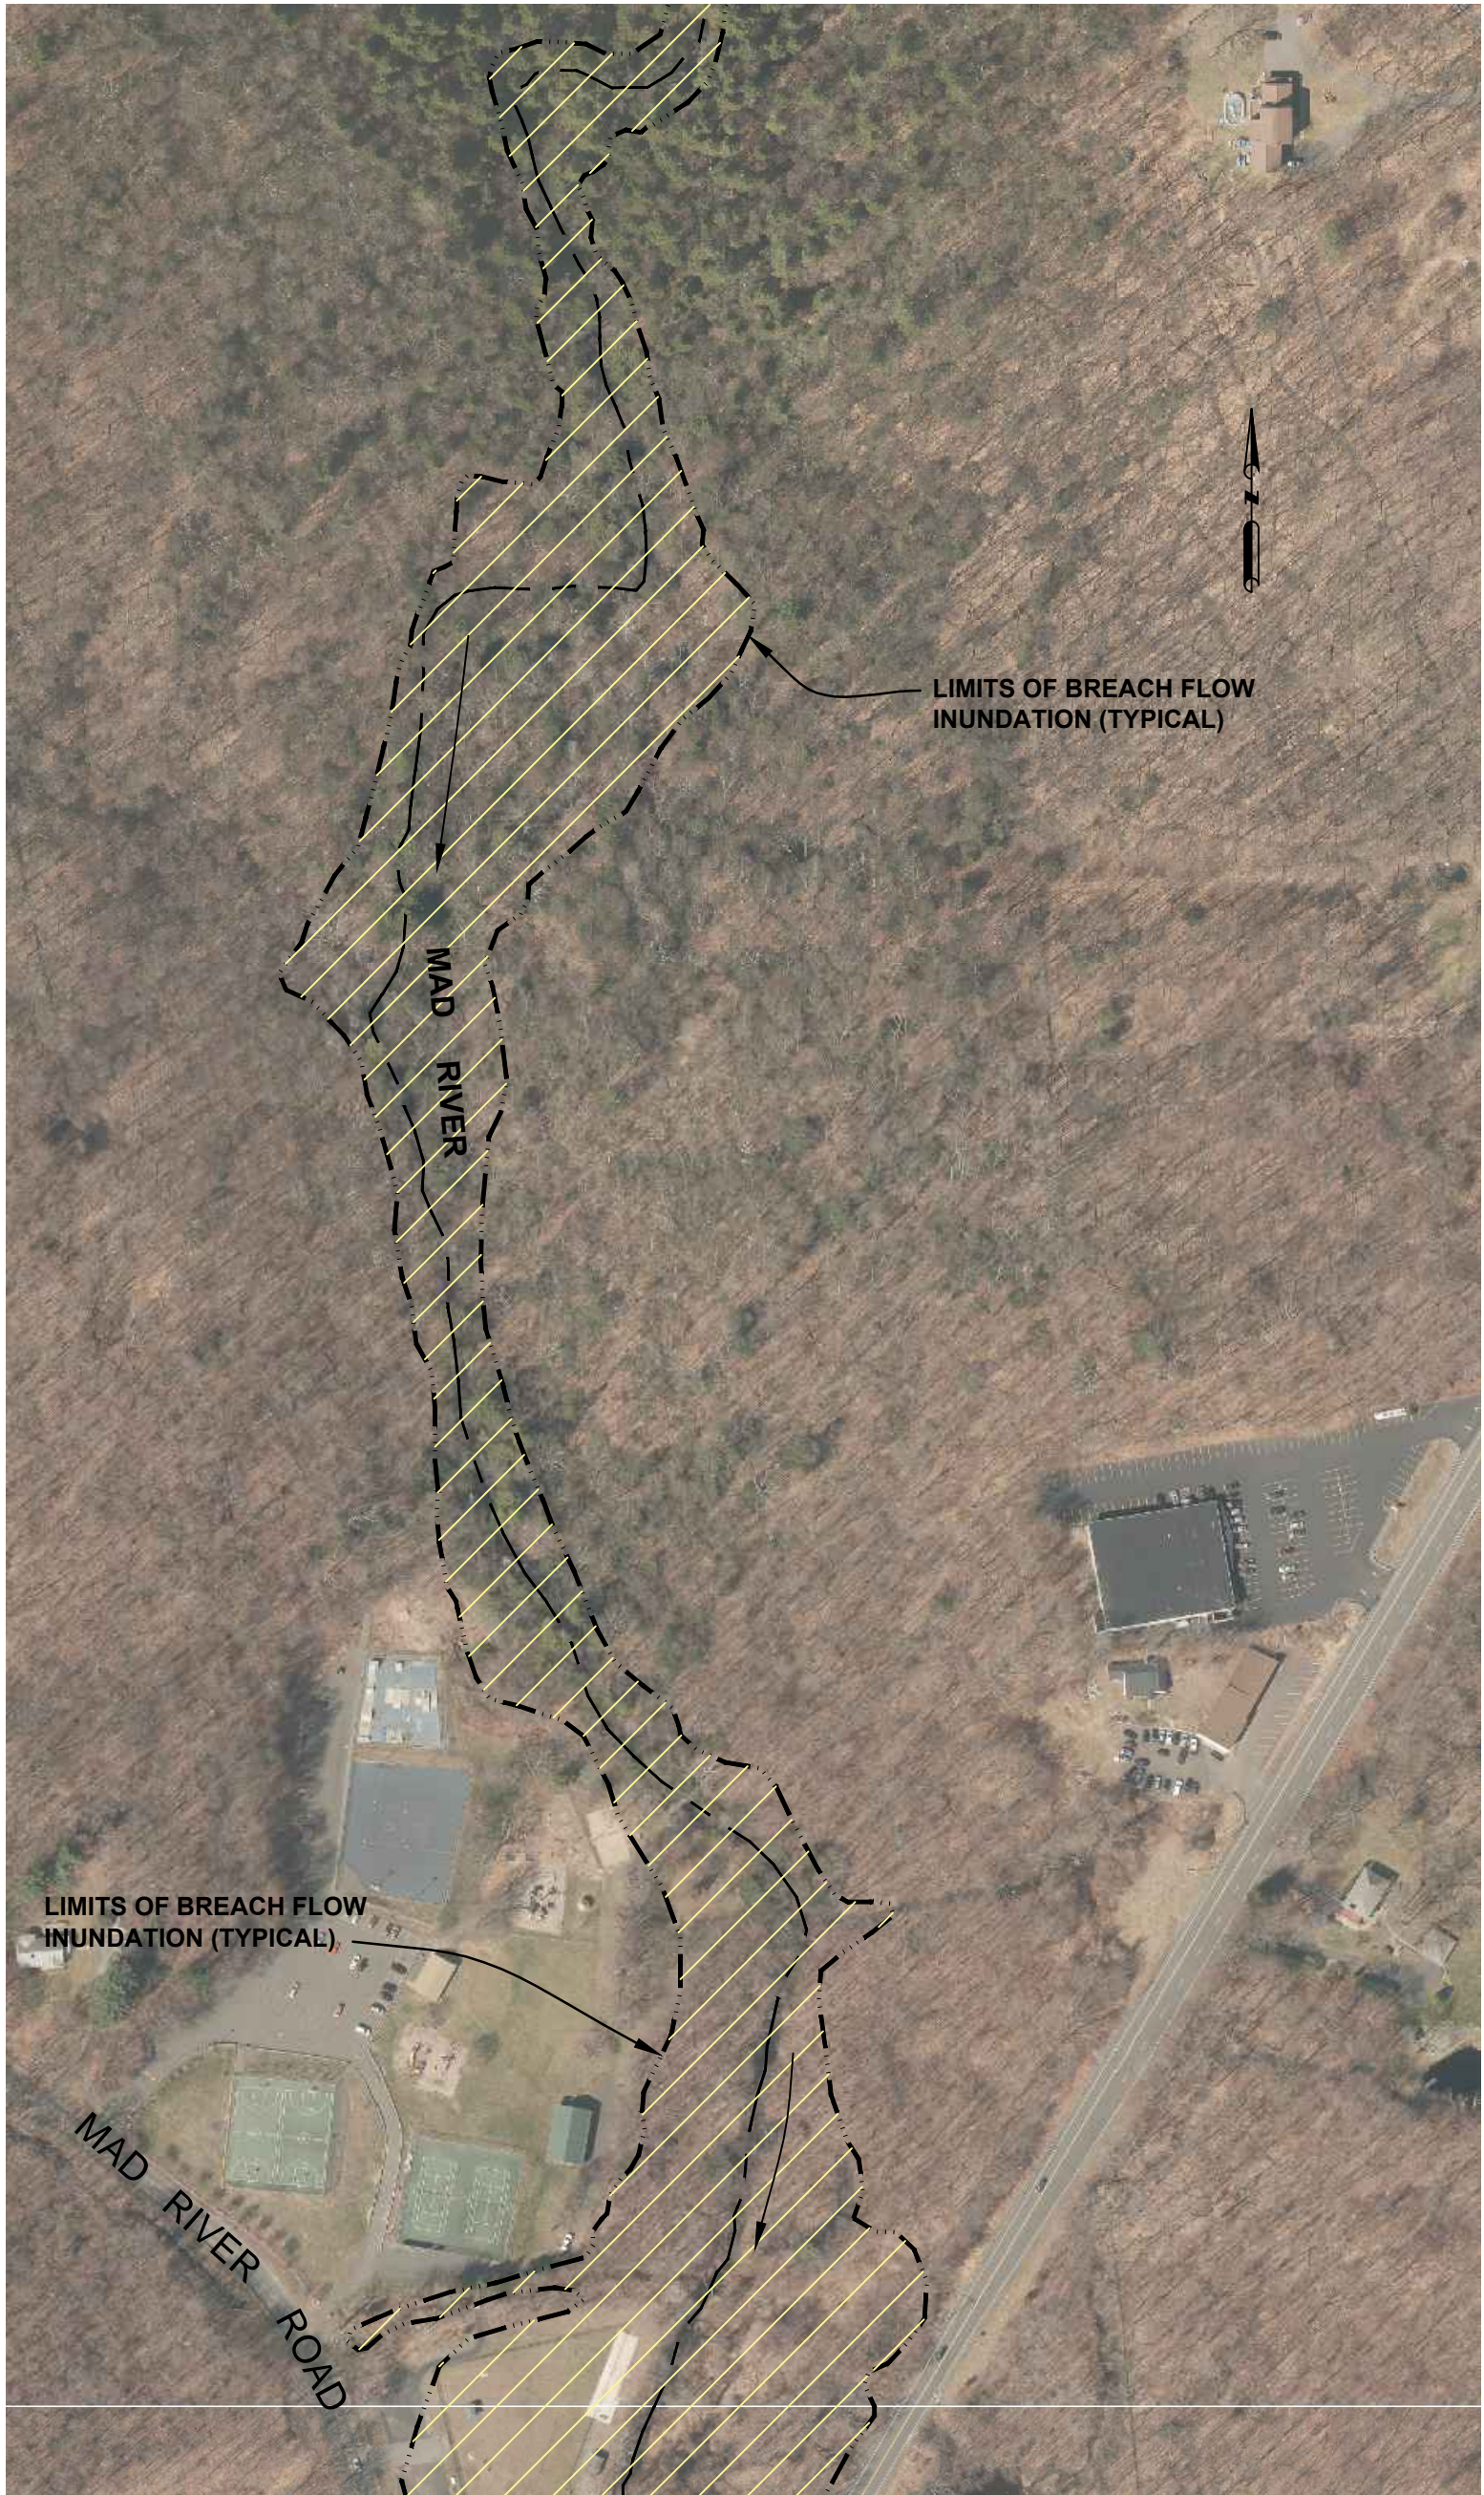
LIMITS OF POTENTIAL DAM BREACH IMPACT AREA
 CEDAR LAKE DAM / WOLCOTT, CONNECTICUT
 DEEP #16603 / HAZARD CLASS "B"

SCALE: 1" = 200'

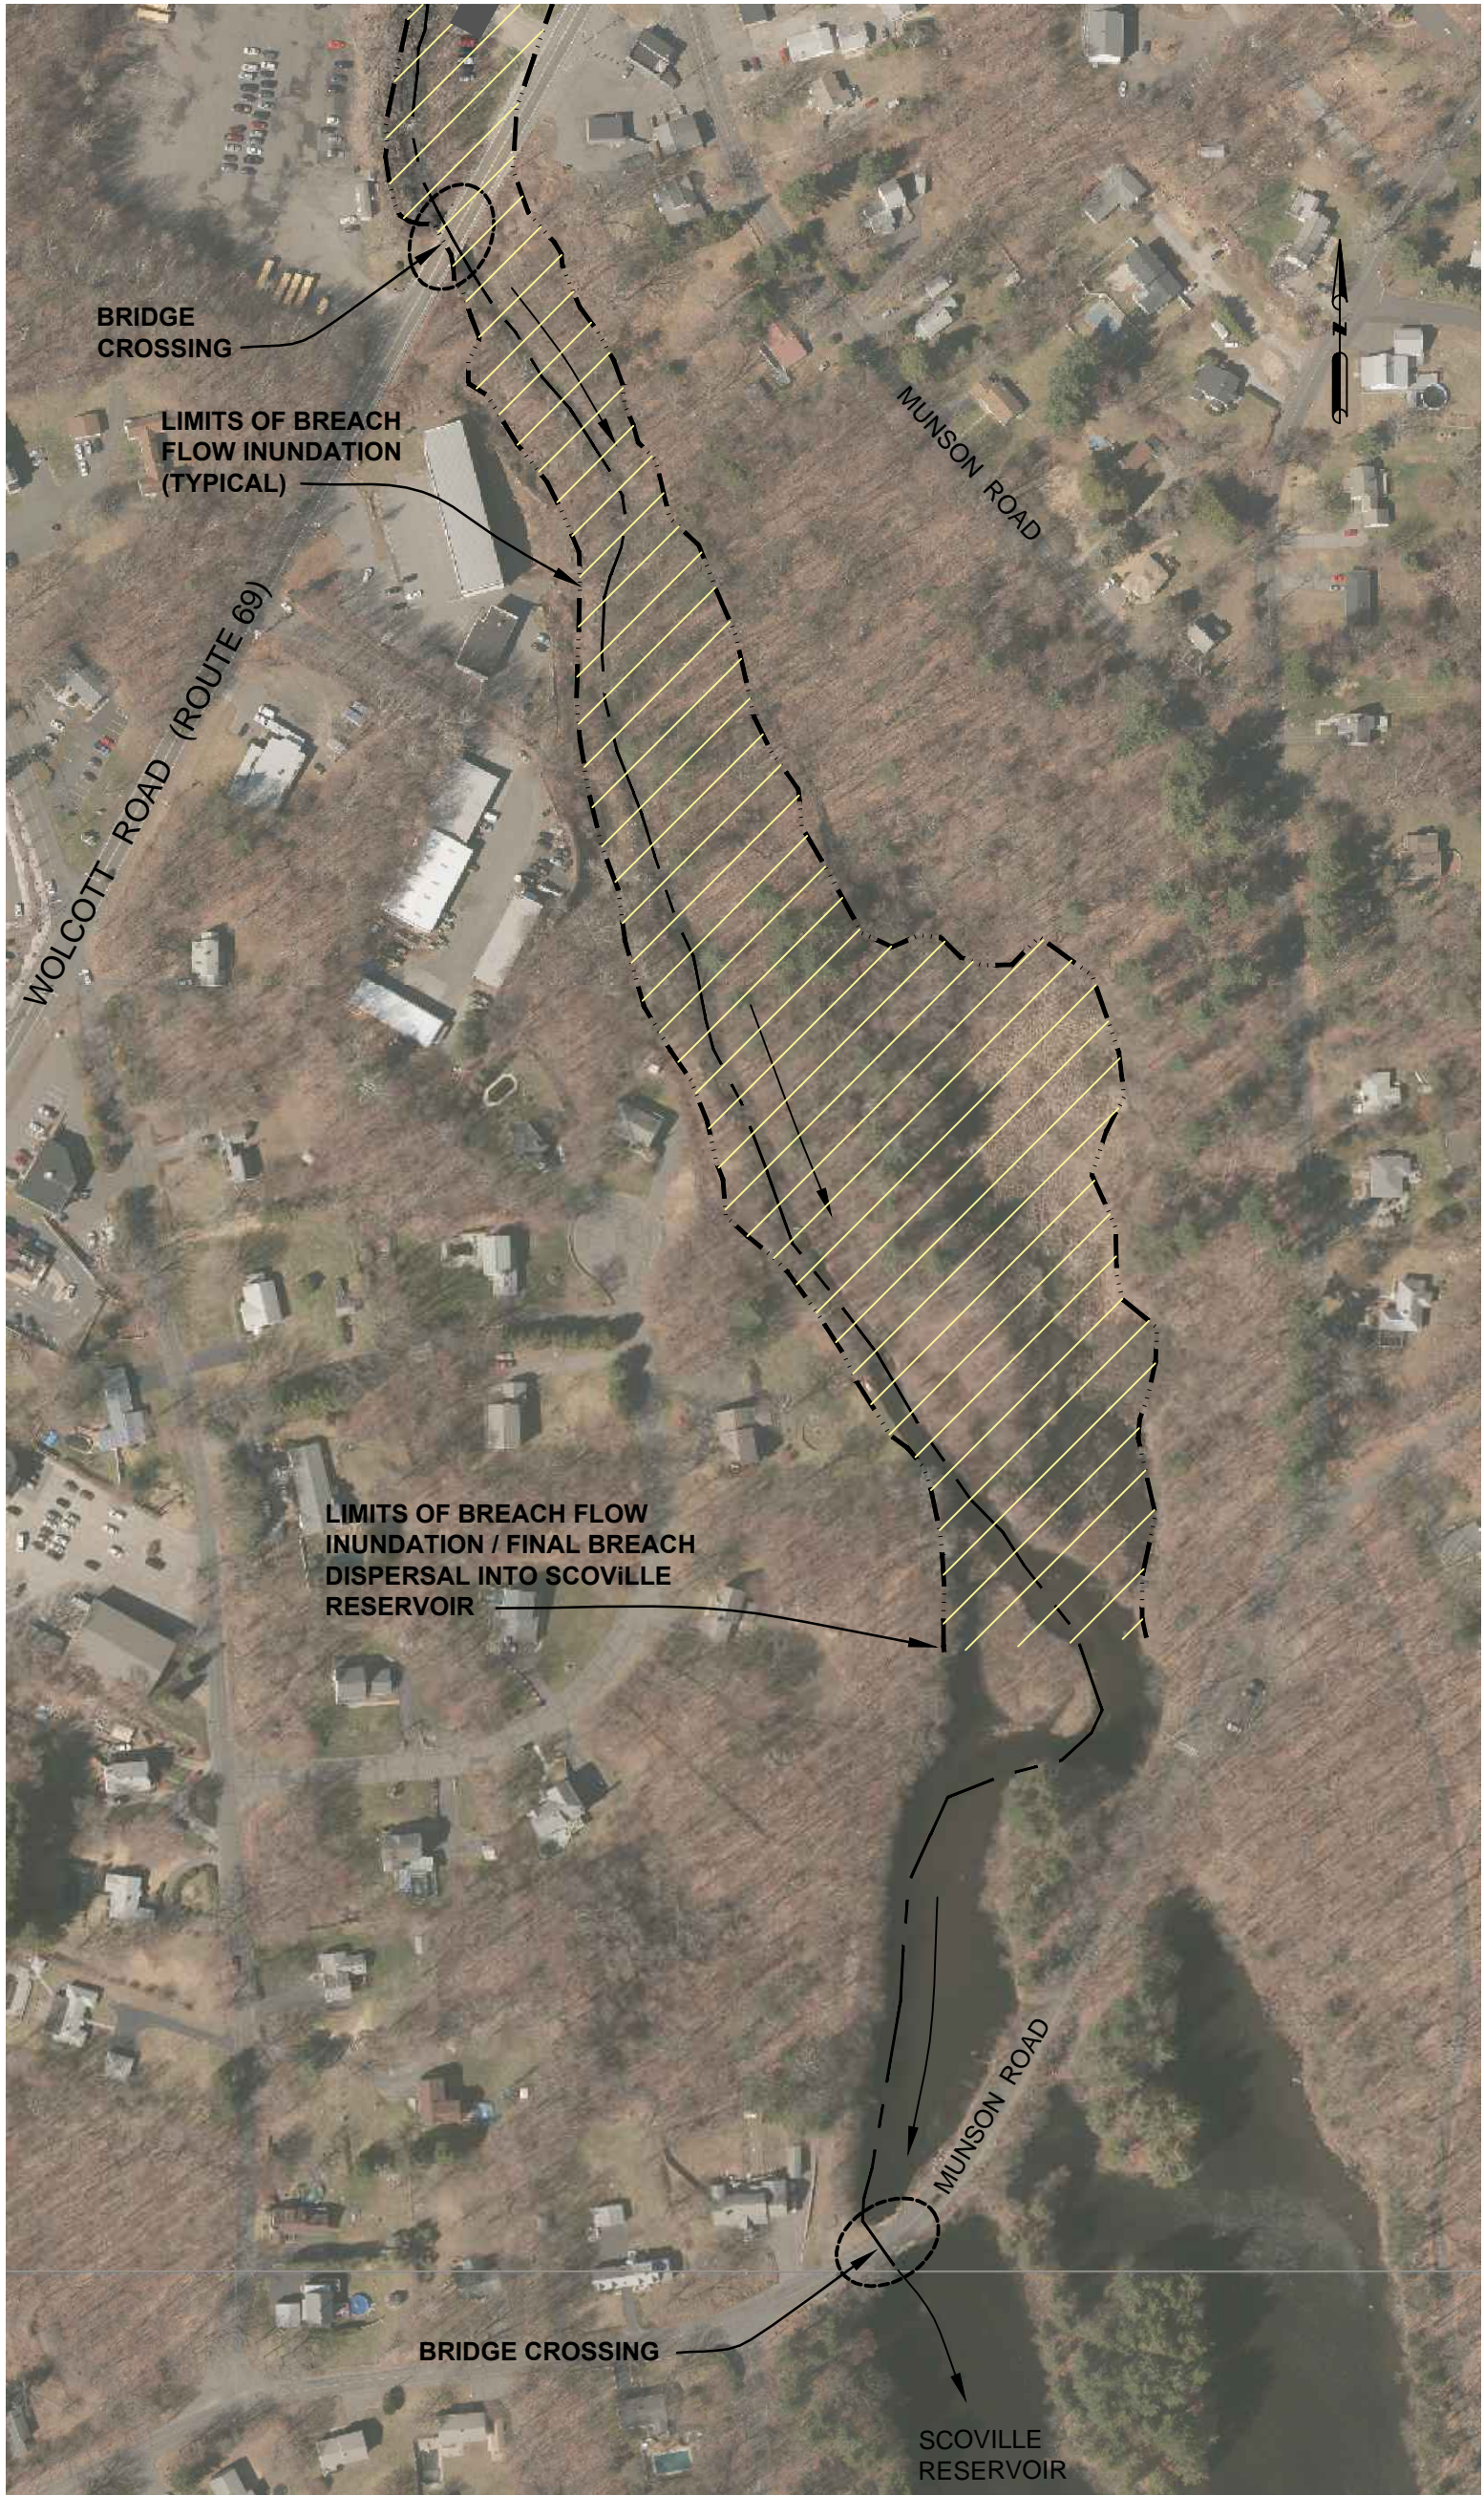
LIMITS OF POTENTIAL DAM BREACH IMPACT AREA
 CEDAR LAKE DAM / WOLCOTT, CONNECTICUT
 DEEP #16603 / HAZARD CLASS "B"

¹⁰ Although there is no overtopping of the bridge at this location due to its hydraulic capacity, adjacent road areas may be flooded due to the overtopping and downward slope / grade of the road at the previous bridge crossing of Wolcott Road (see Inundation Map Sheets 7 and 8.)

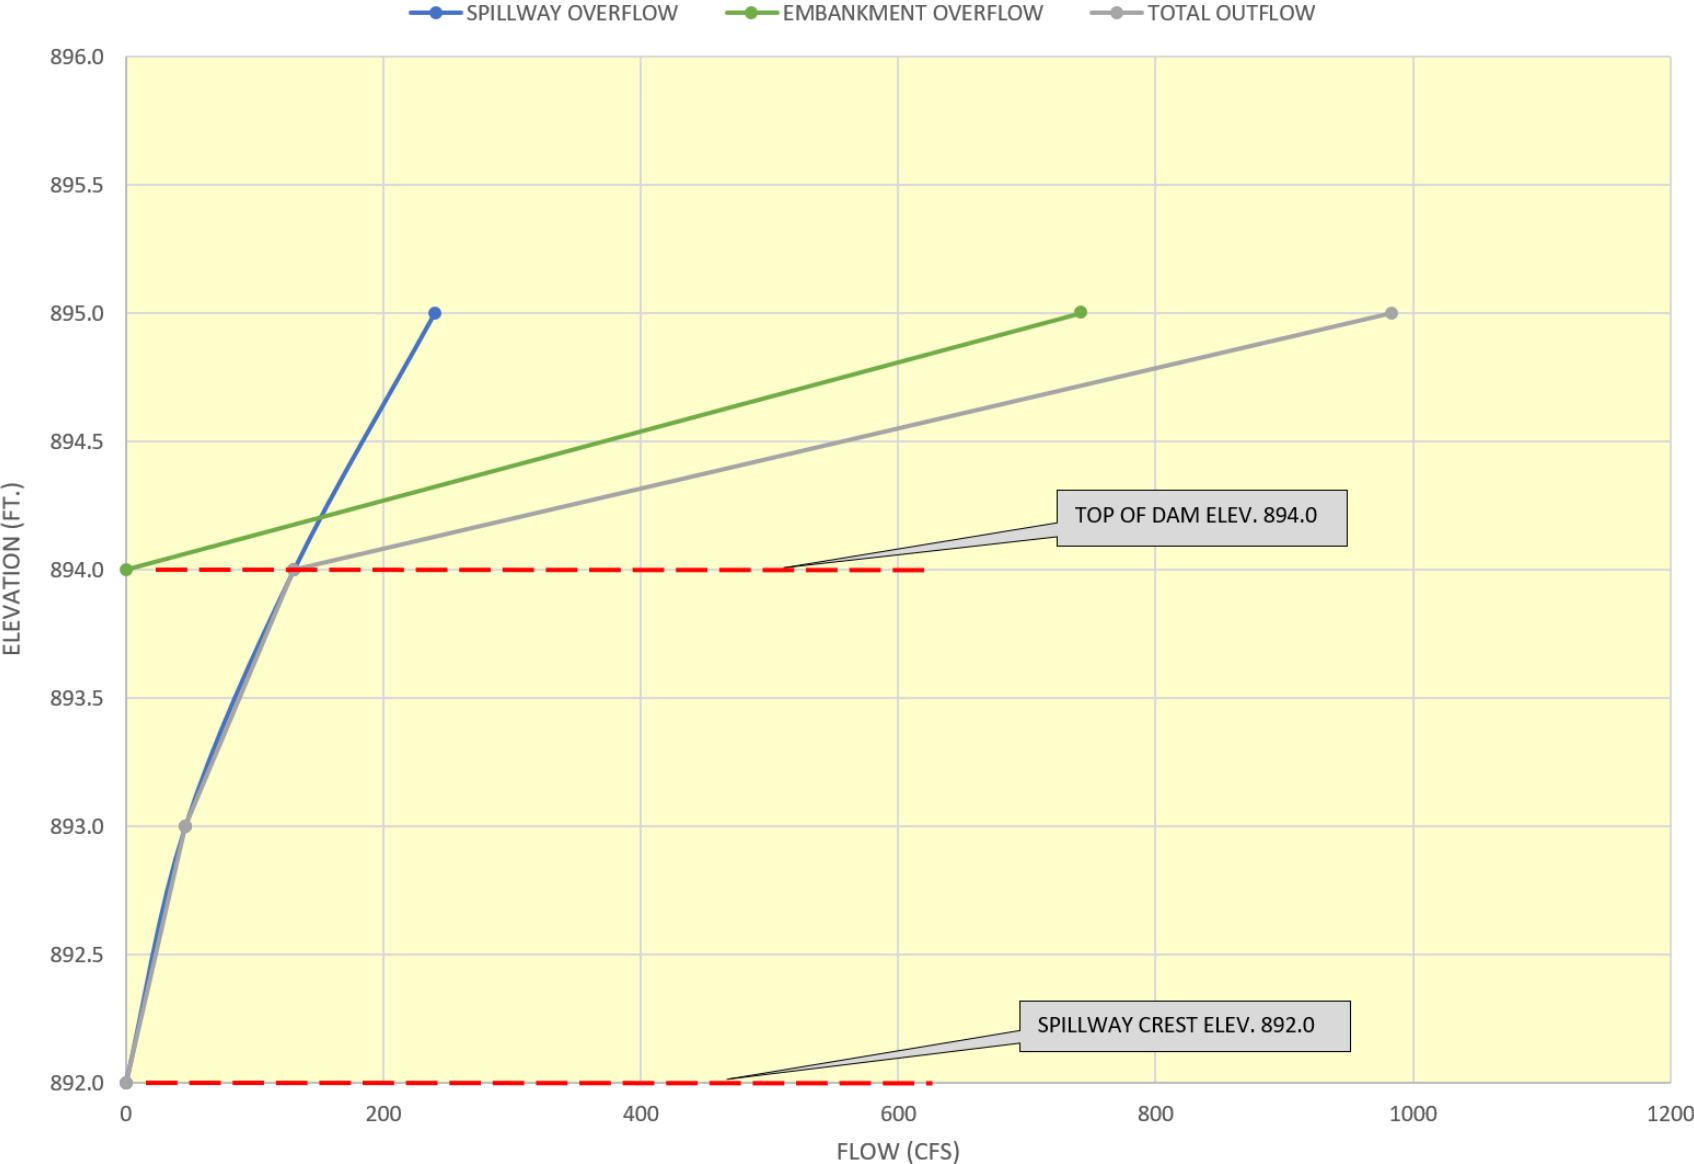
SPILLWAY & EMBANKMENT OUTFLOW & OVERFLOW					
ELEV.	H_{SPILLWAY}	Q_{SPILLWAY}	$H_{\text{EMBANKMENT}}$	Q_{ROAD}	Q_{TOTAL}
892	0	0		0	0
893	1	46		0	46
894	2	131	0	0	131
895	3	240	1	743	984

CEDAR LAKE DAM / OUTFLOWS & EMBANKMENT OVERFLOW

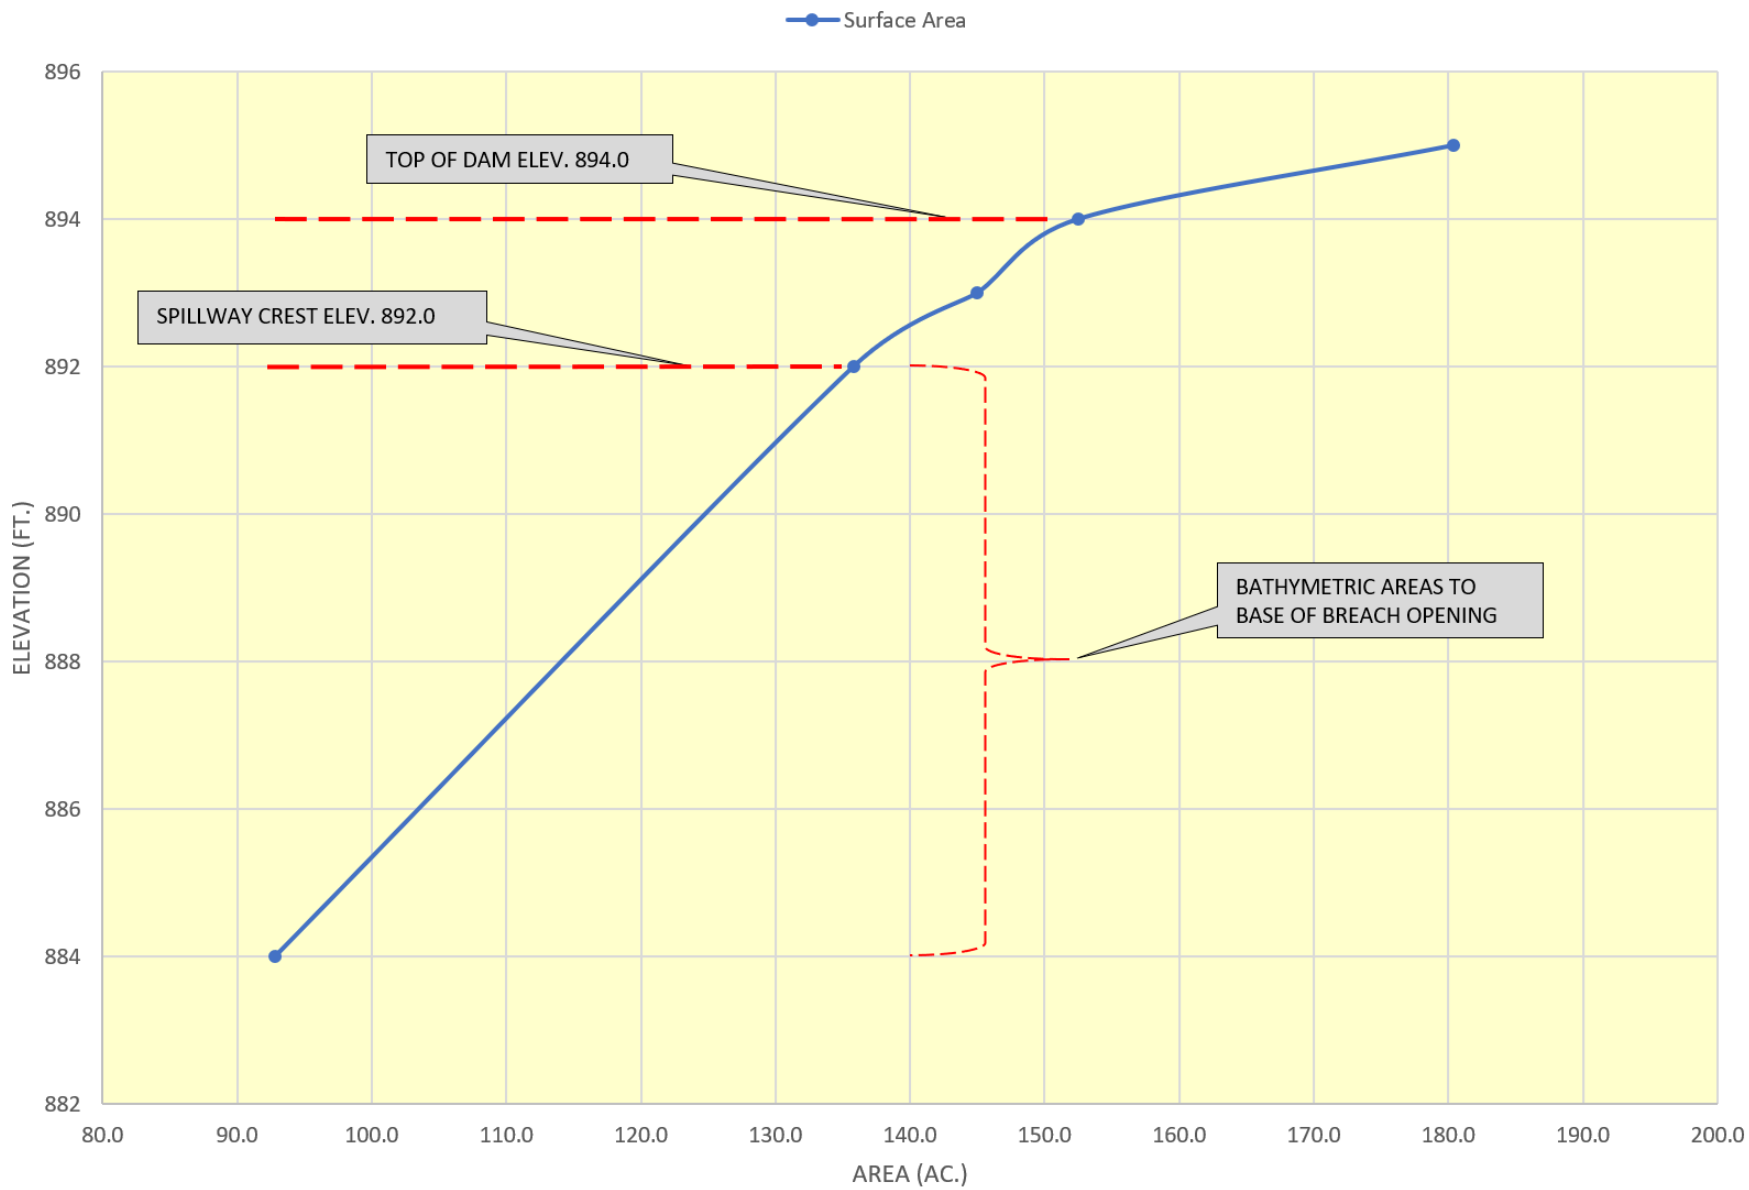
CEDAR LAKE / SURFACE AREAS
