EMERGENCY ACTION PLAN

CEDAR LAKE DAM DEEP #16603 / HAZARD CLASS "B"

NORTH STREET
MAD RIVER
WOLCOTT, CONNECTICUT

NOVEMBER 2020

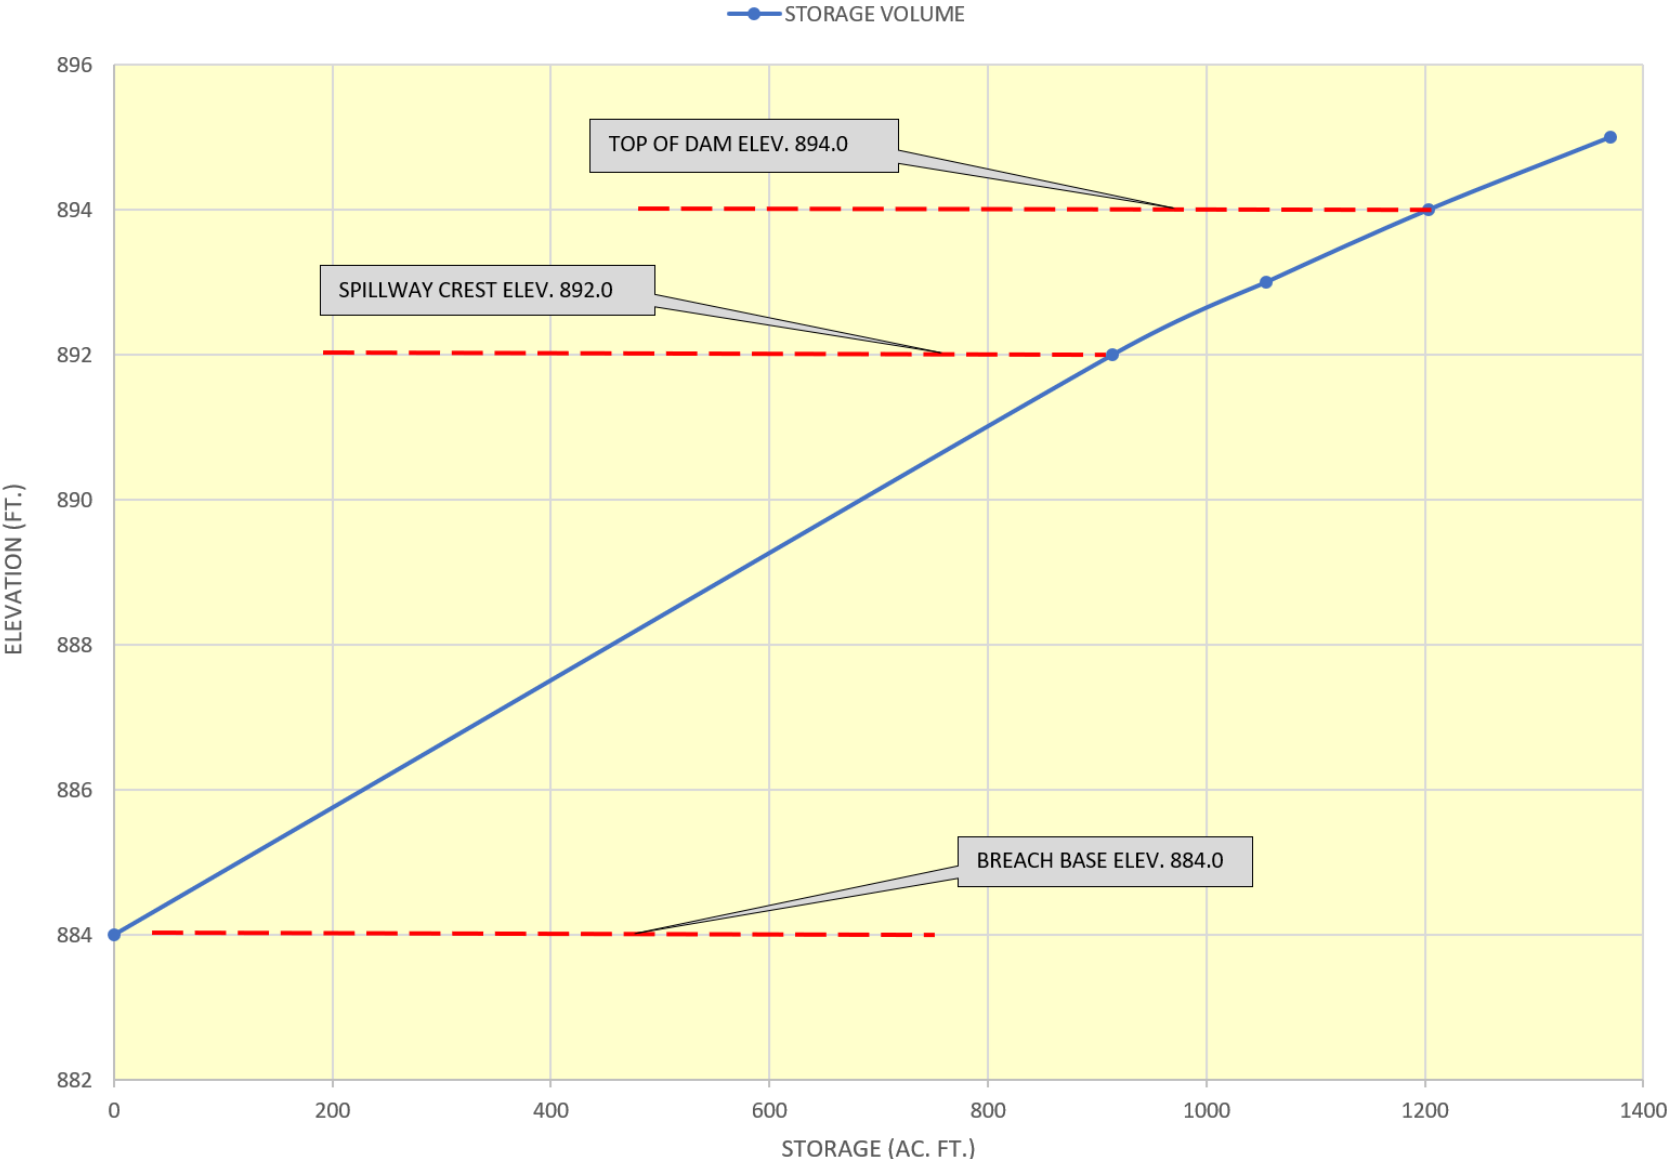
CEDAR LAKE / STORAGE VOLUMES
